SITULA EMT09-554.665 – TIN BRONZE – IRON AGE – SWITZERLAND

Artefact name	Situla EMT09-554.665
Authors	Christian. Degrigny (HE-Arc CR, Neuchâtel, Neuchâtel, Switzerland) & Marie-Jeanne. Scholl (HE-Arc CR, Neuchâtel, Neuchâtel, Switzerland) & Valentin. Boissonnas (HE-Arc CR, Neuchâtel, Neuchâtel, Switzerland)
Url	/artefacts/340/

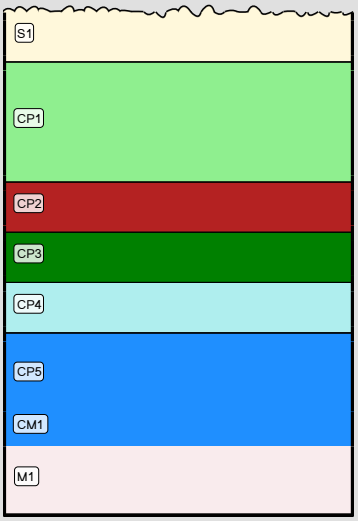
There are 2 stratigraphies (Fig. 5 corresponding to the interior face of the situla and Fig. 6 to its exterior face). The strata are similar in composition but their coding is different: CP1 to CP3 in Fig. 5 correspond to CP3 to CP5 in Fig. 6. Since the stratigraphy of Fig. 6 is more complete, the composition of each of its strata is given below.

Fig. 6: Stratigraphic representation of the object in cross-section using the MiCorr application. This representation shows the interior face and can be compared to Fig. 10 (top square).

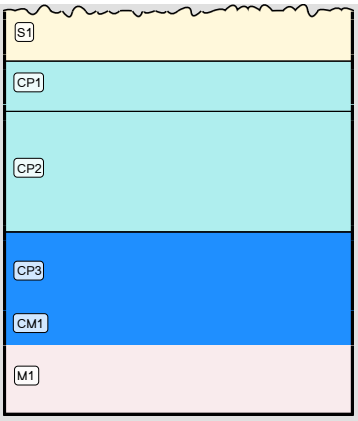
Fig. 5: Stratigraphic representation of the object in cross-section using the MiCorr application. This representation shows the exterior face and can be compared to Fig. 10 (bottom square)
