TANG FRAGMENT OF A KNIFE HR-6567 - LEADED BRONZE - LATE BRONZE AGE - SWITZERLAND

Artefact name	Tang fragment of a knife HR-6567
Authors	Marianne. Senn (EMPA, Dübendorf, Zurich, Switzerland) & Christian. Degrigny (HE-Arc CR, Neuchâtel, Neuchâtel, Switzerland)
Url	/artefacts/341/

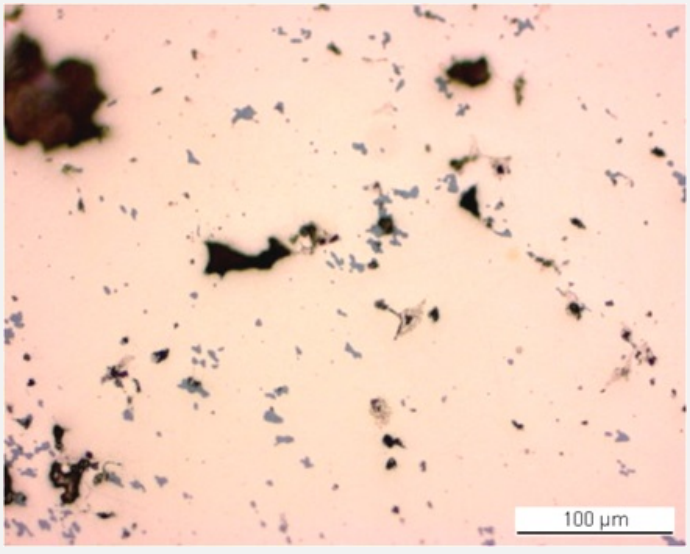
The remaining metal is a leaded bronze (Table 1) containing numerous copper sulphide and tiny Pb inclusions (Figs. 5-7, 10 and Table 2). The porosity within the metal is high, particularly along a band through the middle of the sample (Figs. 3 and 5). The etched structure of the leaded bronze shows small, regular polygonal grains, some with twinning (Fig. 6). Strain lines appear in grains close to the metal surface (Fig. 7). The average hardness of the metal is HV1 120.

Fig. 5: Micrograph of the metal sample from Fig. 3 (detail), unetched, bright field. In pink the metal, in black the porosity and in dark-grey copper sulphide inclusions,

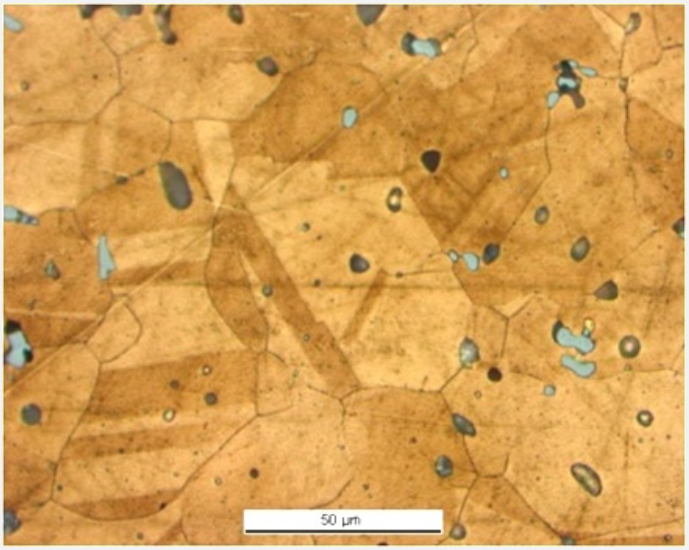
Fig. 6: Micrograph of the metal sample from Fig. 3 (detail), etched, bright field. Angular and twinned grains are revealed as well as copper sulphide inclusions in grey,

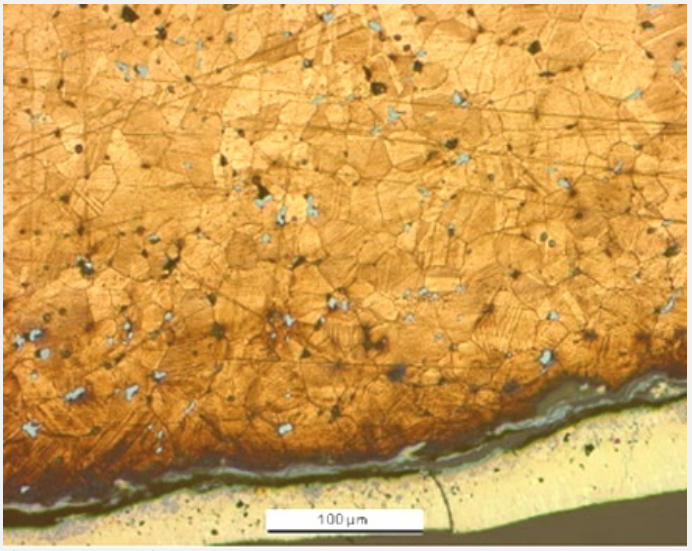
Fig. 7: Micrograph of the metal sample from Fig. 3, etched, bright field (rotated by 270°, detail). Angular grains with strain lines can be seen as well as copper sulphide inclusions in grey,

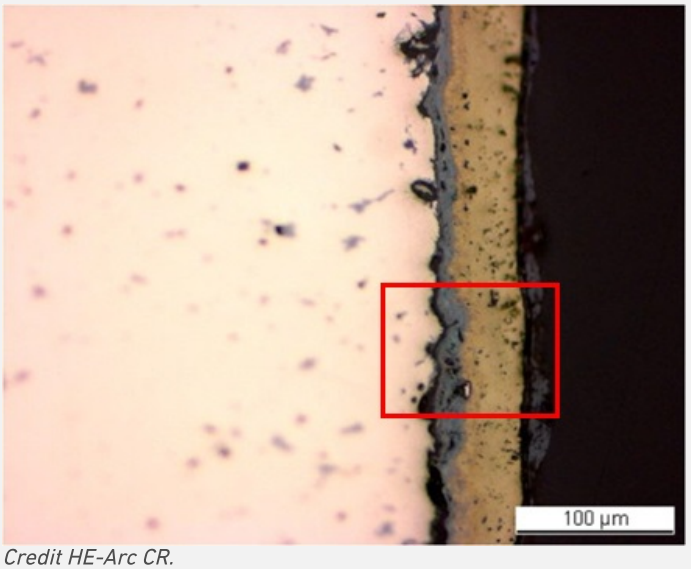
The metal has lost most of its original corrosion crust, the remainder having an average thickness between 60 and 190µm (Fig. 3). In some areas up to three corrosion layers are visible (Fig. 8). In polarised light (Fig. 9), the corrosion stratigraphy appears more clearly: it is composed of a dense black inner layer, an intermediate thick brown layer with bright spots (indicating porosity) and an outer red layer with white particles. The elemental chemical distribution of the SEM image reveals that the black inner layer (CP3) is Sn-rich, but contains Cu, O, Fe, Si, P, Pb, Ni, As, Ca and S (Table 3, Fig. 10). The brown layer (CP2) contains S, Fe and Cu and has a composition similar to chalcopyrite/$CuFeS_2$ (Table 3, Fig. 10). This was confirmed by past XRD analyses carried out by Schweizer (1994, museum report (1987)). The red layer (CP1) is an iron oxide (main elements Fe and O) and is contaminated with calcite/$CaCO_3$ particles (Table 3, Fig. 10).

Fig. 8: Micrograph of the metal sample from Fig. 3 (reversed picture, detail), unetched, bright field. From left to right: metal (in pink), inner light-grey layer, intermediate brown layer and top dark-grey layer. The mapped area of Fig. 10 is marked by a square,

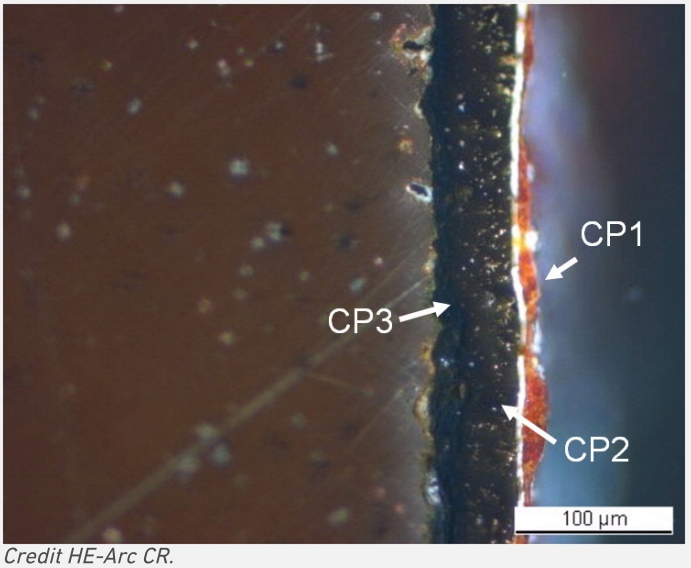
Fig. 9: Micrograph of the same area as Fig. 8 and corresponding to the stratigraphy of Fig. 4, polarized light. From left to right: metal (in brown) covered with a corrosion crust consisting of a black layer, an intermediate brown layer with bright spots, a crack (white line) and a red layer with white particles,

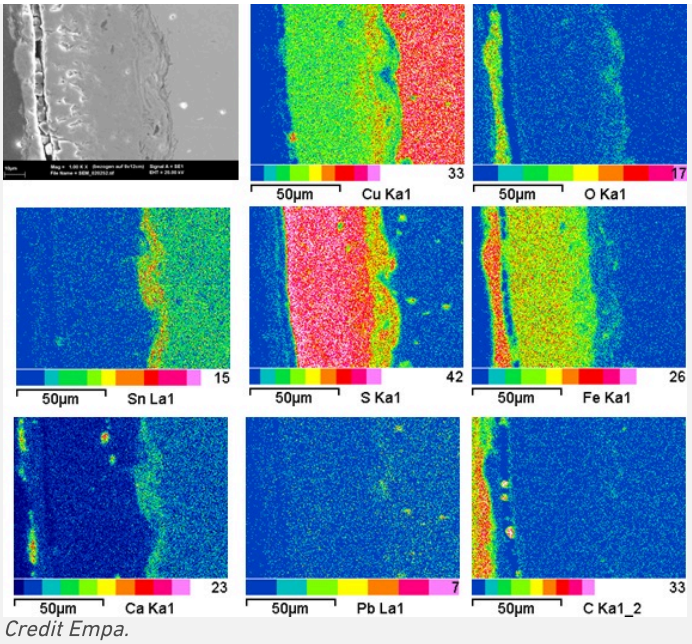
Fig. 10: SEM image, SE-mode, and elemental chemical distribution of the selected area of Fig. 7 (reversed picture). Method of examination: SEM/EDS, Laboratory of Analytical Chemistry, Empa,

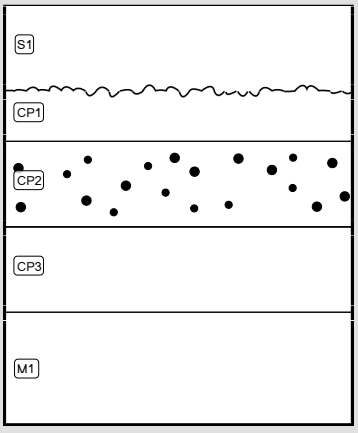
Fig. 4: Stratigraphic representation of the object in cross-section using the MiCorr application. This representation can be compared to Fig. 9.
