OVAL BRACELET WITH SURFACE DECORATIONS OF LINES AND INDENTATIONS MAH ANC. 2662 - LEADED BRONZE - LATE BRONZE AGE - SWITZERLAND

Artefact name Oval bracelet with surface decorations of lines and indentations MAH anc. 2662

Authors Marianne. Senn (EMPA, Dübendorf, Zurich, Switzerland) & Christian. Degrigny (HE-Arc CR, Neuchâtel, Neuchâtel, Switzerland)

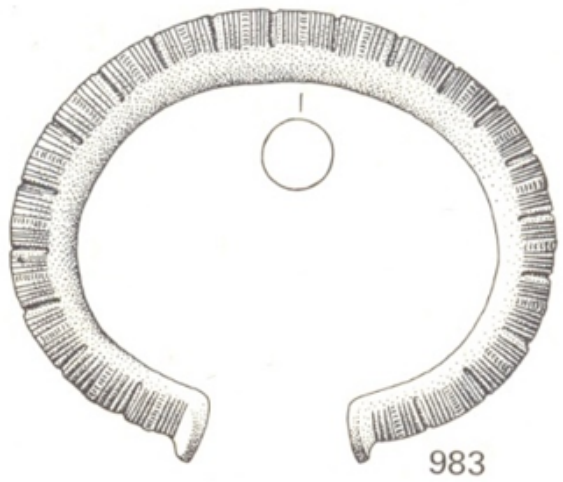
Fig. 1: Leaded bronze bracelet (after Paszthory 1985, Tafel 82),

Description of the artefact Bracelet with a dense, black lake patina (Fig. 1). The bracelet corresponds to the type of bracelet decorated on the outside with alternate of dashes and meanders (Paszthory 1985, 164). Two samples were taken from this object – only one is presented here (Fig. 2). Dimensions: Ø = around 6.1cm; WT = 98g.

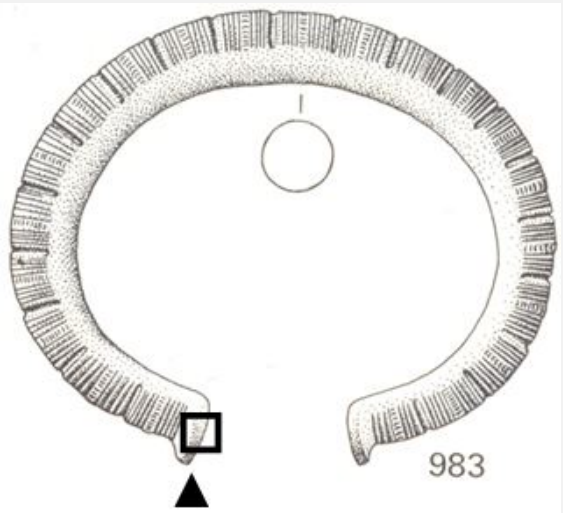
Fig. 2: Location of sampling area,

Description of sample	The sample is a section from one end of the bracelet (Fig. 2). Its dimensions are: L = 1.3mm and W = 0.3mm. The corrosion layer is relatively thick (Fig. 3).
Alloy	Leaded Bronze
Technology	As-cast
Lab number of sample	MAH 77-110-1a
Sample location	Musées d'art et d'histoire, Genève, Geneva
Responsible institution	Musées d'art et d'histoire, Genève, Geneva
Date and aim of sampling	1977, study of black and iron rich surface deposit on the object

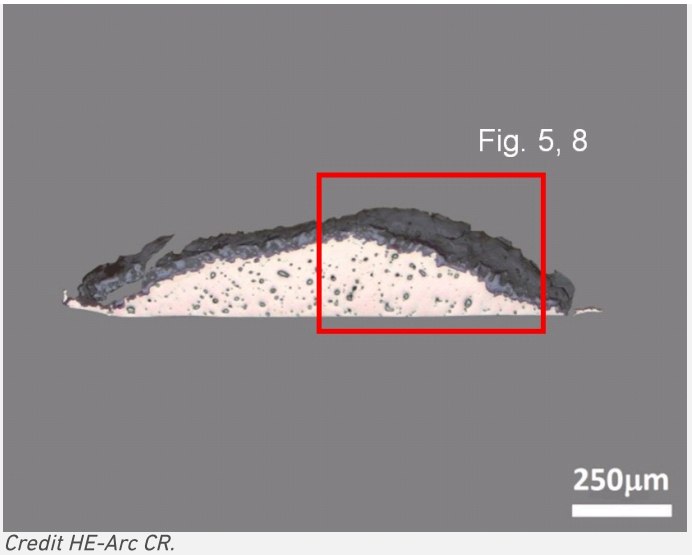
Fig. 3: Micrograph of the cross-section showing the location of Figs. 5 to 8,

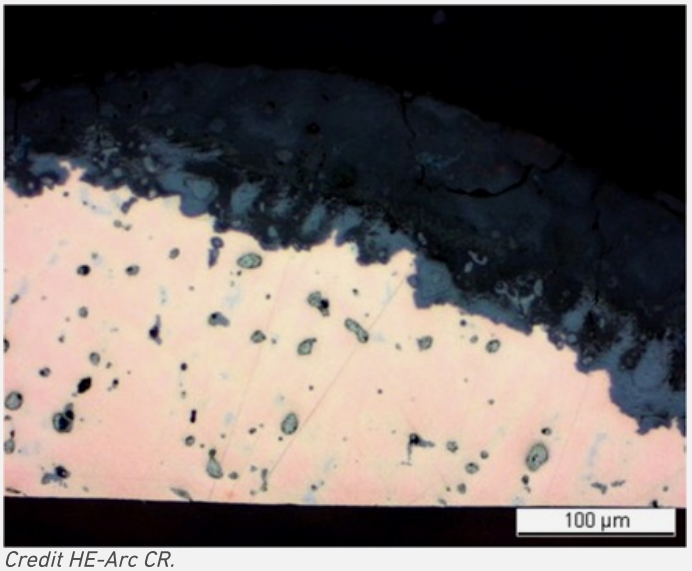
Fig. 6: Micrograph similar to Fig. 5, etched, bright field. The dendritic structure of the leaded bronze is revealed with the alpha-delta eutectoid in white and the alpha phase in pink. The colour difference of the alpha phase is due to coring,

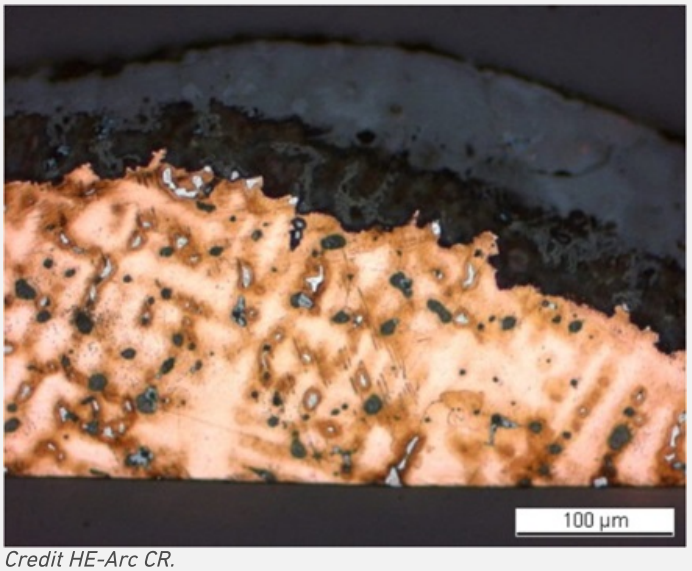
The remaining metal is a leaded bronze (Table 1) with low porosity, light and dark-grey inclusions (Fig. 5). In bright field the unetched alpha-delta eutectoid appears light-blue (Fig. 5). Etching reveals the dendritic structure of an as-cast metal (Fig. 6) with an average hardness of HV1 100. The inclusions appear as dark-grey (Pb-rich) and light-grey (copper sulphide) (Fig. 6 and Table 2) while the alpha-delta eutectoid is white (Fig. 6). The pink alpha phase is cored.

Fig. 5: Micrograph of the metal sample from Fig. 3 (detail), unetched, bright field. The metal is in pink, the Pb-rich inclusions in light-grey, the copper sulphide inclusions in dark-grey and the alpha-delta eutectoid in light-blue,

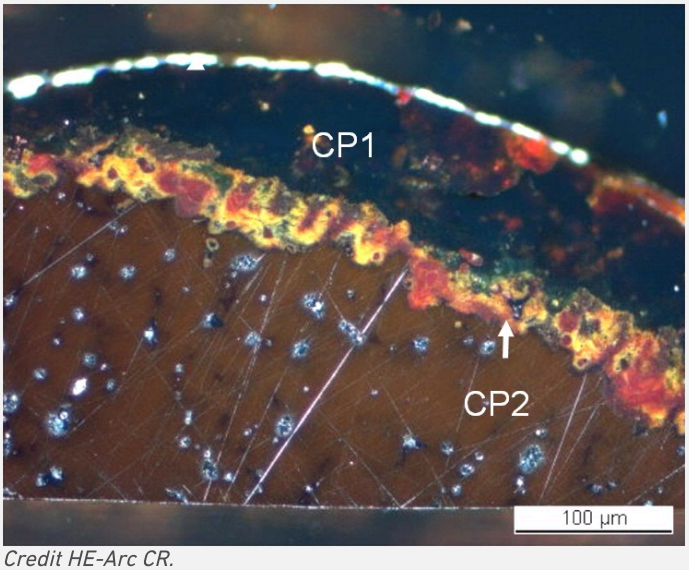
The corrosion crust has an average thickness of 80µm. It is composed of two layers (Fig. 7). The inner layer (CP2), which appears grey in bright field (Fig. 5), retains a Sn-rich dendritic ghost structure (Table 3 and Fig. 8). In polarized light, this layer is a mixture of reddish and yellow-brown corrosion products with some green areas (Fig. 7). The reddish parts have a composition similar to cuprite/Cu2O (Table 3). The adjacent dense, cracked layer, which appears dark-grey in bright field (CP1), is mainly composed of Fe,O and Sn with Sn,O and Fe-rich and Fe and O-rich zones contaminated with Si while being depleted of Cu (Fig. 8). In polarised light, it is dark, almost black with some red areas. In areas it contains Ag, Fe and Sn-rich inclusions with traces of Pb and Cu (Fig. 8 and Table 3).

Fig. 7: Micrograph similar to Fig. 5 and corresponding to the stratigraphy of Fig. 4, polarised light. From bottom left to top right: the metal in brown, the dendritic ghost structure in red, yellow-brown and green and the outer corrosion layer in black with some red areas. The thin white line is a crack,

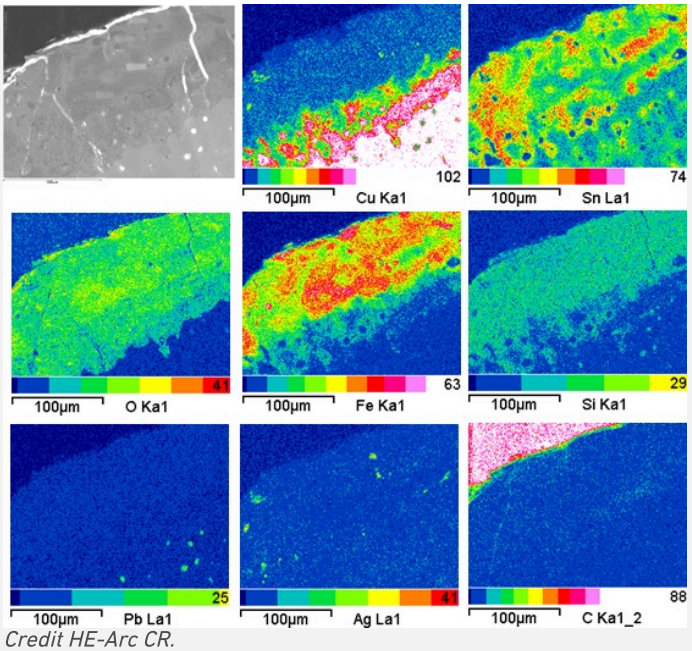
Fig. 8: EDS elemental chemical distribution in an SEM image (detail of Fig. 5, reversed picture). Method of examination: SEM/EDS, Laboratory of Analytical Chemistry, Empa,

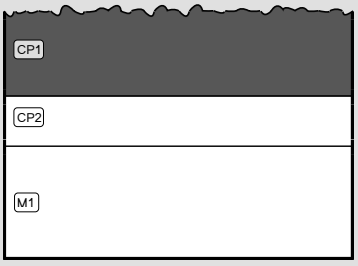
Fig. 4: Stratigraphic representation of the object in cross-section using the MiCorr application. This representation can be compared to Fig. 7.
