OVAL BRACELET WITH A ROUNDED DIAMETER B B3474 - LEADED BRONZE - LATE BRONZE AGE - SWITZERLAND

Artefact name	Oval bracelet with a rounded diameter B B3474
Authors	Marianne. Senn (EMPA, Dübendorf, Zurich, Switzerland) & Christian. Degrigny (HE-Arc CR, Neuchâtel, Neuchâtel, Switzerland)
Url	/artefacts/344/

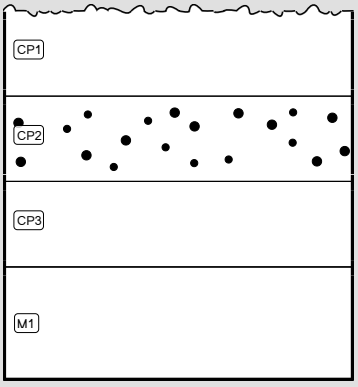
Fig. 4: Stratigraphic representation of the object in cross-section using the MiCorr application. This representation can be compared to Fig. 8.
