PIN WITHOUT HEAD HR-18152 - TIN BRONZE - LATE BRONZE AGE - SWITZERLAND

Artefact name Pin without head HR-18152

Authors Marianne. Senn (EMPA, Dübendorf, Zurich, Switzerland) & Christian. Degrigny (HE-Arc CR, Neuchâtel, Neuchâtel, Switzerland)

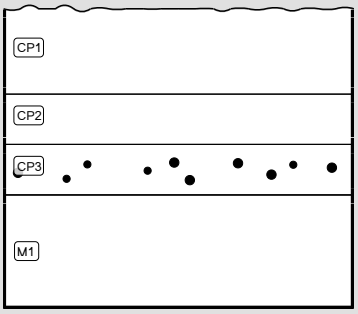
Fig. 4: Stratigraphic representation of the object in cross-section using the MiCorr application. This representation can be compared to Fig. 10.
