SWORD M-SCH-B2735 - P-RICH IRON - IRON AGE - SWITZERLAND

Artefact name	Sword M-Sch-B2735
Authors	Marianne. Senn (EMPA, Dübendorf, Zurich, Switzerland) & Christian. Degrigny (HE-Arc CR, Neuchâtel, Neuchâtel, Switzerland)
Url	/artefacts/349/

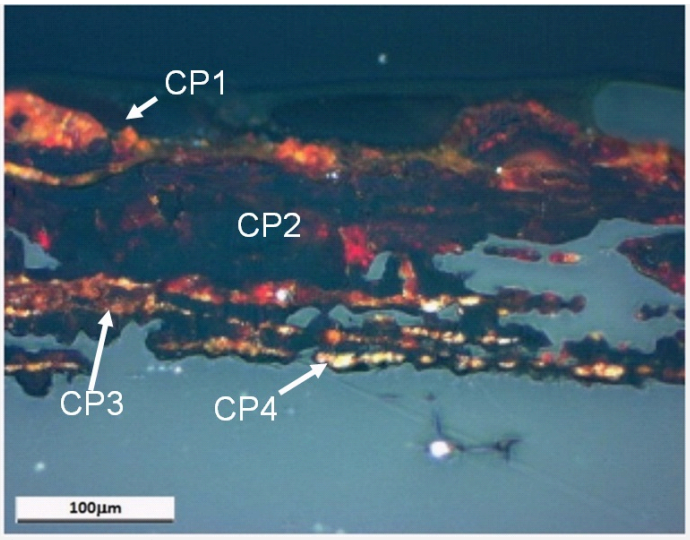
The remaining metal, including the large crack, is covered by a thin, fissured corrosion crust (Figs. 3, 5, 7 and 9). The corrosion crust is thicker on the side containing the long slag inclusions (Fig. 3). In bright field and in the BSE-mode of the SEM image only light and dark-grey areas can be distinguished (Figs. 5 and 10). Under polarised light the corrosion products appear yellow-orange near the metal surface and then become successively dark-red and black. The outer layer (CP1) is orange-yellow, as is the inner one (CP4, Fig. 9). There is a correlation between the level of grey in SEM/BSE-mode, the colours under polarised light, and the chemical composition of the corrosion layer (Table 3, Figs. 9 and 10). The lighter the grey of the SEM/BSE-mode, or the colours (light-brown and red) under polarised light, the richer the area is in Fe and the more depleted it is in O. Surprisingly the inner corrosion layers (CP3 and CP4) are contaminated with Si, Al and O.

Fig. 9: Micrograph showing the metal - corrosion crust interface from Fig. 3 (inverted picture, rotated by 135°, detail) and corresponding to the stratigraphy of Fig. 4, unetched, polarised light. The metal appears in blue and the corrosion changes from yellow-orange (CP4) to dark-red (CP3), black (CP2) and orange (CP1),

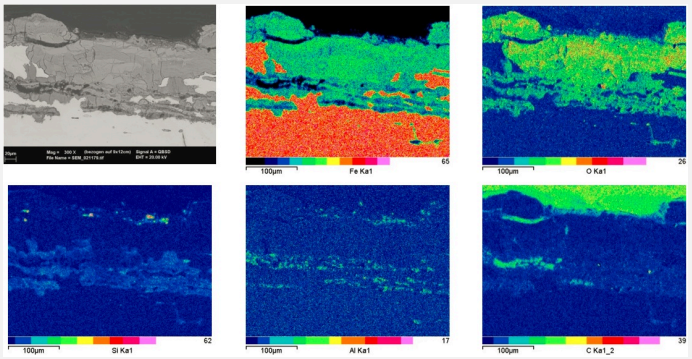
Fig. 10: SEM image, BSE-mode, and elemental chemical distribution of the selected area from Fig. 9. Method of examination: SEM/EDS, Laboratory of Analytical Chemistry, Empa.,

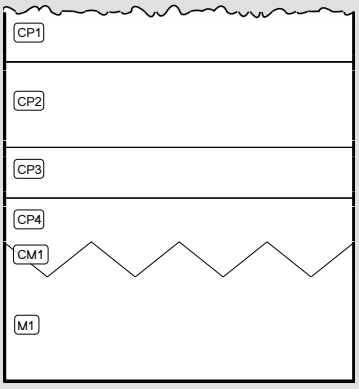
Fig. 4: Stratigraphic representation of the object in cross-section using the MiCorr application. This representation can be compared to Fig. 9.
