CORRODED METAL SHEET FN 655.13.01 – FE ALLOY – MODERN TIMES – SWITZERLAND

Authors Marianne. Senn (EMPA, Dübendorf, Zurich, Switzerland) & Christian. Degrigny (HE-Arc CR, Neuchâtel, Neuchâtel, Switzerland)

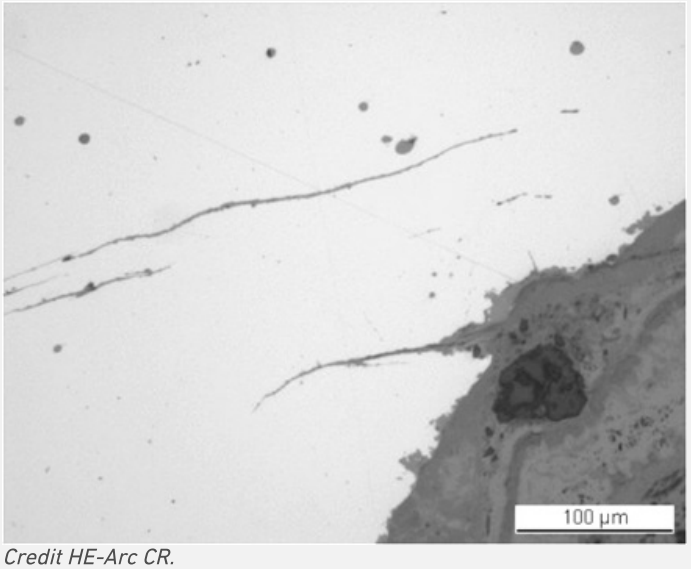
The remaining metal is an iron containing elevated (more than 1g/kg) concentrations of Co and Ni (Table 1), small round slag inclusions and cracks resulting from corrosion and deformation (Fig. 5). The composition of the round, elongated slag inclusions is similar to wüstite-FeO (Table 2). Iron reduced in the direct smelting process never contains such pure compounds and only FeO inclusions. In modern steels FeO occurs in low carbon alloys and Armco-iron (Schumann 1991, 474). After etching, the cross-section shows a heavily deformed ferritic microstructure from cold working (Fig. 6). The cracks have the same orientation as the deformation. The average hardness of the metal is HV1 195.

Fig. 5: Micrograph of metal sample from Fig. 3 (inverted picture, detail), unetched, bright field. In white the metal with round slag inclusions as well as cracks filled with corrosion products,

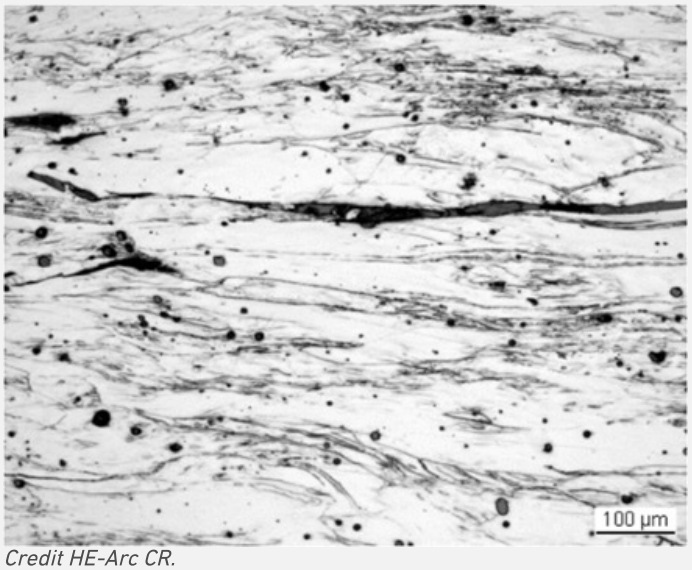
Fig. 6: Micrograph of metal sample from Fig. 3 (detail), etched, bright field. The heavily cold worked metal shows elongated grains with nearly invisible grain boundaries and cracks parallel to the grains,

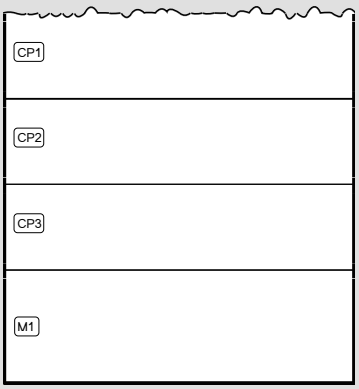
Fig. 4: Stratigraphic representation of the object in cross-section using the MiCorr application. This representation can be compared to Figs. 7 and 8.
