# WEDGE PART OF AN ALTAR CROWN SUSPENSION – P-RICH IRON AND HYPOEUTECTOID STEEL – MODERN TIMES – SWITZERLAND

| **Artefact name** | Wedge part of an altar crown suspension |
| **Authors** | Marianne. Senn (EMPA, Dübendorf, Zurich, Switzerland) & Christian. Degrigny (HE-Arc CR, Neuchâtel, Neuchâtel, Switzerland) |

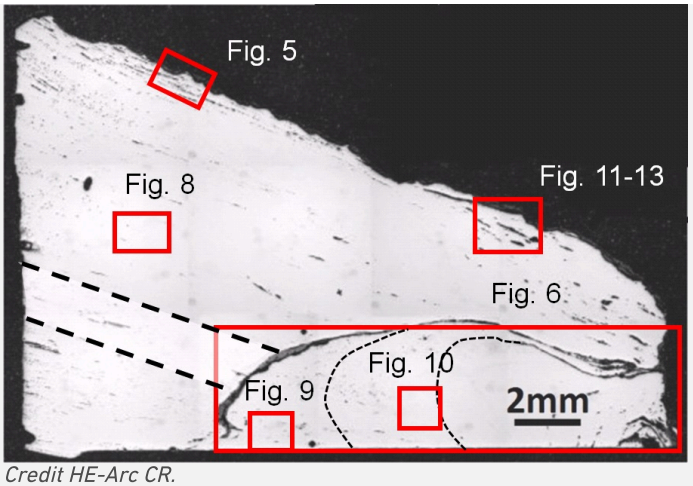
Fig. 3: Micrograph of the cross-section showing the location of Figs. 5 to 13. Steel areas are delimited by black dotted lines,

The remaining metal (M1) is a P-rich iron (0.3-0.45 mass%) with two zones (M3) consisting of soft, hypoeutectoid steel (C content 0.2 mass%) (Fig. 3 and Table 1). The P-rich iron contains many elongated slag inclusions of various sizes forming parallel rows (Figs. 3 and 5). The number of slag inclusions is higher than in bloomery iron and their distribution is typical for rolled metal. A crack, partially filled by hammer scale and corrosion products, indicates a poor quality welding seam (Fig. 3). Below the inclusions the curve produced by forging is highlighted. In good quality wrought iron slag inclusions are small, uniformly distributed and have identical compositions (Boesenberg 2006, 622). This is not the case in this sample, but can be explained by the rudimentary rolling process of the 18$^{th}$ century. The chemical composition of the slag inclusions shows that iron oxides dominate, beside phosphorus oxide, calcium oxide and silica (Table 2). The composition is typical for slag formed by hearth refining of pig iron (Dillmann and

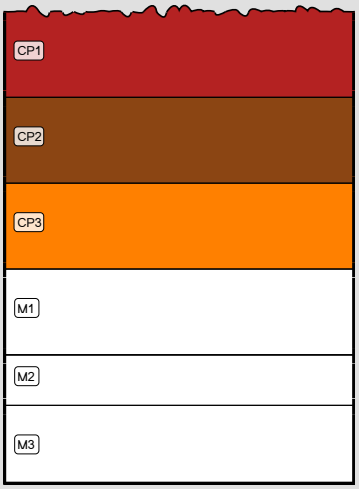
Fig. 4: Stratigraphic representation of the object in cross-section using the MiCorr application. This representation can be compared to Fig. 12.
