MOIL CHISEL DEV 995 762 PR – STEEL – EARLY MEDIEVAL TIMES – SWITZERLAND

Artefact name	Moil chisel DEV 995 762 PR
Authors	Marianne. Senn (EMPA, Dübendorf, Zurich, Switzerland) & Christian. Degrigny (HE-Arc CR, Neuchâtel, Neuchâtel, Switzerland)
Url	/artefacts/352/

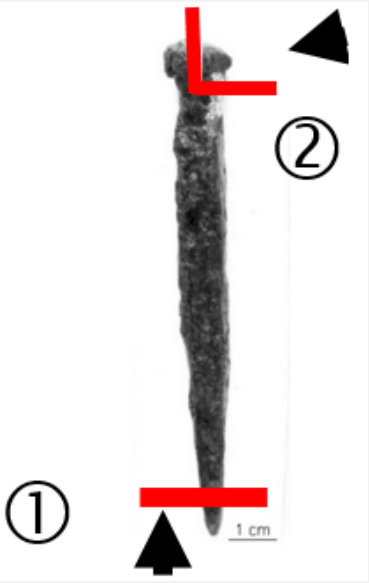
Fig. 1: Steel chisel (after Eschenlohr et al. 2007, 265, 302-303),

Description of the artefact	Moil chisel, the square shaft is rounded near the point, the head is concave and shows traces of flattening (Fig. 1). The black colour of the surface is due to the conservation treatment (see below).
Type of artefact	Tool
Origin	Settlement Develier, Courtételle, Jura, Switzerland
Recovering date	Excavated in 1995, farm 1
Chronology category	Early medieval times
chronology tpq	550 A.D.
chronology taq	750 A.D.
Chronology comment	550 _ 750 AD
Burial conditions / environment	Soil
Artefact location	Office de la Culture, Porrentruy, Jura
Owner	Office de la Culture, Porrentruy, Jura

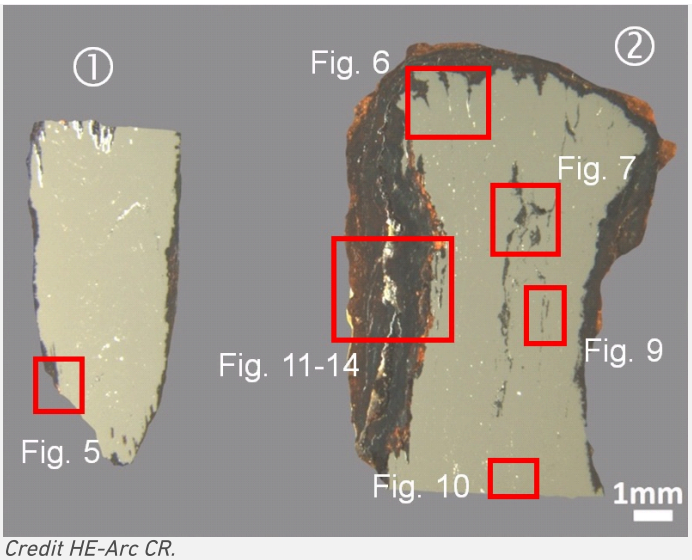
Fig. 3: Micrograph of the cross-sections from samples 1 and 2 showing the location of Figs. 5 to 7 and 9 to 14,

Description of sample	Two samples were taken on both extremities of the chisel (Fig. 2). They show the remaining metal covered by thick and cracked corrosion crusts (Fig. 3).
Alloy	Steel
Technology	Welded
Lab number of sample	DEV 762
Sample location	Empa (Marianne Senn)
Responsible institution	Office de la Culture, Porrentruy, Jura
Date and aim of sampling	2000, metallography and chemical composition of the metal

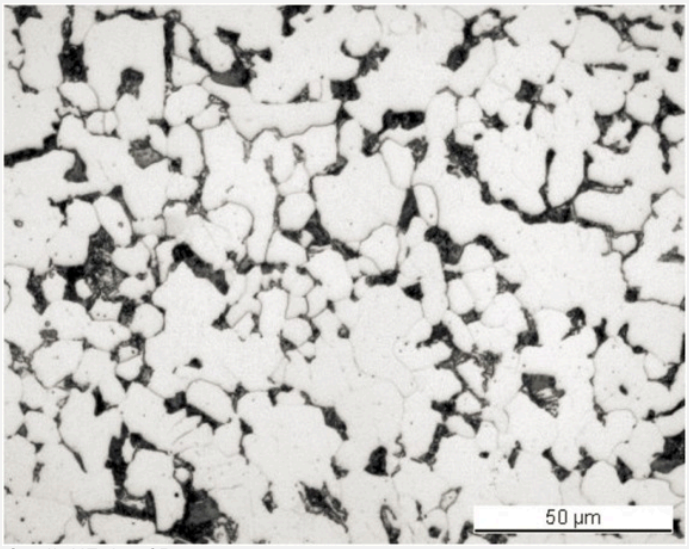
Fig. 9: Micrograph of cross-section from Fig. 3 (detail), nital etched, bright field. We observe a hypoeutectoid steel including a ferritic zone surrounded by slag inclusions,

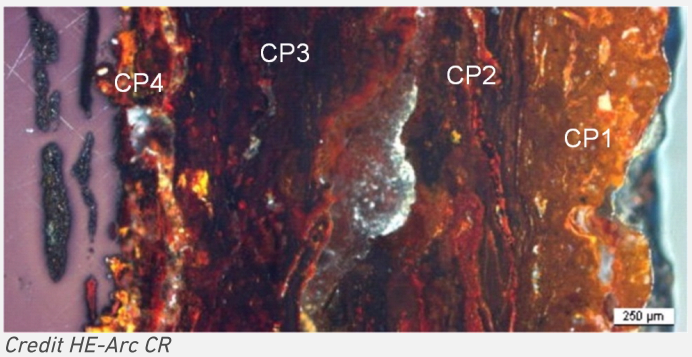
The metal - corrosion products interface is irregular (Fig. 3) and the average thickness of the corrosion crust is about 0.6mm. However, on the left side of the sample taken from the head of the chisel (Fig. 3) the corrosion crust is deeper with an average thickness of about 2mm. This area is further detailed below (Figs. 11 and 12). The corrosion crust can be divided into several layers (CP1-CP4). In bright field, and in the BSE-mode of the SEM image, darker and lighter regions are visible (Figs. 11, 13 and 14). In this area the corrosion layer contains typical trace elements of the metal (As and P, Table 3). In polarised light we see a dark-red zone in which different grey zones are included (Fig. 12). The element mapping and the analyses show that at the metal - corrosion crust interface iron chlorides occur (Figs. 13 and Table 3, CP4 in Fig. 4). Only the outer zone, which has reacted with the soil, has a different colour (orange) and incorporates many rock inclusions (Si, Al and Ca) (Fig. 14 and Table 3, CP1 in Fig. 4).

Fig. 11: Micrograph showing the metal - corrosion crust interface from Fig. 3 (reversed picture, detail), unetched, bright field. The micrographs of Fig. 13 (left) and Fig. 14 (right) are marked by rectangles,

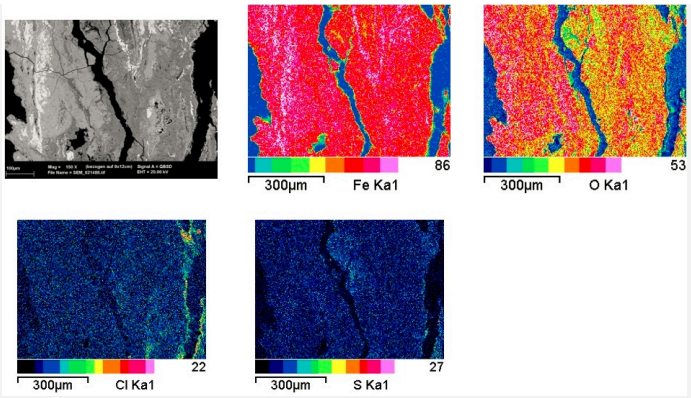
Fig. 13: SEM image, BSE-mode, and elemental chemical distribution of the selected area from Fig. 10 (reversed picture). Method of examination: SEM/EDS, Laboratory of Analytical Chemistry, Empa,

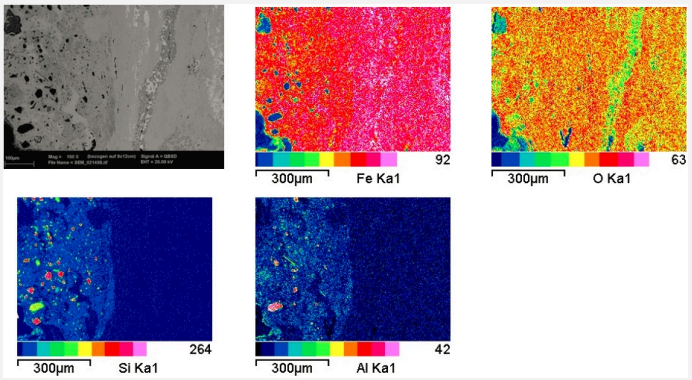
Fig. 14: SEM image, BSE-mode, and elemental chemical distribution of the selected area from Fig. 10 (reversed picture). Method of examination: SEM/EDS, Laboratory of Analytical Chemistry, Empa,

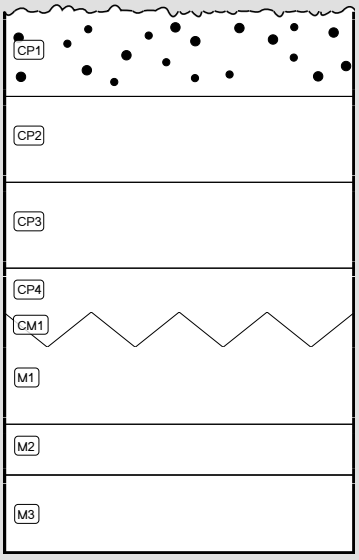
Fig. 4: Stratigraphic representation of the object in cross-section using the MiCorr application. This representation can be compared to Fig. 12.
