RAIN GUTTER FRAGMENT – GREY CAST IRON – MODERN TIMES – FRANCE

Artefact name	Rain gutter fragment
Authors	Christian. Degrigny (HE-Arc CR, Neuchâtel, Neuchâtel, Switzerland) & Mathea. Hovind (University of Oslo, Department of archaeology, conservation and history (IAKH-UiO), Oslo, Oslo, Norway)
Url	/artefacts/358/

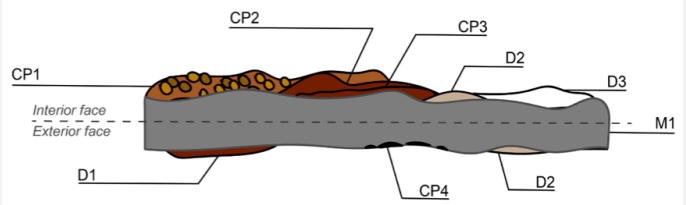
Fig. 2. The exterior and interior faces before sampling. The dotted line represents the sample location (a cross-section of the metal). The fracture edge corresponds to the edge that was formerly attached to the remaining artefact,

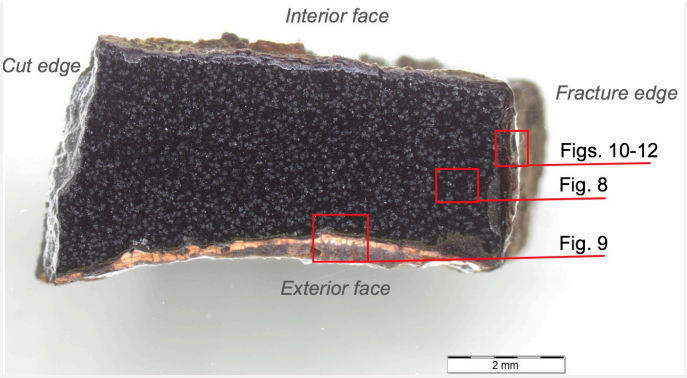
Captions	Description
D1	Scattered, orange to dark red encrustations. Probably corrosion products mixed with soil.
D2	Grey-brown and matte deposit, somewhat powdery - possibly corrosion product mixed with soil. This layer is located both on the interior and exterior surface of the artefact.
D3	Localized, white and strongly adherent deposit.
CP1	Bright orange to dark red corrosion product. Uneven surface with pustules.
CP2	Red-brown corrosion crust. Brittle, but adherent. Flakes off in bits when force is applied perpendicular to the surface with a scalpel.
CP3	Similar to CP2 but appears to be an individual layer.
CP4	Isolated corrosion blisters. Circular and black in colour. Mainly located on the exterior surface.
M1	Intact metal with a dark grey metallic sheen.

Fig. 3. Preliminary stratigraphy corresponding to the overall surface of the artefact. The interior surface is shown above the stippled line and the exterior surface below. D = Deposit, CP = Corrosion products, M = Metal,

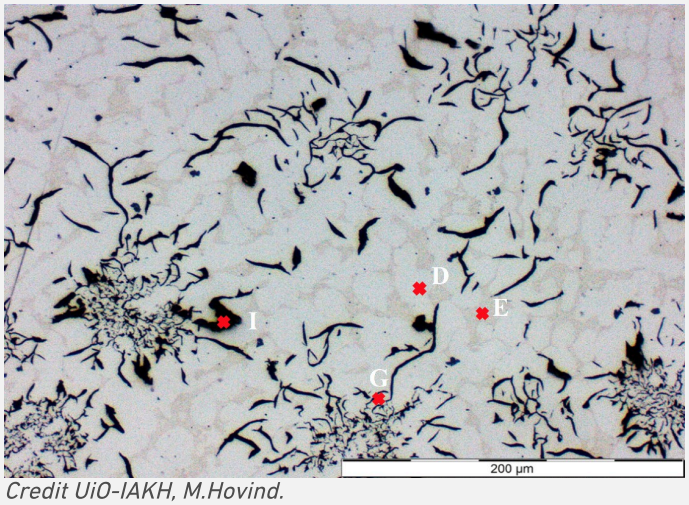
The metal is a P-rich grey cast iron with Si and Mn (Fig. 7). Its microstructure is characterized by evenly distributed graphite flakes in a matrix composed of dendrites and an interdendritic eutectic phase (Fig. 8). What appears to be irregular graphite flakes/porosity is in fact deformed graphite flakes; graphite is soft and prone to destruction by smearing and/or preferential removal during polishing (Scott 1991:38-39).

Fig. 7: EDS-spectrum showing the chemical composition of the metal. Method of analysis: SEM-EDS. Lab. of Electronic Microscopy and Microanalysis, Néode, HEI Arc,

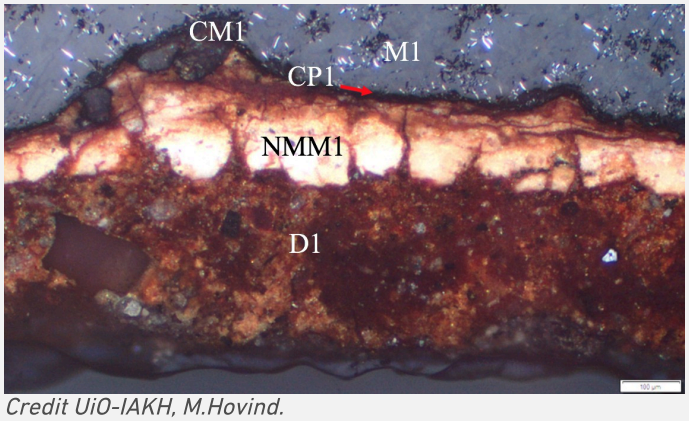
The exterior face (Figs. 2, 4 and 9) consists of a white cracked layer (NMM1 in Fig. 5) superimposed by a layer of deposit mixed with orange-red corrosion products (D1 in Fig. 5). Punctual analysis by SEM-EDS (Table 2) revealed that the white layer is rich in Ba, O, S, Fe, C and Zn. It has a chemical composition similar to Lithopone (BaSO4 ZnS), a preparatory paint layer. Fe is probably a contamination from the superimposed deposit/corrosion product D1 (Table 2). The latter (D1) is Fe- and O-rich and contains Si, Al and some Ca, in addition to a range of elements (K, P, Na, Cl, S and Ti) present in minor

Table 2: Chemical composition of the strata from Fig. 9. Method of analysis: SEM-EDS. Lab. of Electronic Microscopy and Microanalysis, Néode, HEI Arc, credit MiCorr_HEI Arc, C.Csefalvay. *The value is the calculated average of three analyses of the same feature, but in different areas.

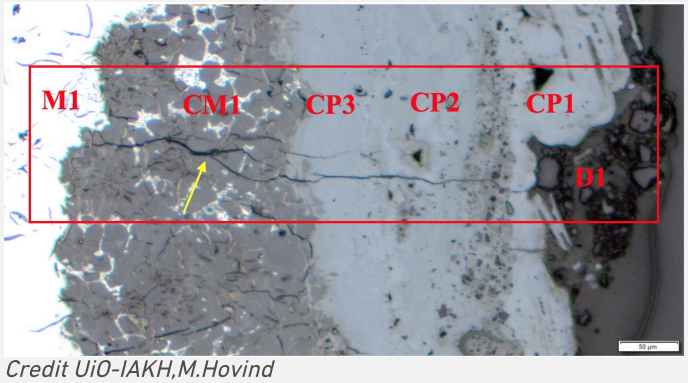
amounts (Table 2). A thin layer of corrosion products (CP1) is located just beneath the paint layer, appearing dark grey under polarized light (Fig. 9). This layer is followed by a corroded metal phase (CM1). Their exact composition was not analyzed but is likely to correspond to the corroded metal phase of the fracture edge, described below.

Fig. 9. Micrograph of the metal sample from Fig. 4 (detail), unetched, polarized light, 5x. The stratigraphy of the exterior surface, from top to bottom: the metal (M1) in grey, a thin layer of corroded metal (CM1) and a white cracked layer (NMM1) superimposed by a porous dark-red deposit (D1),

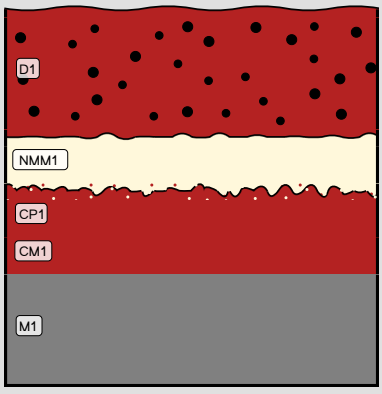
Fig. 5. MiCorr stratigraphy of the exterior face, to be related to the micrograph of Fig. 9. CP1 corresponds to CP2 in Fig. 3, Credit UiO-IAKH, M.Hovind.

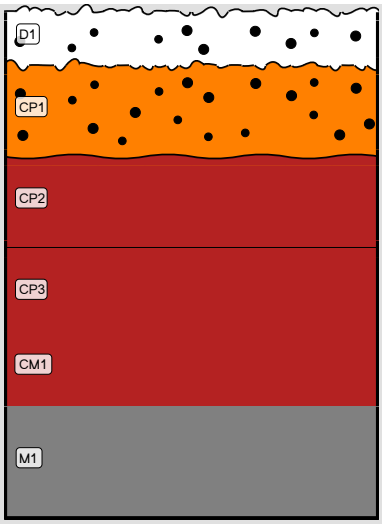
Fig. 6. MiCorr stratigraphy of the fractured edge, to be related to the micrograph of Fig. 11. D1 corresponds to D3 in Fig. 3, Credit UiO-IAKH, M.Hovind.

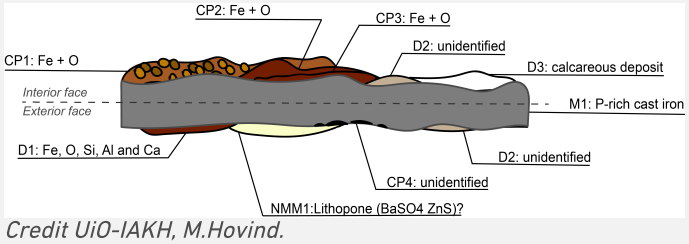
Based on the analyses carried out, the stratigraphy of Fig. 3 has been corrected.

Fig. 13. Corrected stratigraphic representation with results of SEM-EDS analysis and visual microscopic observation,

The rain gutter fragment is a grey cast iron with a microstructure consisting of graphite flakes and a P-rich eutectic phase. The exterior surface contains a preparatory paint layer, located beneath a layer of corrosion products mixed with soil. It seems likely that the cast iron gutter has been covered with a protective layer of paint (e.g. Lithopone) to slow down the rate of atmospheric corrosion. The presence of Lithopone reinforces the suggested dating of the artefact (20th century) as this pigment was developed and used from the 1880s and onwards (Lithopone 2007). It seems however that the protective layer has none or only very limited effect as (pitting) corrosion is present also in these areas.

The corrosion layers consist mainly of Fe and O, indicating atmospheric corrosion with presence of none or only a very small amount of contaminants/pollution. The scattered white deposit is possibly originating from exposure to calcareous water as it is localized mainly on the interior face of the fragment, where rain water would hit the metal before entering the ground.
