TOWEL BAR – AL ALLOY – MODERN TIMES – FRANCE

Artefact name Towel bar

Authors Christian. Degrigny (HE-Arc CR, Neuchâtel, Neuchâtel, Switzerland)

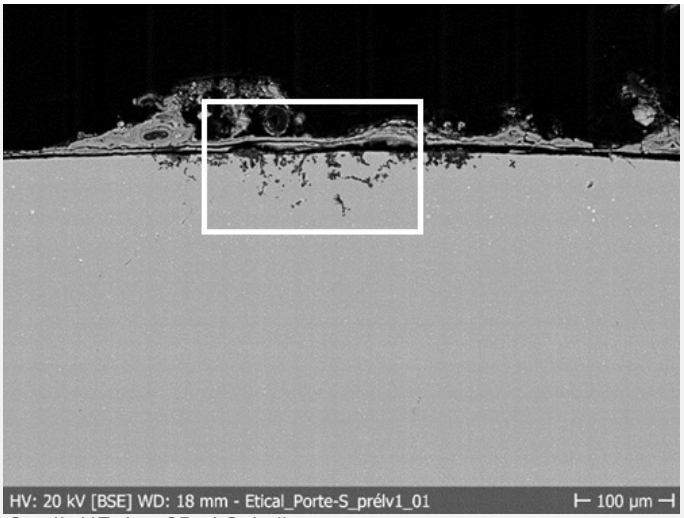
Fig. 3: SEM image of the cross-section showing the location of Fig. 5,

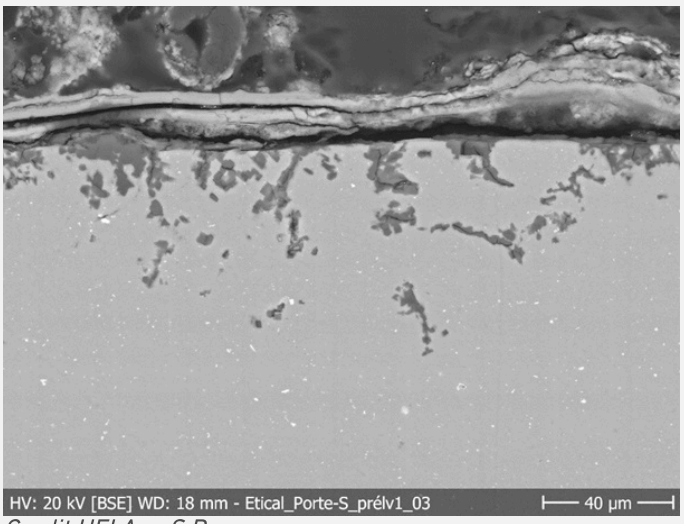
The metal is a relatively pure aluminium alloy with numerous inclusions (Fig. 5). From their chemical composition they can be interpreted as Al3Fe intermetallic compounds (Fig. 6). Pitting corrosion as well as a start of intergranular

corrosion develops locally under the deposits, outlining some of the grains (Fig. 5).

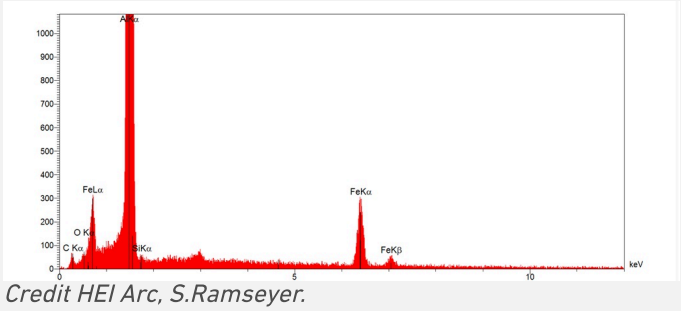
Fig. 5: SEM image of the metal sample from Fig. 3 (detail), BSE-mode. We observe the presence of numerous inclusions,

Fig. 6: EDS spectrum of the inclusions of Fig. 5,
