SHINGLE OF A ROOF – CU ALLOY – MODERN TIMES – SWITZERLAND

Artefact name	Shingle of a roof
Authors	Marianne. Senn (EMPA, Dübendorf, Zurich, Switzerland) & Christian. Degrigny (HE-Arc CR, Neuchâtel, Neuchâtel, Switzerland)
Url	/artefacts/370/

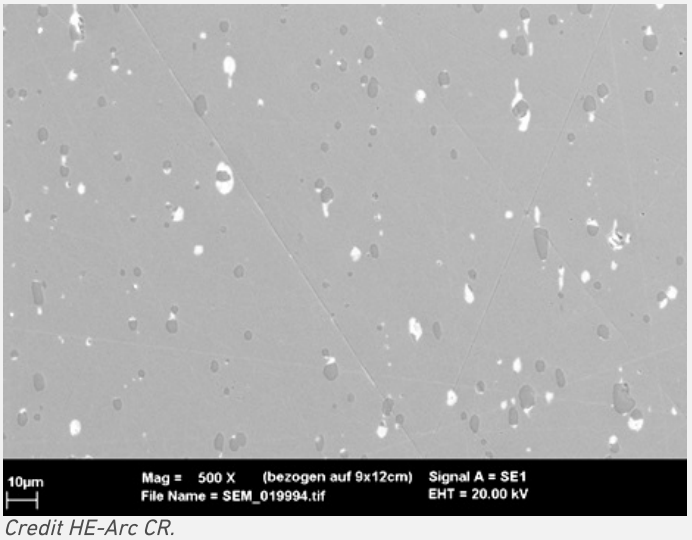
The remaining metal is a copper alloy (Table 1). The evenly distributed inclusions observed under SEM, SE-mode, are either light-grey or white (Fig. 5). The oval shape of the light-grey inclusions is due to deformation, probably by hot rolling (a common technique in the 18th century). Under polarised light they look red (Fig. 7) and their analysis reveals a composition similar to cuprite/Cu2O (Table 2). The white inclusions are rich in Pb and are remnants of the refining process (Table 2). The etched copper shows a structure of polygonal and twinned grains (Fig. 6). The grain size is variable. The average hardness of the metal is about HV1 70.

Table 2: Chemical composition (mass %) of the inclusions in the metal (from Fig. 5). Method of analysis: SEM/EDS, Laboratory of Analytical Chemistry, Empa.

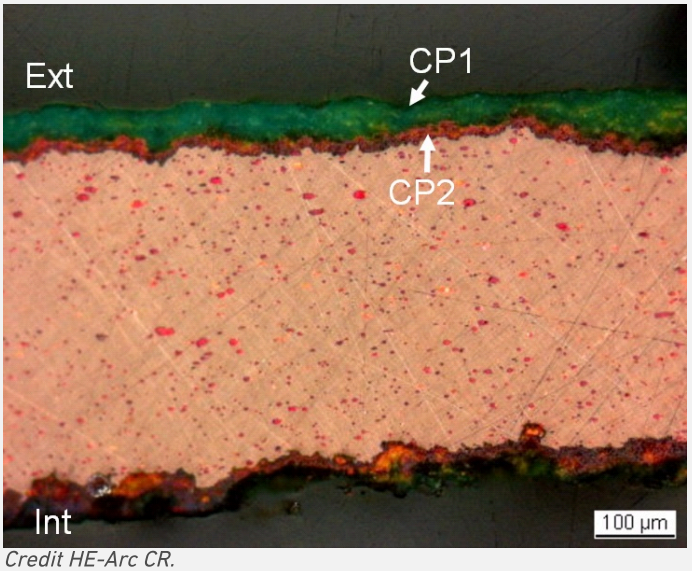
The corrosion crusts of the external and internal sides are distinctively different (Fig. 7). On the internal side an irregular red-orange corrosion layer has developed, and pitting corrosion has occurred. The more uniform corrosion layers on the external side are composed of a red-orange layer, followed by a thicker green outer layer. In some areas, dark-red corrosion products can be observed between the green and red-orange sub-layers. The same dark-red sub-layer can be seen in areas on the internal side covering the red-orange corrosion products. The red-orange corrosion layer on both sides (CP2) has a chemical composition similar to cuprite/Cu_2O, while the green layer on the external side (CP1) contains Cu, S and O and is enriched on its upper surface with Si (Table 3 and Fig. 8). XRD analysis of the corrosion products on the external side of another shingle fragment from the same roof identified brochantite/$Cu_4SO_4(OH)_6$ and cuprite as corrosion products (Rapport d'analyse no. MAH 98-257). These results are confirmed by Raman spectroscopy of the external side of this sample where the same compounds were clearly identified (Figs. 9 and 10).

Table 3: Chemical composition (mass %) of the corrosion layers of the external side. Method of analysis: SEM/EDS, Laboratory of Analytical Chemistry, Empa.

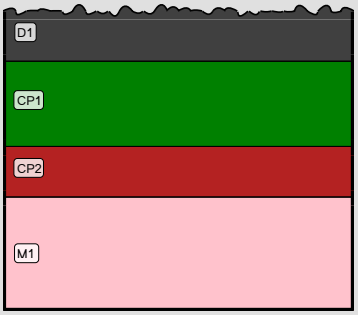
Fig. 4: Stratigraphic representation of the object in cross-section using the MiCorr application. This representation can be compared to Fig. 7, Credit HE-Arc CR.
