CORRODED METAL SHEET FN 655.13.01 – FE ALLOY – MODERN TIMES – SWITZERLAND

Authors Marianne. Senn (EMPA, Dübendorf, Zurich, Switzerland) & Christian. Degrigny (HE-Arc CR, Neuchâtel, Neuchâtel, Switzerland)

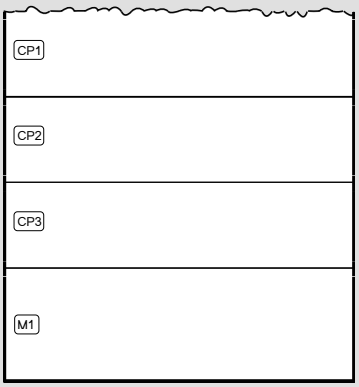
Fig. 4: Stratigraphic representation of the object in cross-section using the MiCorr application. This representation can be compared to Figs. 7 and 8, Credit HE-Arc CR.
