PIN WITHOUT HEAD HR-18152 - TIN BRONZE - LATE BRONZE AGE - SWITZERLAND

Artefact name Pin without head HR-18152

Authors Marianne. Senn (EMPA, Dübendorf, Zurich, Switzerland) & Christian. Degrigny (HE-Arc CR, Neuchâtel, Neuchâtel, Switzerland)

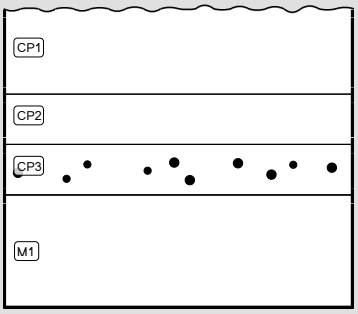
Fig. 4: Stratigraphic representation of the object in cross-section using the MiCorr application. This representation can be compared to Fig. 10, Credit HE-Arc CR.
