PIN OR NEEDLE FRAGMENT HR-3031 - TIN BRONZE - LATE BRONZE AGE - SWITZERLAND

Artefact name	Pin or needle fragment HR-3031
Authors	Marianne. Senn (EMPA, Dübendorf, Zurich, Switzerland) & Christian. Degrigny (HE-Arc CR, Neuchâtel, Neuchâtel, Switzerland)
Url	/artefacts/377/

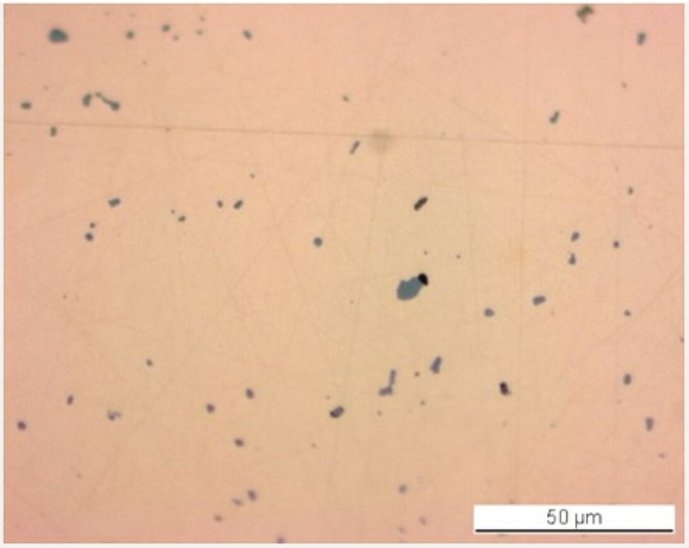
The remaining metal is a tin bronze and contains small copper sulphide and Pb-rich inclusions evenly distributed throughout the metal (Fig. 5, Tables 1 and 2). The Pb-rich inclusions are only visible with SEM appearing as white particles. The etched structure of the tin bronze shows re-crystallised and angular grains, some of them with twins (Fig. 6). Strain or slip lines are visible, especially near the metal surface. They indicate a final cold working. Copper sulphide inclusions are found both at the grain boundaries and inside the grains (Fig. 6). The average hardness of the metal is about HV1 120.

Fig. 5: Micrograph of the metal sample from Fig. 3 (detail), unetched, bright field. Grey copper sulphide inclusions are clearly visible,

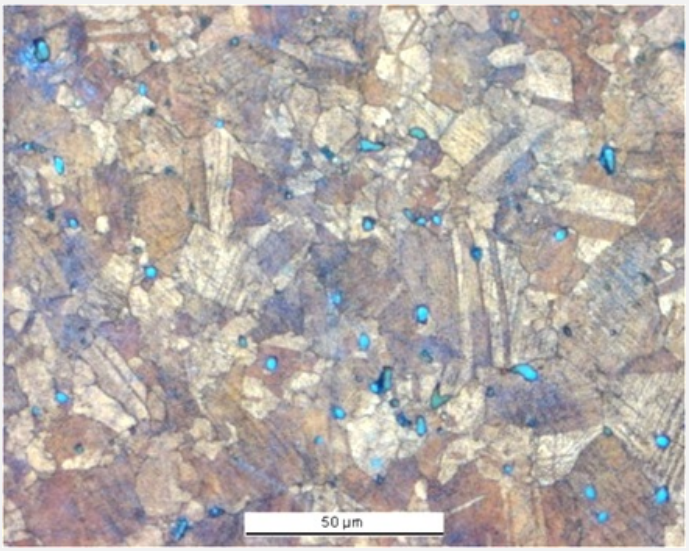
Fig. 6: Micrograph of the metal sample from Fig. 3 (detail), etched, bright field. Small angular re-crystallised grains (some with twins) with slip lines are observed. Copper sulphide inclusions appear in blue,

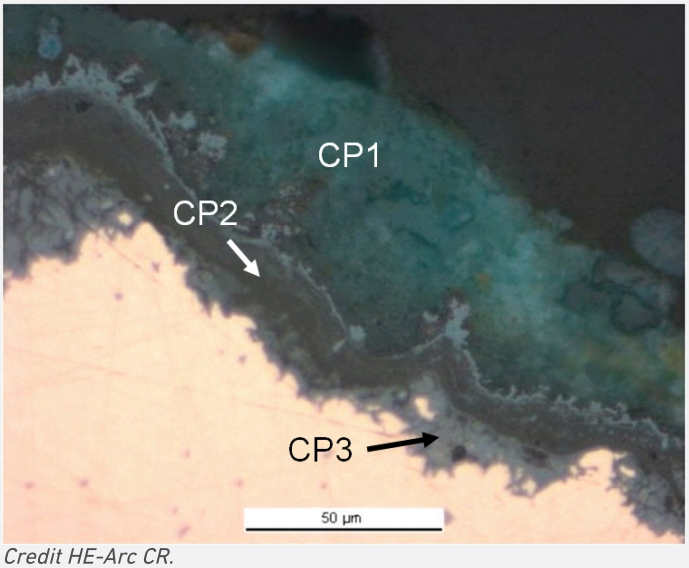
The corrosion crust has an average thickness of about 50µm (Fig. 7). In polarised light (Fig. 8), the corrosion stratigraphy is more clearly visible: it is composed of an inner orange-red corrosion layer (CP3, an agglomerate of nanoscale stannic oxides with cuprite) directly on the metal core (Table 3 and Fig. 9, already studied by Piccardo et al. 2007), an intermediate multi-layered black band (CP2) and an outer turquoise-green layer (CP1) analysed with XRD by Schweizer and identified as malachite/CuCO3Cu(OH)2 (Schweizer 1994, 150). In some areas the orange-red layers (CP3) can also be found in between the black band (CP2) and the malachite (CP1). Elemental chemical distribution of the SEM image of Fig. 9 shows that the black layers are enriched in Sn but also contain Fe (Fig. 9). Superior markers such as contextual Al and Si are present in the outer malachite layers. S is present both on the rim of the outer black layer and in the malachite (Fig. 9, Table 3).

Fig. 8: Micrograph of the metal sample from Fig. 3 and corresponding to the stratigraphy of Fig. 4, polarised light. The metal appears in brown; the inner layer appears as red-orange, the intermediate layer as black and the outer layer as turquoise,

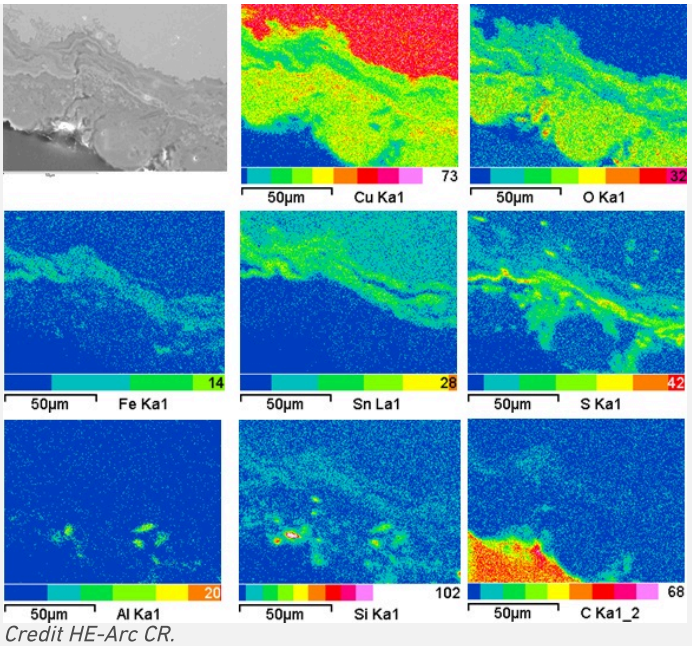
Fig. 9: SEM image, SE-mode, and elemental chemical distribution of a selected area of Fig. 3. Method of examination: SEM/EDS, Laboratory of Analytical Chemistry, Empa,

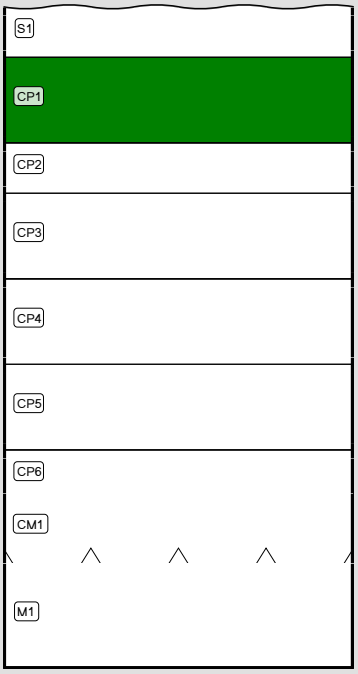
Fig. 4: Stratigraphic representation of the object in cross-section using the MiCorr application. This representation can be compared to Figs. 7 and 8, Credit HE-Arc CR.
