PIN OR NEEDLE FRAGMENT HR-3031 - TIN BRONZE - LATE BRONZE AGE - SWITZERLAND

Artefact name	Pin or needle fragment HR-3031
Authors	Marianne. Senn (EMPA, Dübendorf, Zurich, Switzerland) & Christian. Degrigny (HE-Arc CR, Neuchâtel, Neuchâtel, Switzerland)
Url	/artefacts/377/

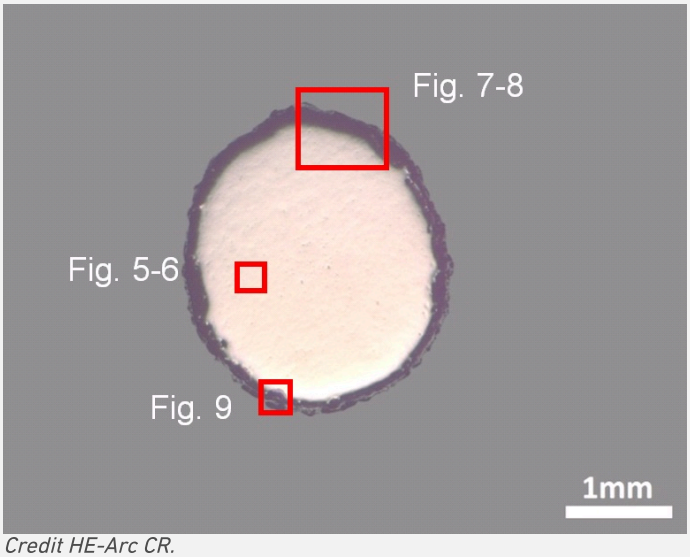
Fig. 3: Micrograph of the cross-section showing the location of Figs. 5 to 9,

Description of sample	The cross-section is circular and is a complete section through the pin (Fig. 2). The surface is completely covered with a rather thin corrosion crust of irregular thickness (Fig. 3).
Alloy	Tin Bronze
Technology	Cold worked after annealing
Lab number of sample	MAH 87-195
Sample location	Musées d'art et d'histoire, Genève, Geneva
Responsible institution	Musées d'art et d'histoire, Genève, Geneva
