# OVAL BRACELET WITH A ROUNDED DIAMETER B B3474 – LEADED BRONZE – LATE BRONZE AGE – SWITZERLAND

Artefact name	Oval bracelet with a rounded diameter B B3474
Authors	Marianne. Senn (EMPA, Dübendorf, Zurich, Switzerland) & Christian. Degrigny (HE-Arc CR, Neuchâtel, Neuchâtel, Switzerland)
Url	/artefacts/378/

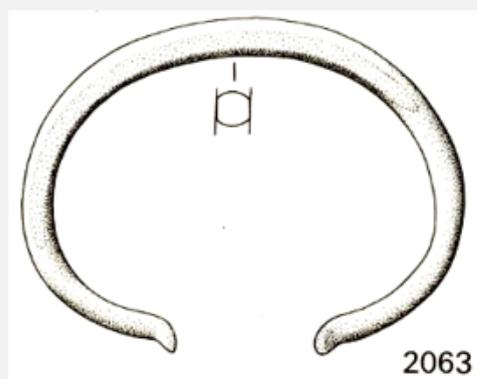
Fig. 1: Leaded bronze bracelet (after Paszthory 1985, Tafel 171),

Description of the artefact	Bracelet with round diameter after Paszthory (1985, 243). Ends shaped to form little paws, with a casting seam on the inside (Fig. 1). Dimensions: Øobject = around 6.2cm.
Type of artefact	Jewellery
Origin	Les Eaux-Vives, Genève, Geneva, Switzerland
Recovering date	None
Chronology category	Late Bronze Age
chronology tpq	1000 B.C. ⌄
chronology taq	---- ⌄
Chronology comment	Hallstatt B2/3 (1000BC _ not defined)
Burial conditions / environment	Lake
Artefact location	Musées d'art et d'histoire, Genève, Geneva
Owner	Musées d'art et d'histoire, Genève, Geneva

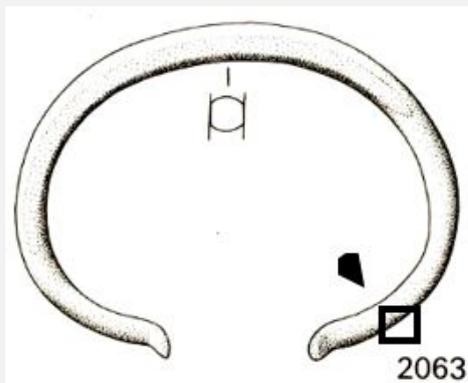
Fig. 2: Location of sampling area,

Description of sample	The sample is a section from one end of the bracelet (Fig. 2). Its dimensions are: L = 2.3mm and W = 0.55mm. The corrosion layer is relatively thin (Fig. 3).
Alloy	Leaded Bronze
Technology	As-cast
Lab number of sample	MAH 77-110-2

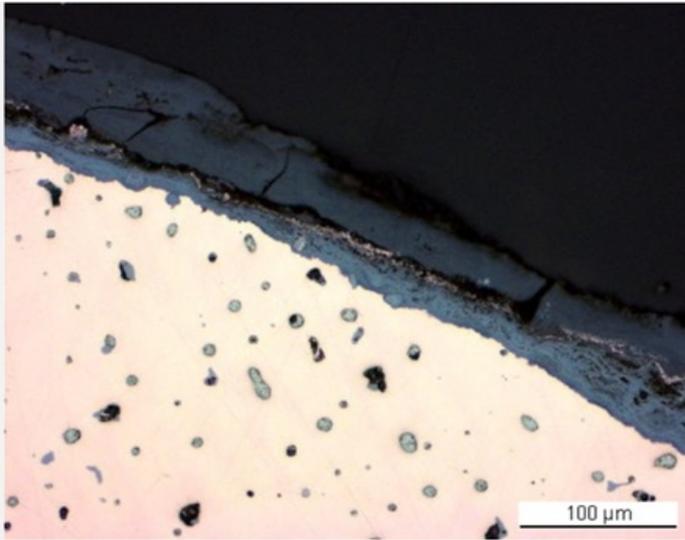
The remaining metal is a porous leaded bronze (Table 1). Under bright field light Pb and dark-grey copper sulphide inclusions can be seen (Fig. 5, Table 2). The copper sulphide inclusions are rather small with various forms, while the Pb inclusions are generally larger and round. The etched leaded bronze has the dendritic structure of an as-cast metal (Fig. 6) with an average hardness of HV1 80. After etching the Pb-inclusions turned dark grey and the copper sulphide light grey (Fig. 6).

Fig. 5: Micrograph of the metal sample from Fig. 3 (detail), unetched, bright field. In pink the metal with porosity (black), light-grey lead inclusions and dark-grey copper sulphide inclusions,

The corrosion crust has an average thickness of 60µm and is composed of two main layers (CP2 and CP3, Fig. 5). In bright field, the inner layer (CP3) has a slight blue hue (Fig. 5). The corrosion products are stratified and the outer part is porous (Fig. 7). In polarised light, the inner layer appears as a mixture of reddish and orange corrosion products (Fig. 8). This layer is Cu- and O-rich with some Sn, Fe and Si in the porous zone (Table 3, Fig. 9). In bright field, the outer cracked and stratified layer (CP2) is dark grey (Fig. 5). It is depleted of Cu and rich in Fe and Sn with significant amounts of O and Si (Fig. 9). In polarised light, large red angular crystals (possibly cuprite) appear clearly in this outer corrosion layer (Fig. 8). The surface of the outermost layer (CP1) is Sn and O and Fe enriched (CP1, Fig. 9).

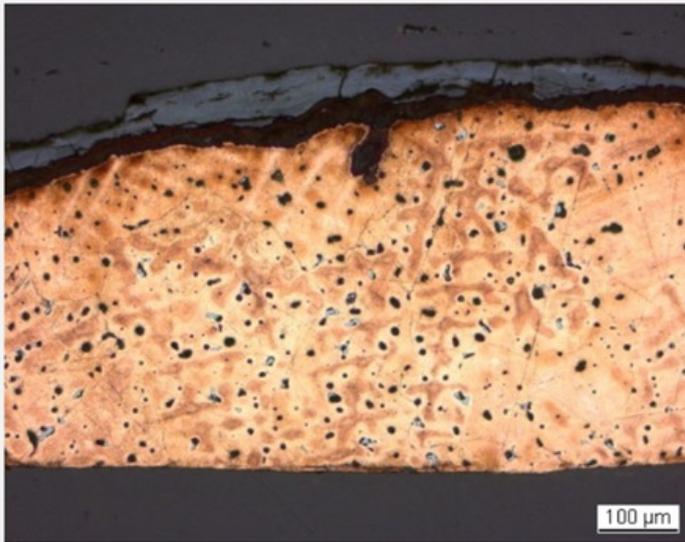
Fig. 6: Micrograph of the metal sample from Fig. 3 (detail), etched, bright field. The dendritic structure is revealed with dark-grey lead inclusions and porosities (in black),

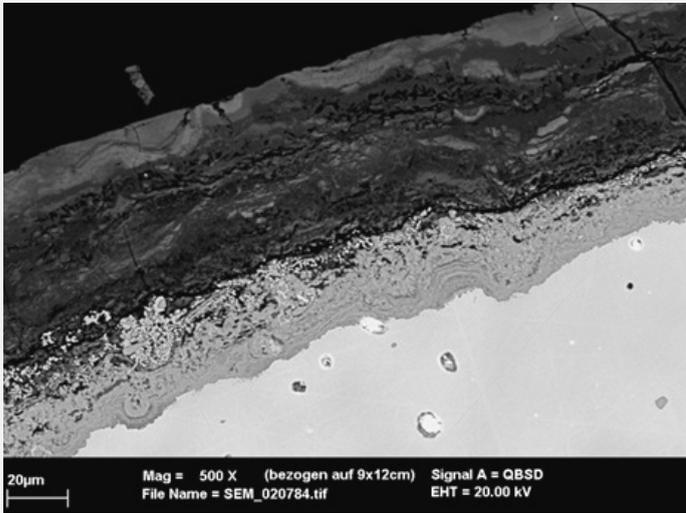
Fig. 7: SEM picture (detail of Fig. 3), BSE-mode. From bottom right to top left: the metal, the inner light-grey layer, the outer dark-grey layer with a lighter top zone,

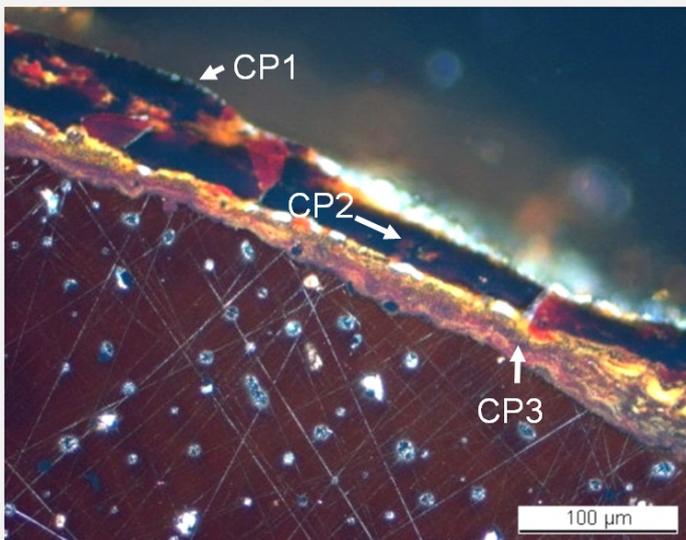
Fig. 8: Micrograph similar to Fig. 5 and corresponding to the stratigraphy of Fig. 4, polarised light. From bottom left to top right: the metal (in brown with white porosities and blue Pb inclusions), the inner layer (CP3) appearing as stratified red and orange layers followed by an outer layer (CP2, black with red angular crystals) and a superimposed light green layer (CP1),

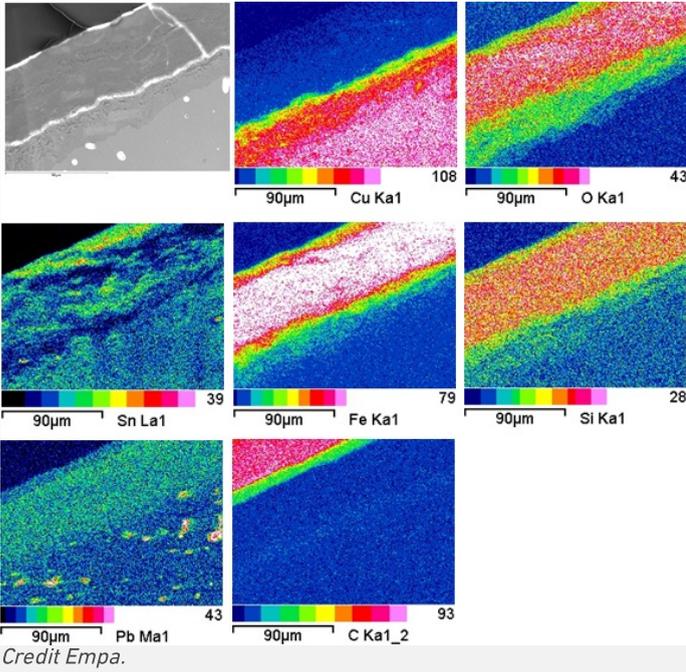
Fig. 9: SEM image, SE-mode, and elemental chemical distribution of a selected area of Fig. 7. The Pb mapping includes the Pb and copper sulphide inclusions, because of a peak interference. Method of examination: SEM/EDS, Laboratory of Analytical Chemistry, Empa,

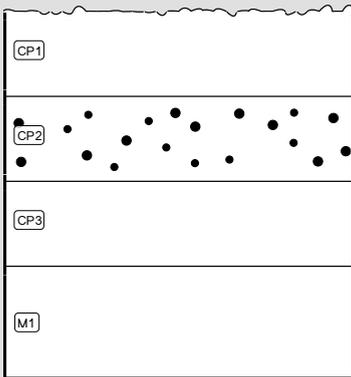
Fig. 4: Stratigraphic representation of the object in cross-section using the MiCorr application. This representation can be compared to Fig. 8, Credit HE-Arc CR.
