OVAL BRACELET WITH SURFACE DECORATIONS OF LINES AND INDENTATIONS MAH ANC. 2662 – LEADED BRONZE – LATE BRONZE AGE – SWITZERLAND

Artefact name	Oval bracelet with surface decorations of lines and indentations MAH anc. 2662
Authors	Marianne. Senn (EMPA, Dübendorf, Zurich, Switzerland) & Christian. Degrigny (HE-Arc CR, Neuchâtel, Neuchâtel, Switzerland)
Url	/artefacts/380/

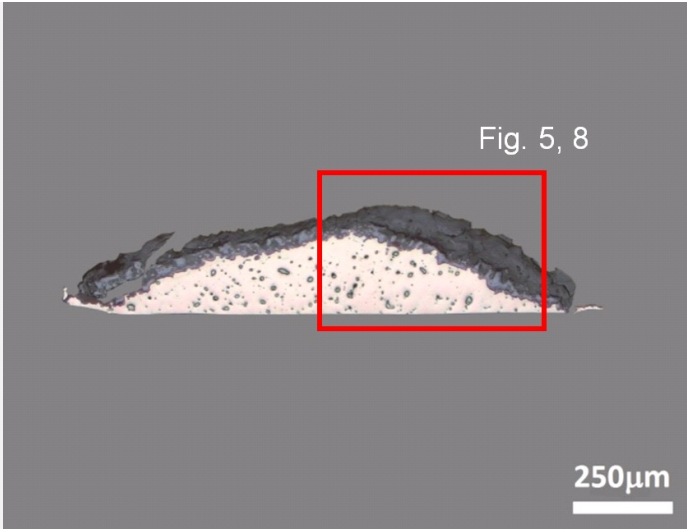
Fig. 1: Leaded bronze bracelet (after Paszthory 1985, Tafel 82),

Description of the artefact	Bracelet with a dense, black lake patina (Fig. 1). The bracelet corresponds to the type of bracelet decorated on the outside with alternate of dashes and meanders (Paszthory 1985, 164). Two samples were taken from this object – only one is presented here (Fig. 2). Dimensions: Ø = around 6.1cm; WT = 98g.
Type of artefact	Jewellery
Origin	Les Eaux-Vives, Genève, Geneva, Switzerland
Recovering date	None
Chronology category	Late Bronze Age
chronology tpq	1000 B.C.
chronology taq	----
Chronology comment	Hallstatt B2/3 (1000BC _ not defined)
Burial conditions / environment	Lake

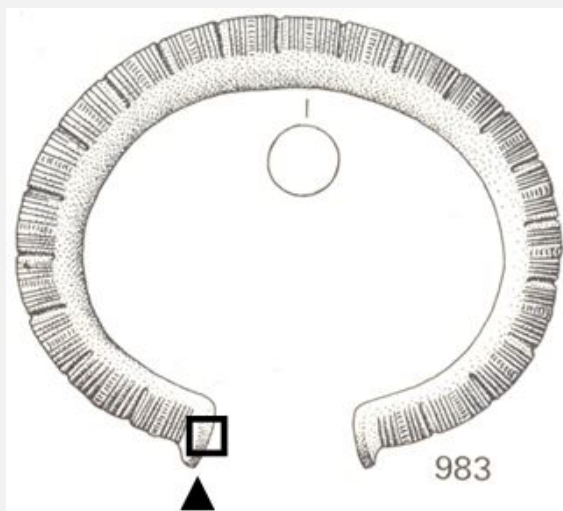
Fig. 2: Location of sampling area,

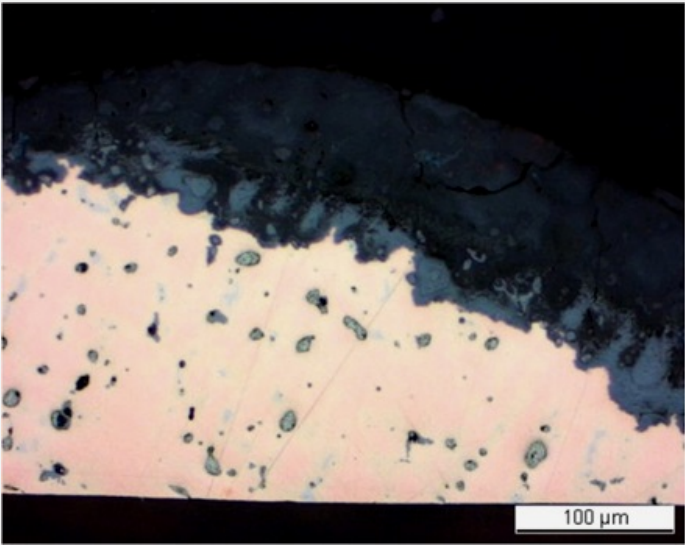
The remaining metal is a leaded bronze (Table 1) with low porosity, light and dark-grey inclusions (Fig. 5). In bright field the unetched alpha-delta eutectoid appears light-blue (Fig. 5). Etching reveals the dendritic structure of an as-cast metal (Fig. 6) with an average hardness of HV1 100. The inclusions appear as dark-grey (Pb-rich) and light-grey (copper sulphide) (Fig. 6 and Table 2) while the alpha-delta eutectoid is white (Fig. 6). The pink alpha phase is cored.

Fig. 5: Micrograph of the metal sample from Fig. 3 (detail), unetched, bright field. The metal is in pink, the Pb-rich inclusions in light-grey, the copper sulphide inclusions in dark-grey and the alpha-delta eutectoid in light-blue,

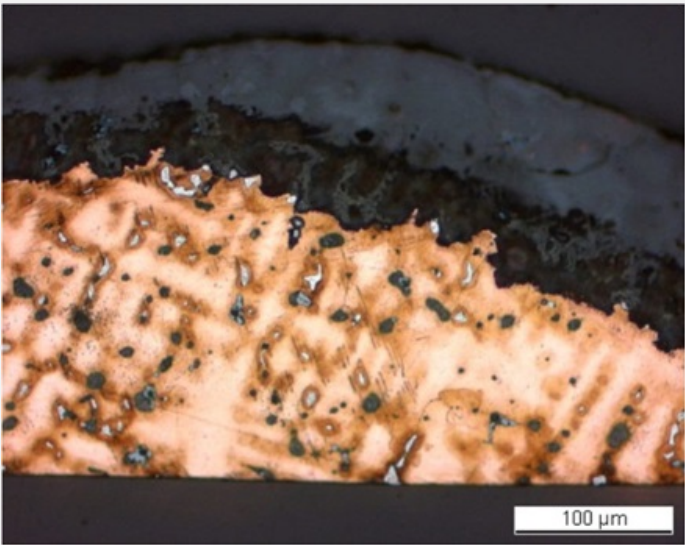
Fig. 6: Micrograph similar to Fig. 5, etched, bright field. The dendritic structure of the leaded bronze is revealed with the alpha-delta eutectoid in white and the alpha phase in pink. The colour difference of the alpha phase is due to coring,

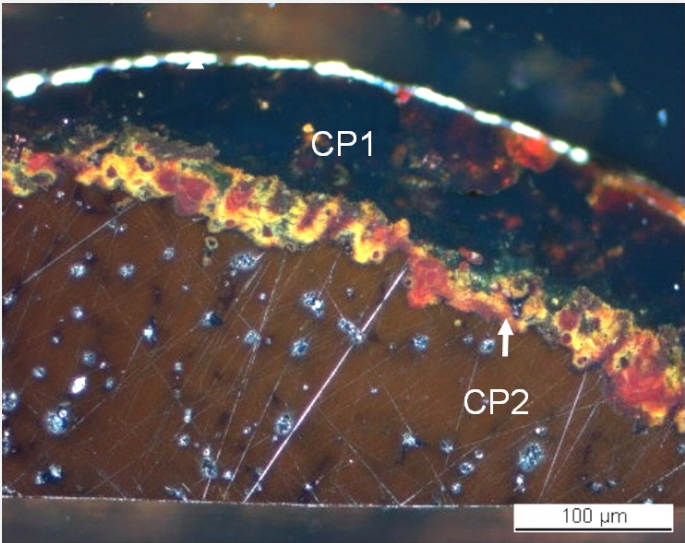
The corrosion crust has an average thickness of 80µm. It is composed of two layers (Fig. 7). The inner layer (CP2), which appears grey in bright field (Fig. 5), retains a Sn-rich dendritic ghost structure (Table 3 and Fig. 8). In polarized light, this layer is a mixture of reddish and yellow-brown corrosion products with some green areas (Fig. 7). The reddish parts have a composition similar to cuprite/Cu2O (Table 3). The adjacent dense, cracked layer, which appears dark-grey in bright field (CP1), is mainly composed of Fe,O and Sn with Sn,O and Fe-rich and Fe and O-rich zones contaminated with Si while being depleted of Cu (Fig. 8). In polarised light, it is dark, almost black with some red areas. In areas it contains Ag, Fe and Sn-rich inclusions with traces of Pb and Cu (Fig. 8 and Table 3).

Fig. 7: Micrograph similar to Fig. 5 and corresponding to the stratigraphy of Fig. 4, polarised light. From bottom left to top right: the metal in brown, the dendritic ghost structure in red, yellow-brown and green and the outer corrosion layer in black with some red areas. The thin white line is a crack,

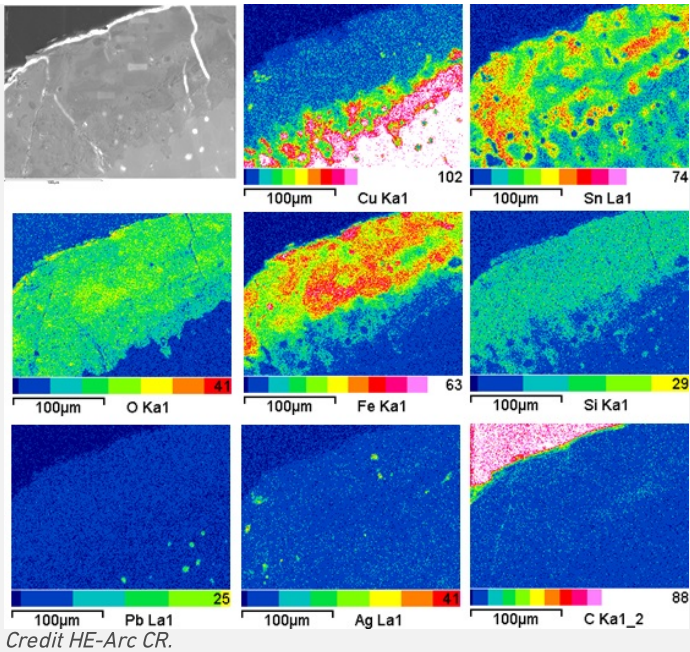
Fig. 8: EDS elemental chemical distribution in an SEM image (detail of Fig. 5, reversed picture). Method of examination: SEM/EDS, Laboratory of Analytical Chemistry, Empa,

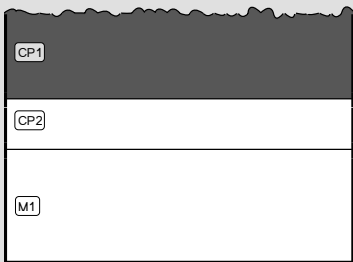
Fig. 4: Stratigraphic representation of the object in cross-section using the MiCorr application. This representation can be compared to Fig. 7, Credit HE-Arc CR.
