OVAL BRACELET WITH SURFACE DECORATIONS OF LINES AND INDENTATIONS MAH ANC. 2662 – LEADED BRONZE – LATE BRONZE AGE – SWITZERLAND

Artefact name Oval bracelet with surface decorations of lines and indentations MAH anc. 2662

Authors Marianne. Senn (EMPA, Dübendorf, Zurich, Switzerland) & Christian. Degrigny (HE-Arc CR, Neuchâtel, Neuchâtel, Switzerland)

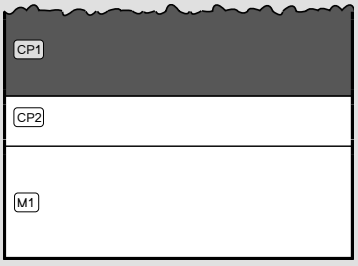
Fig. 4: Stratigraphic representation of the object in cross-section using the MiCorr application. This representation can be compared to Fig. 7, Credit HE-Arc CR.

The surface of the cast leaded bronze has been replaced by a Sn-rich corrosion that retains a dendritic ghost structure. It is composed of a mixture of copper oxides (cuprite?) and a Sn-rich corrosion product (cassiterite?). The outer corrosion layer is composed of Fe-O and Sn-O-Fe areas depleted of Cu, but contaminated with Si. The enrichment in Fe seems to be the same as for the formation of patinas from lake contexts. However the outer corrosion layer was not formed in anaerobic conditions (Fig. 7). Since the original surface is absent (destroyed) we refer to type corrosion 2 after Robbiola et al. 1998.
