OVAL BRACELET WITH SURFACE DECORATIONS OF LINES AND INDENTATIONS MAH ANC. 2662 – LEADED BRONZE – LATE BRONZE AGE – SWITZERLAND

Authors Marianne. Senn (EMPA, Dübendorf, Zurich, Switzerland) & Christian. Degrigny (HE-Arc CR, Neuchâtel, Neuchâtel, Switzerland)

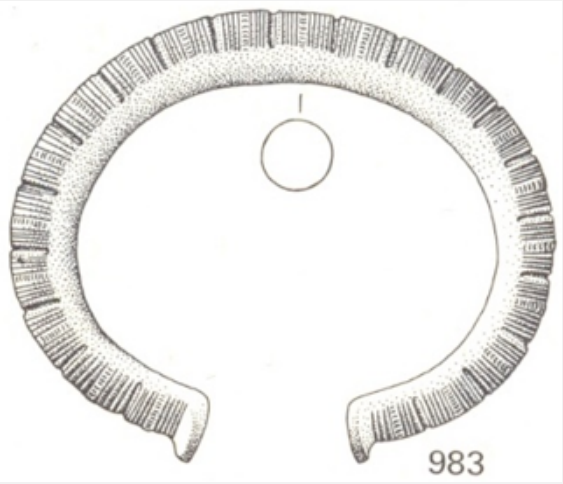
Fig. 1: Leaded bronze bracelet (after Paszthory 1985, Tafel 82),

Description of the artefact Bracelet with a dense, black lake patina (Fig. 1). The bracelet corresponds to the type of bracelet decorated on the outside with alternate of dashes and meanders (Paszthory 1985, 164). Two samples were taken from this object – only one is presented here (Fig. 2). Dimensions: Ø = around 6.1cm; WT = 98g.

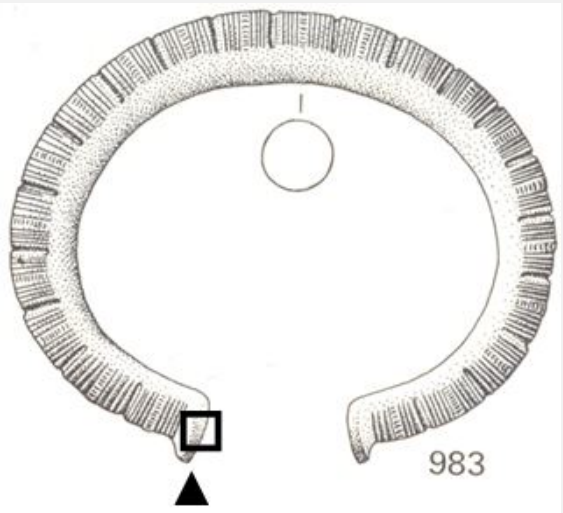
Fig. 2: Location of sampling area,

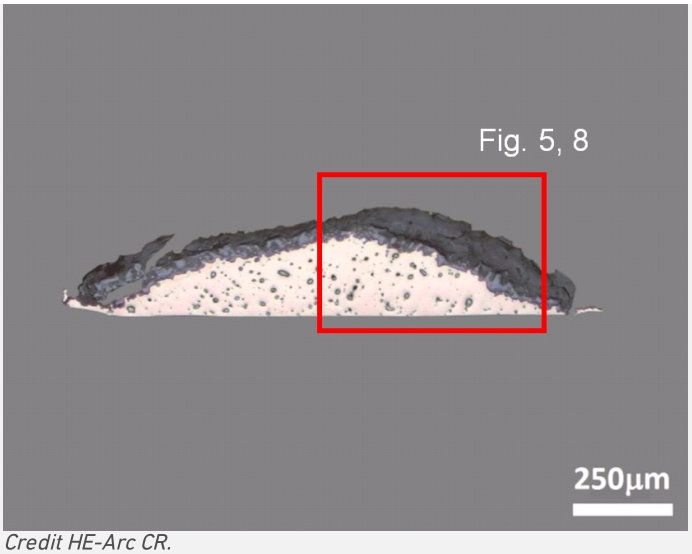
Fig. 3: Micrograph of the cross-section showing the location of Figs. 5 to 8,

Description of sample	The sample is a section from one end of the bracelet (Fig. 2). Its dimensions are: L = 1.3mm and W = 0.3mm. The corrosion layer is relatively thick (Fig. 3).
Alloy	Leaded Bronze
Technology	As-cast
Lab number of sample	MAH 77-110-1a
Sample location	Musées d'art et d'histoire, Genève, Geneva
Responsible institution	Musées d'art et d'histoire, Genève, Geneva
Date and aim of sampling	1977, study of black and iron rich surface deposit on the object

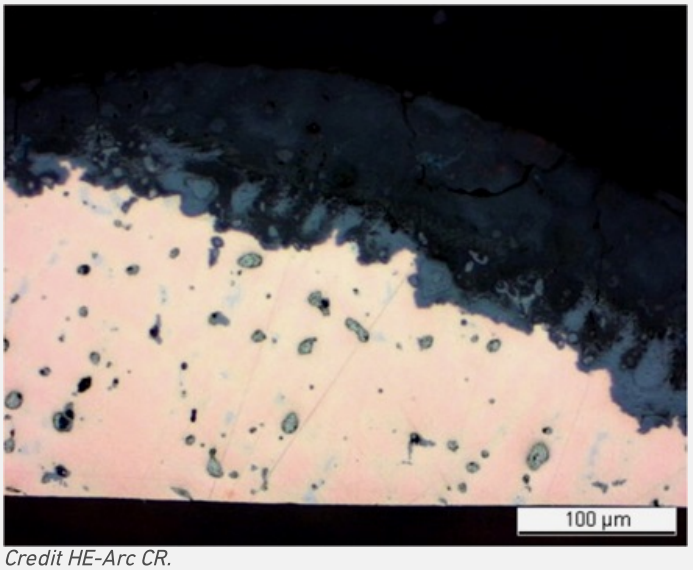
The remaining metal is a leaded bronze (Table 1) with low porosity, light and dark-grey inclusions (Fig. 5). In bright field the unetched alpha-delta eutectoid appears light-blue (Fig. 5). Etching reveals the dendritic structure of an as-cast metal (Fig. 6) with an average hardness of HV1 100. The inclusions appear as dark-grey (Pb-rich) and light-grey (copper sulphide) (Fig. 6 and Table 2) while the alpha-delta eutectoid is white (Fig. 6). The pink alpha phase is cored.

Fig. 5: Micrograph of the metal sample from Fig. 3 (detail), unetched, bright field. The metal is in pink, the Pb-rich inclusions in light-grey, the copper sulphide inclusions in dark-grey and the alpha-delta eutectoid in light-blue,

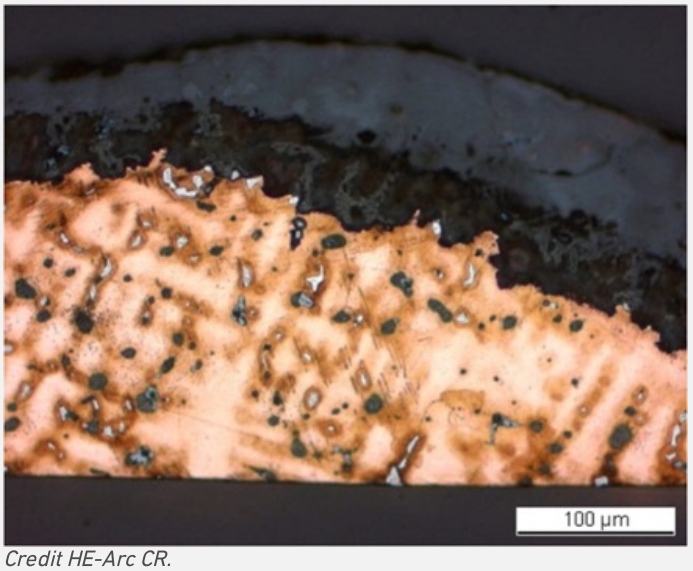
Fig. 6: Micrograph similar to Fig. 5, etched, bright field. The dendritic structure of the leaded bronze is revealed with the alpha-delta eutectoid in white and the alpha phase in pink. The colour difference of the alpha phase is due to coring,

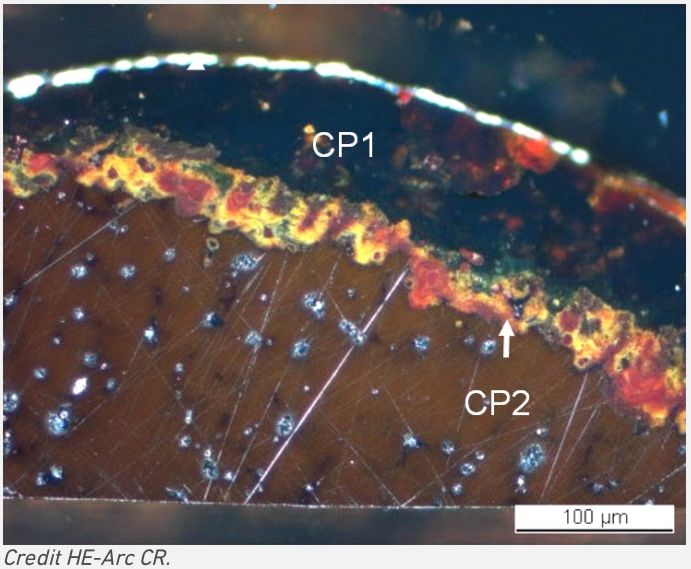
The corrosion crust has an average thickness of 80µm. It is composed of two layers (Fig. 7). The inner layer (CP2), which appears grey in bright field (Fig. 5), retains a Sn-rich dendritic ghost structure (Table 3 and Fig. 8). In polarized light, this layer is a mixture of reddish and yellow-brown corrosion products with some green areas (Fig. 7). The reddish parts have a composition similar to cuprite/Cu2O (Table 3). The adjacent dense, cracked layer, which appears dark-grey in bright field (CP1), is mainly composed of Fe,O and Sn with Sn,O and Fe-rich and Fe and O-rich zones contaminated with Si while being depleted of Cu (Fig. 8). In polarised light, it is dark, almost black with some red areas. In areas it contains Ag, Fe and Sn-rich inclusions with traces of Pb and Cu (Fig. 8 and Table 3).

Fig. 7: Micrograph similar to Fig. 5 and corresponding to the stratigraphy of Fig. 4, polarised light. From bottom left to top right: the metal in brown, the dendritic ghost structure in red, yellow-brown and green and the outer corrosion layer in black with some red areas. The thin white line is a crack,

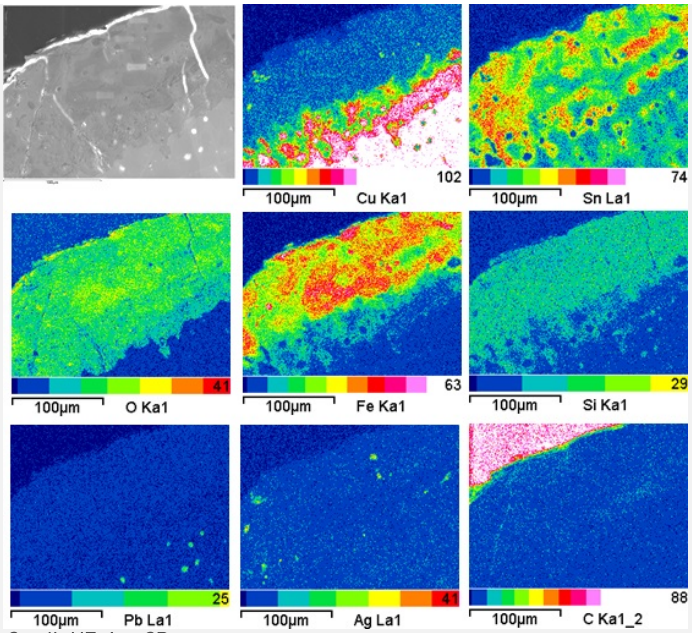
Fig. 8: EDS elemental chemical distribution in an SEM image (detail of Fig. 5, reversed picture). Method of examination: SEM/EDS, Laboratory of Analytical Chemistry, Empa,

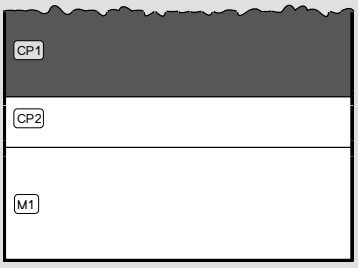
Fig. 4: Stratigraphic representation of the object in cross-section using the MiCorr application. This representation can be compared to Fig. 7, Credit HE-Arc CR.
