TANG FRAGMENT OF A KNIFE HR-6567 - LEADED BRONZE - LATE BRONZE AGE - SWITZERLAND

Artefact name	Tang fragment of a knife HR-6567
Authors	Marianne. Senn (EMPA, Dübendorf, Zurich, Switzerland) & Christian. Degrigny (HE-Arc CR, Neuchâtel, Neuchâtel, Switzerland)
Url	/artefacts/381/

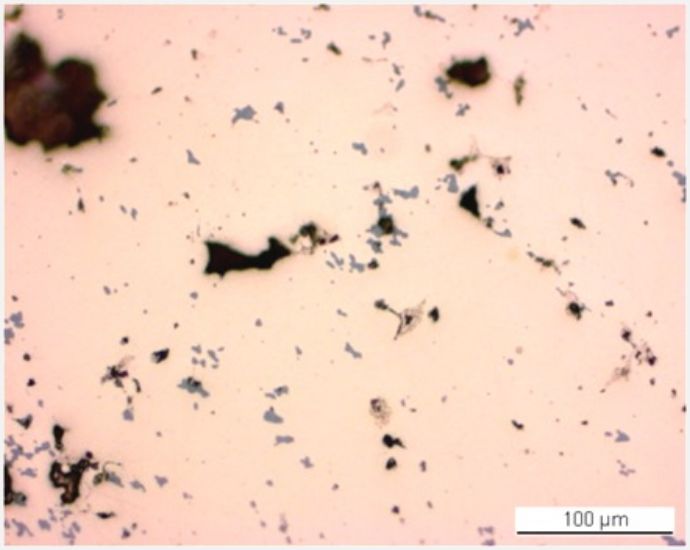
The remaining metal is a leaded bronze (Table 1) containing numerous copper sulphide and tiny Pb inclusions (Figs. 5-7, 10 and Table 2). The porosity within the metal is high, particularly along a band through the middle of the sample (Figs. 3 and 5). The etched structure of the leaded bronze shows small, regular polygonal grains, some with twinning (Fig. 6). Strain lines appear in grains close to the metal surface (Fig. 7). The average hardness of the metal is HV1 120.

Fig. 5: Micrograph of the metal sample from Fig. 3 (detail), unetched, bright field. In pink the metal, in black the porosity and in dark-grey copper sulphide inclusions,

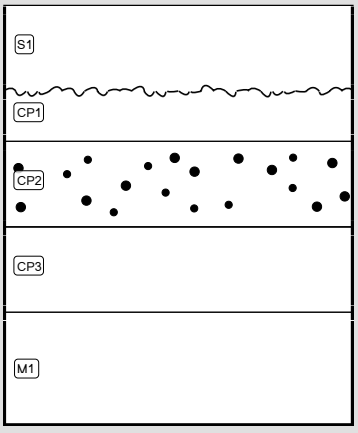
Fig. 4: Stratigraphic representation of the object in cross-section using the MiCorr application. This representation can be compared to Fig. 9, Credit HE-Arc CR.
