TANG FRAGMENT OF A KNIFE HR-6567 - LEADED BRONZE - LATE BRONZE AGE - SWITZERLAND

Artefact name	Tang fragment of a knife HR-6567
Authors	Marianne. Senn (EMPA, Dübendorf, Zurich, Switzerland) & Christian. Degrigny (HE-Arc CR, Neuchâtel, Neuchâtel, Switzerland)
Url	/artefacts/381/

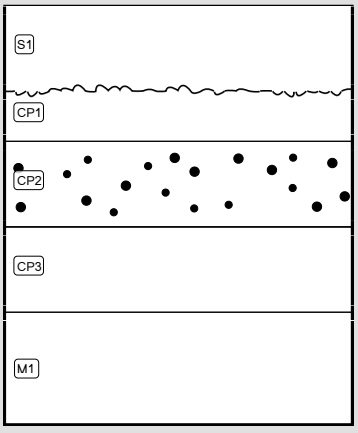
Fig. 4: Stratigraphic representation of the object in cross-section using the MiCorr application. This representation can be compared to Fig. 9, Credit HE-Arc CR.
