SITULA EMT09-554.665 – TIN BRONZE – IRON AGE – SWITZERLAND

Artefact name	Situla EMT09-554.665
Authors	Christian. Degrigny (HE-Arc CR, Neuchâtel, Neuchâtel, Switzerland) & Marie-Jeanne. Scholl (HE-Arc CR, Neuchâtel, Neuchâtel, Switzerland) & Valentin. Boissonnas (HE-Arc CR, Neuchâtel, Neuchâtel, Switzerland)
Url	/artefacts/382/

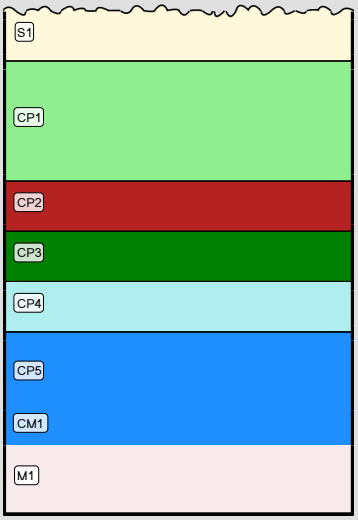
The inner layers (CP3-CP5) are Sn and O-rich and depleted in Cu (Table 2). The outer layers (CP1 and CP2) are Cu and O-rich, contain no Sn, and are contaminated with Ca, Si, Al and Fe coming from the soil (Fig. 12). The colour of the corrosion crust varies according to the content of Sn (the more Sn, the darker green or blue the corrosion). FTIR on the inner blue (CP5 and Fig. 14) and outer green (CP1 and Fig. 15) layers were difficult to interpret. Only malachite could be identified in both cases. XRD spectra could not be interpreted because of the deficiency of peaks.

Fig. 6: Stratigraphic representation of the object in cross-section using the MiCorr application. This representation shows the interior face and can be compared to Fig. 10 (top square), Credit HE-Arc CR, M-J.Scholl.

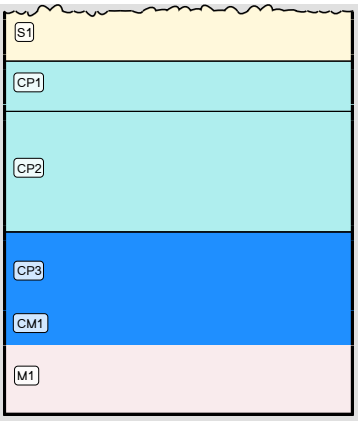
Fig. 5: Stratigraphic representation of the object in cross-section using the MiCorr application. This representation shows the exterior face and can be compared to Fig. 10 (bottom square), Credit HE-Arc CR, M-J.Scholl.
