SITULA EMT09-554.665 – TIN BRONZE – IRON AGE – SWITZERLAND

Artefact name	Situla EMT09-554.665
Authors	Christian. Degrigny (HE-Arc CR, Neuchâtel, Neuchâtel, Switzerland) & Marie-Jeanne. Scholl (HE-Arc CR, Neuchâtel, Neuchâtel, Switzerland) & Valentin. Boissonnas (HE-Arc CR, Neuchâtel, Neuchâtel, Switzerland)
Url	/artefacts/382/

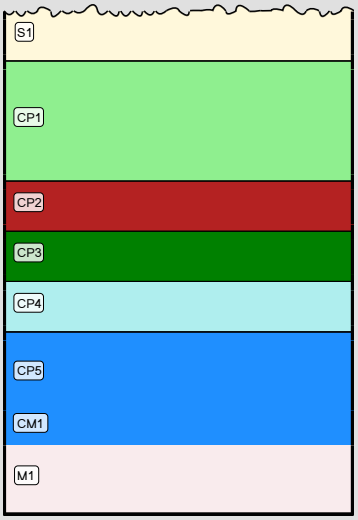
There are 2 stratigraphies (Fig. 5 corresponding to the interior face of the situla and Fig. 6 to its exterior face). The strata are similar in composition but their coding is different: CP1 to CP3 in Fig. 5 correspond to CP3 to CP5 in Fig. 6. Since the stratigraphy of Fig. 6 is more complete, the composition of each of its strata is given below.

Fig. 6: Stratigraphic representation of the object in cross-section using the MiCorr application. This representation shows the interior face and can be compared to Fig. 10 (top square), Credit HE-Arc CR, M-J.Scholl.

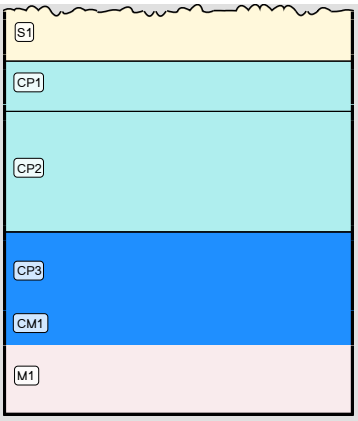
Fig. 5: Stratigraphic representation of the object in cross-section using the MiCorr application. This representation shows the exterior face and can be compared to Fig. 10 (bottom square), Credit HE-Arc CR, M-J.Scholl.
