FRAGMENTS OF OENOCHOE GV132-01 US26-OBJ.10 - TIN BRONZE - ROMAN TIMES - SWITZERLAND

Artefact name	Fragments of oenochoe GV132-01 US26-obj.10
Authors	Christian. Degrigny (HE-Arc CR, Neuchâtel, Neuchâtel, Switzerland) & S. Gillioz (HE-Arc CR, Neuchâtel, Neuchâtel, Switzerland) & Valentin. Boissonnas (HE-Arc CR, Neuchâtel, Neuchâtel, Switzerland)
Url	/artefacts/383/

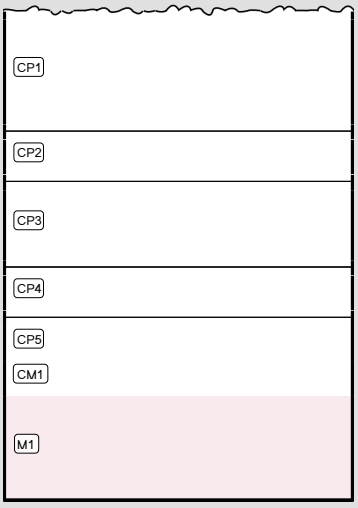
Fig. 5: Stratigraphic representation of the object in cross-section using the MiCorr application. This representation can be compared to Fig. 11, Credit HE-Arc CR, C.Degrigny.

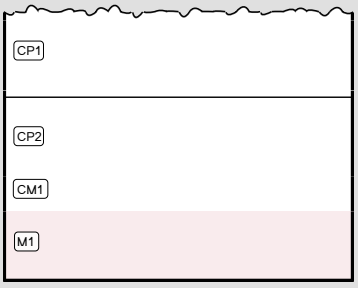
The corrosion crust on the metal has an average thickness of about 70 µm (Fig. 13). It consists of two sub-layers. The inner corrosion layer (CP2) is thin and dark brown in dark field or light grey in bright field. It has penetrated into the metal structure in some areas (Fig. 9). In dark field, the outer corrosion layer (CP1) is constituted of a heterogeneous light grey corrosion crust (Fig.13). The inner brown corrosion layer is enriched in Sn and O but also contains P, while the outer light grey corrosion layer is mainly composed of Pb and O but also contains P and Fe (Fig. 12). The outer light grey layer is probably due to the presence of a soft solder used to assemble the base to the body.

Fig. 6: Stratigraphic representation of the object in cross-section using the MiCorr application. This presentation can be compared to Fig. 13, Credit HE-Arc CR, C.Degrigny.
