SHOE NAIL 2637 1370.B. - HYPOEUTECTOID STEEL - ROMAN TIMES - SWITZERLAND

Artefact name Shoe nail 2637 1370.B.

Authors Christian. Degrigny (HE-Arc CR, Neuchâtel, Neuchâtel, Switzerland) & Valentin. Boissonnas (HE-Arc CR, Neuchâtel, Neuchâtel, Switzerland) & Vincent Chappuis. (HE-Arc CR, Neuchâtel, Neuchâtel, Switzerland)

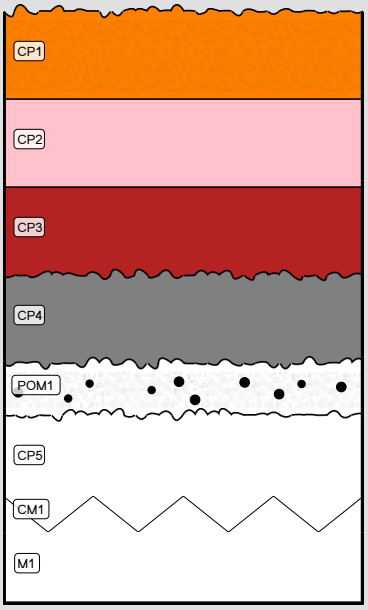
Fig. 6: Stratigraphic representation of the object in cross-section using the MiCorr application. This representation can be compared to Fig. 14, Credit HE-Arc CR, V.Chappuis.

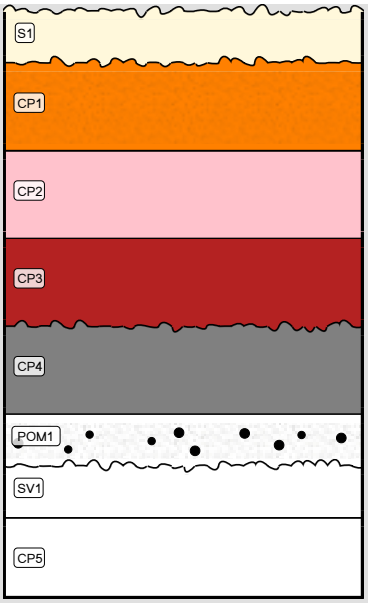
Fig. 5: Stratigraphic representation of the object in cross-section using the MiCorr application. This representation can be compared to Fig. 14, Credit HE-Arc CR, V.Chappuis.
