BUST OF AN APPLIQUE 2005.054.F00265.1 - QUARTERNARY BRONZE ALLOY - ROMAN TIMES - SWITZERLAND

Artefact name Bust of an applique 2005.054.F00265.1

Authors Christian. Degrigny (HE-Arc CR, Neuchâtel, Neuchâtel, Switzerland) & Marie. Arnautou (HE-Arc CR, Neuchâtel, Neuchâtel, Switzerland) & Valentin. Boissonnas (HE-Arc CR, Neuchâtel, Neuchâtel, Switzerland)

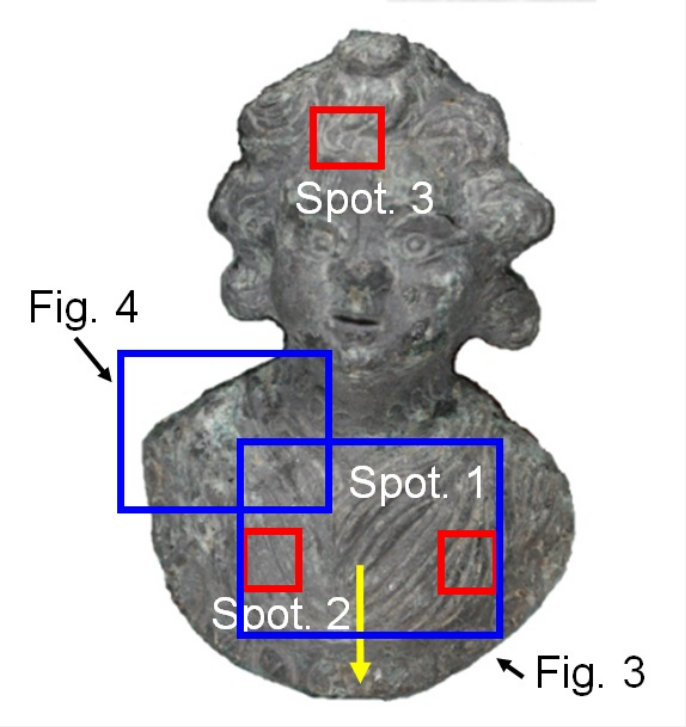
Fig.2: Location of areas of visual observation in blue, of sampling in yellow and of analyses (XRF) in red,

Fig. 3: Dark patina located on Fig. 2 (blue square),

Fig. 4: Porous zone located on Fig. 2 (blue square),

The entire surface of the bust is covered by a dark grey layer directly attached to the remaining metal (CP2) (Fig. 3). The surface analyses (Table 1) performed on the bust have revealed a high amount of Cu, as well as Pb, Sn and Zn. These are elements which can be constituents of the alloy, while elements in minor amount such as Al, Si and Fe are likely to originate from the environment. The qualitative analysis carried out on the dark patina by SEM/EDS (Fig. 6) confirms the XRF results (Table 1), showing the same elements and the presence of O, which probably correspond to copper oxide (cuprite Cu2O or tenorite CuO). The dark patina is covered by an adherent green corrosion layer (CP1) which has developed in scattered clusters (probably copper carbonate). The clusters have a surface area of 2 mm2 to 2 cm2, and have a thickness of 0.5 to 5 millimeters. In some places, the green corrosion layer has formed in the porous blisters of the dark layer (Fig. 5). Charcoal might be found locally (POM1) as well as different sediments: S1 (discontinuous and brown), S2 (mixed with fine and coarse sand grains) and S3 (scattered homogeneous brown layer).

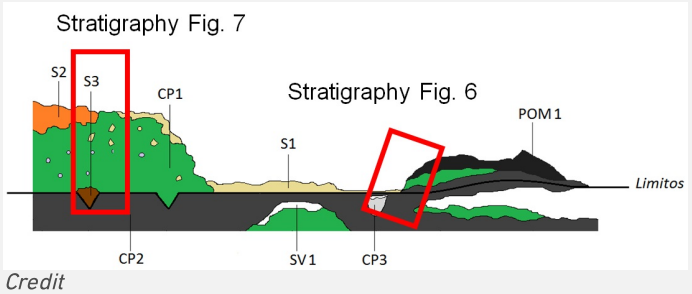
The schematic representation below gives an overview of the corrosion layers encountered on the bust from a first visual macroscopic observation.

Fig. 5: Stratigraphic representation based on visual observation and visualization of the stratigraphies of Figs. 6 and 7.

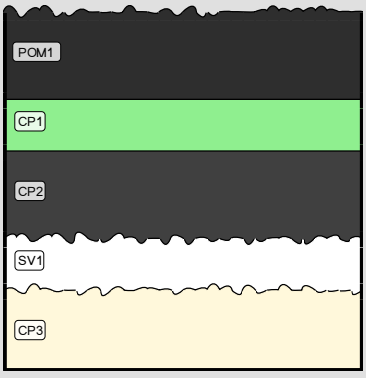
Fig. 6: Stratigraphic representation of the object in cross-section using the MiCorr application. This representation can be compared to Fig. 5, Credit HE-Arc CR, C.Degrigny.

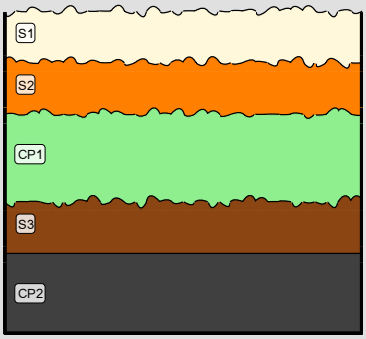
Fig. 7: Stratigraphic representation of the object in cross-section using the MiCorr application. This representation can be compared to Fig. 5, Credit HE-Arc CR, C.Degrigny.

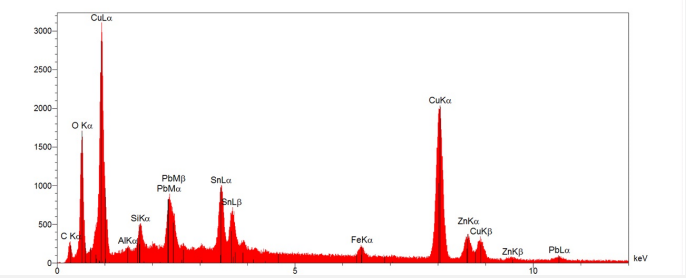
Fig. 6: EDS spectrum of sample 1 located in Fig. 2 (yellow arrow),

The metal is probably a quaternary bronze (Cu-Pb-Sn-Zn) according to the qualitative XRF analysis performed on the surface of the bust. The high amount of lead is probably due to its diffusion towards the metal surface caused by exposure to high temperatures. The dark patina (CP2) has developed from a smooth layer to voluminous green crusts (CP1) corresponding to a type 1 corrosion according to Robbiola and al. 1998. The artefact has been excavated from a burial context characterized by burnt soil, which could explain the formation of the black patina (tenorite will form at temperatures above 300/400°C). A green corrosion has developed in the porous blisters of the dark layer. The limit of the original surface is located at the interface of the dark smooth corrosion and the green adherent corrosion product. In certain areas the limit of the original surface has been elevated from its original position.
