FRAGMENT OF A BED STRUCTURE 03 12751-20.2.5 - TIN BRONZE - ROMAN TIMES - SWITZERLAND

Artefact name	Fragment of a bed structure 03 12751-20.2.5
Authors	Marianne Senn. (Empa, None) & Christian. Degrigny (HE-Arc CR, Neuchâtel, Neuchâtel, Switzerland)
Url	/artefacts/386/

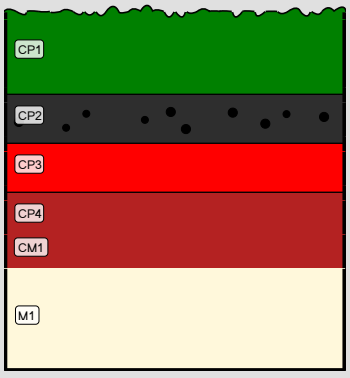
Fig. 4: Stratigraphic representation of the object in cross-section using the MiCorr application. This representation can be compared to Fig. 8, Credit HE-Arc CR.
