AIRCRAFT FRONT FASTENING PLATE VHS-497 (2) - AL CU SN ZN SI ALLOY - MODERN TIMES

Artefact name	Aircraft front fastening plate VHS-497 (2)
Authors	Marianne. Senn (EMPA, Dübendorf, Zurich, Switzerland) & Christian. Degrigny (HE-Arc CR, Neuchâtel, Neuchâtel, Switzerland)
Url	/artefacts/390/

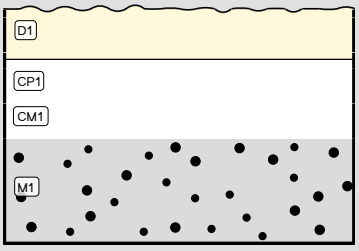
Fig. 4: Stratigraphic representation of the object in cross-section using the MiCorr application. This representation can be compared to Fig. 8, Credit HE-Arc CR.
