AIRCRAFT REAR FASTENING PLATE VHS-497 - AL ALLOY - MODERN TIMES

Artefact name	Aircraft rear fastening plate VHS-497
Authors	Marianne. Senn (EMPA, Dübendorf, Zurich, Switzerland) & Christian. Degrigny (HE-Arc CR, Neuchâtel, Neuchâtel, Switzerland)
Url	/artefacts/391/

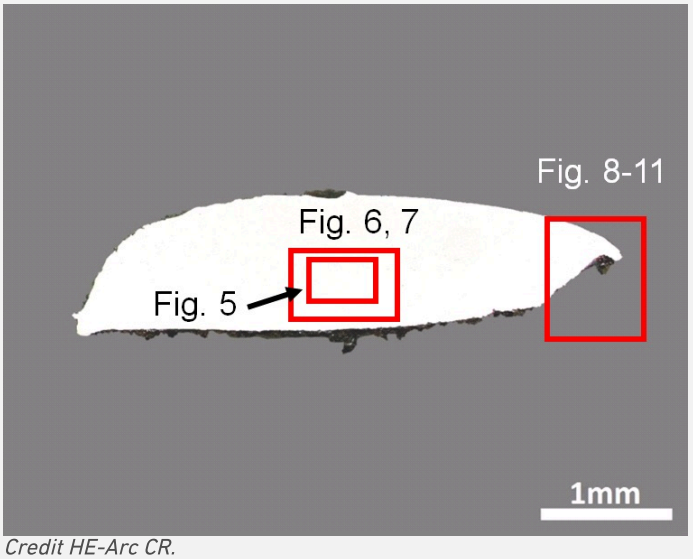
Fig. 3: Micrograph of the cross-section showing the location of Figs. 5 to 11,

Sample cut from the corner of the fixation plate (Fig. 2). Dimensions: L = 4mm ; W = 1.2mm.

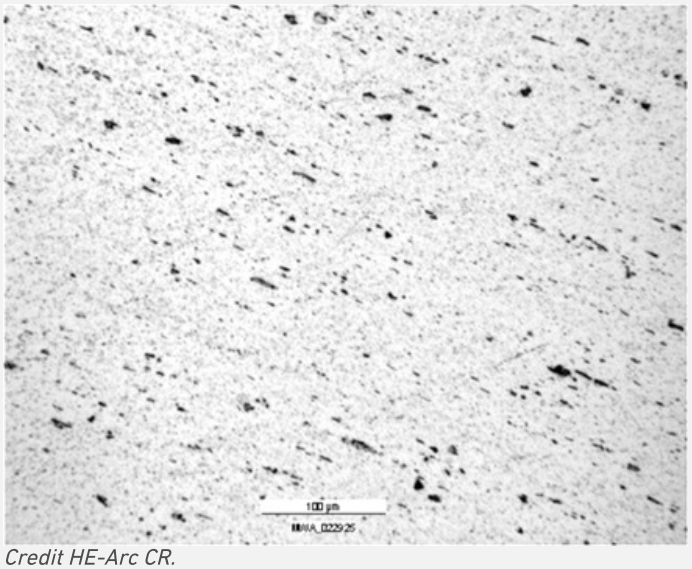
The metal is a relatively pure aluminium alloy with numerous inclusions (Table 1). From the chemical composition of the inclusions they can be interpreted as alpha-AlFeSi intermetallic compounds. In bright field we observe elongated inclusions indicating that the metal was rolled (Fig. 5). The alloy composition is similar to an unalloyed primary aluminium (Al content between 99 and 99.8 mass%). The O content reflects the immediate oxidation of the metal and is not part of the alloy. After etching the organisation of inclusions in rows is more easily seen (Fig. 6). The SEM image shows large grains formed after annealing (Fig. 7). The average hardness of the metal is HV1 40.

Fig. 5: Micrograph of the metal sample from Fig. 3 (detail), unetched, bright field. The metal matrix is in white, the elongated inclusions in grey,

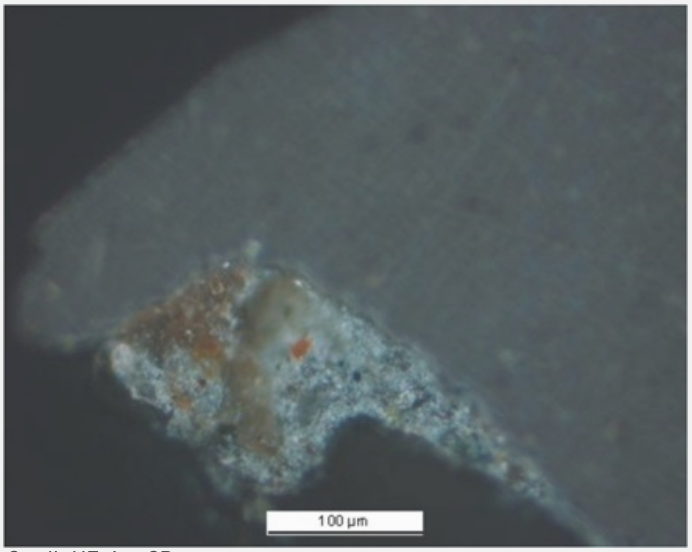
The metal is covered by a very thin corrosion layer (CP1). In addition to this, locally thicker “corrosion products” or adherent material can be observed (D1, appearing as dark-grey area in Fig. 8). Under polarized light, they appear blue-brown (Fig. 9). Analysis by SEM-EDS indicates that the metal is, as expected, covered by a very thin Al and O-rich layer whereas the particles in the adherent material contain C, O, Si, Ca, Fe, Zn, S and even Ti (Figs. 10 and 11). The location of the adherent material and the presence of both Zn and Ti suggest that it is a residue of a paint coating.

Fig. 8: Micrograph showing the metal - “corrosion products” interface from Fig. 3 (reversed picture, detail), unetched, bright field. We observe in white the metal matrix and dark-grey the adhering material,
