HEADREST OR HORSE BIT VFIG 2003.7 – LEADED BRONZE – MODERN TIMES

Artefact name Headrest or horse bit VFig 2003.7

Authors Christian. Degrigny (HE-Arc CR, Neuchâtel, Neuchâtel, Switzerland) & Valentin. Boissonnas (HE-Arc CR, Neuchâtel, Neuchâtel, Switzerland)

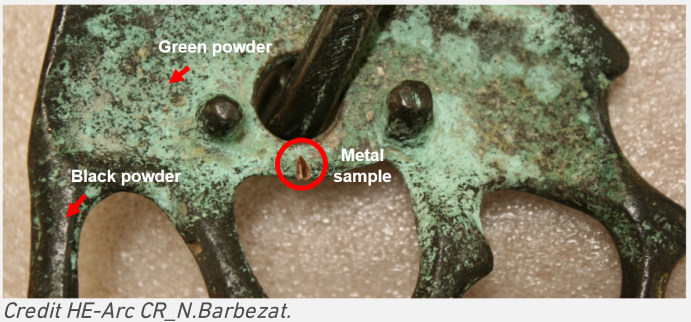
Fig. 2: Location of sampling areas,

Description of sample	The sample was cut on the bottom of one of the plates (Fig. 2). On Fig. 4, the top and round shape of the sample is the outer part of the metal. It is covered with corrosion layers. The lower part of the sample corresponds to the cut metal with no corrosion products.
Alloy	Leaded Bronze
Technology	Cast and cold worked (with final annealing?)
Lab number of sample	None
Sample location	HE-Arc CR, Neuchâtel, Neuchâtel
Responsible institution	Bible & Orient Museum, Fribourg, Fribourg
Date and aim of sampling	2014, metallography and chemical analyses

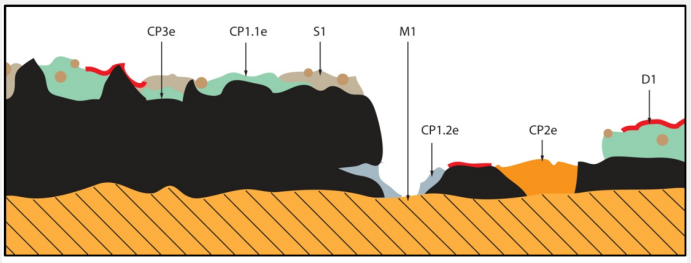
S1: soil (sand and limestone)
D1: red deposit
CP1.1e: outer light green-blue corrosion layer
CP1.2e: outer white-blue-grey corrosion layer
CP2e: outer orange corrosion layer
CP3e/i: outer/inner black brown corrosion layer
M1: metal

Fig. 3: Stratigraphic representation of the artefact in cross-section by macroscopic observation,

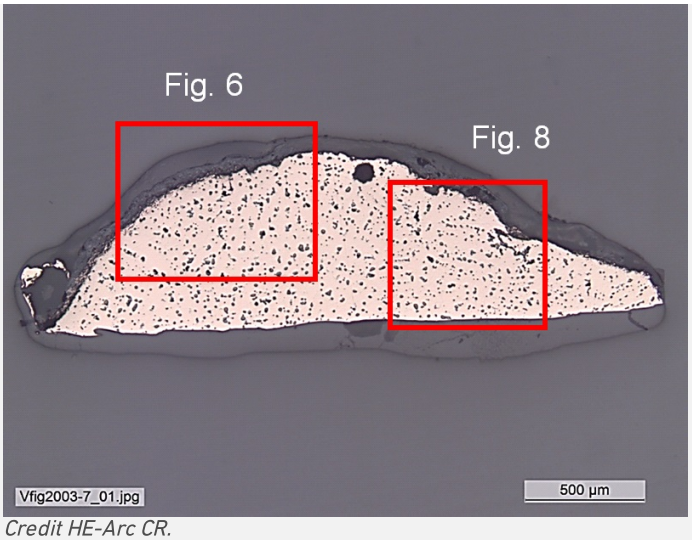
Fig. 4: Micrograph of the cross-section of sample from Fig. 2 showing the location of Figs. 6 and 8,

The remaining metal is a leaded bronze (Table 1) containing numerous copper sulphide and lead (Pb) inclusions (Figs. 6 and 7). The porosity is difficult to distinguish since the pores seem to have similar dimensions as the inclusions that could have been removed during the polishing of the sample (Fig. 6). After etching, the structure of the metal appears to be made up mostly of dendrites, but a grain structure seems to have developed on the right side of the sample, with occasional twin lines (Figs. 8 and 9). The twinned grain

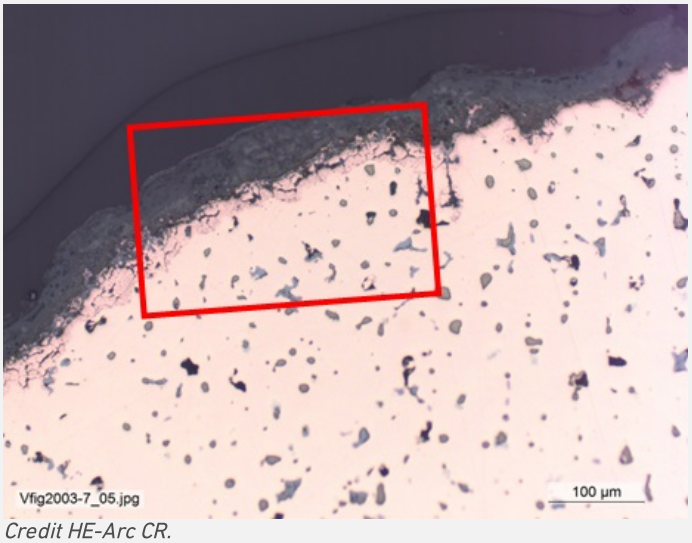
Fig. 6: Micrograph of the cross-section of Fig. 4 (detail), unetched, bright field. Light grey copper sulphide and tiny round Pb inclusions as well as "porosities" can be observed. Area of Fig. 10 is marked by a rectangle,

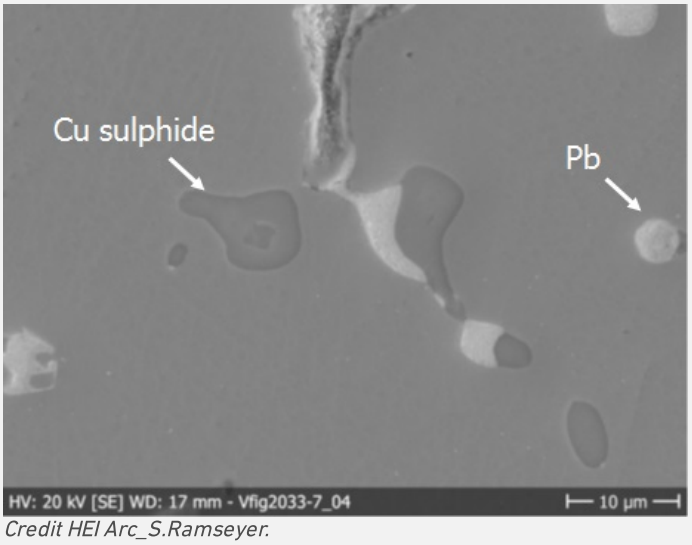
Fig. 7: SEM image, SE-mode, showing copper sulphide and lead inclusions,

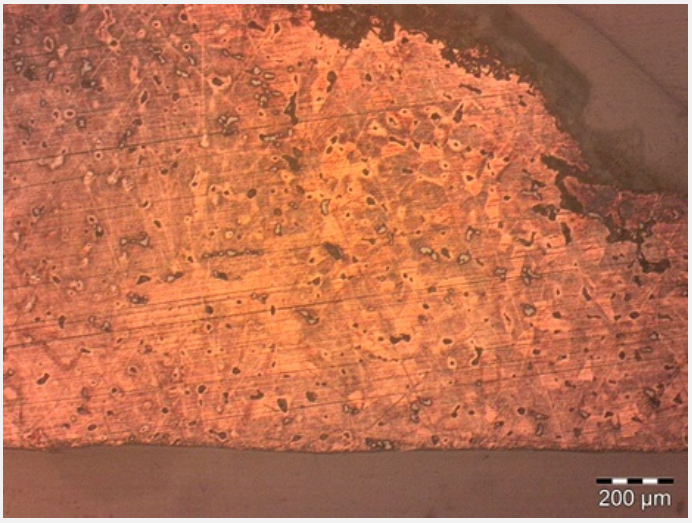
Fig. 8: Micrograph of the metal sample from Fig. 4 showing a dendritic structure and grains,

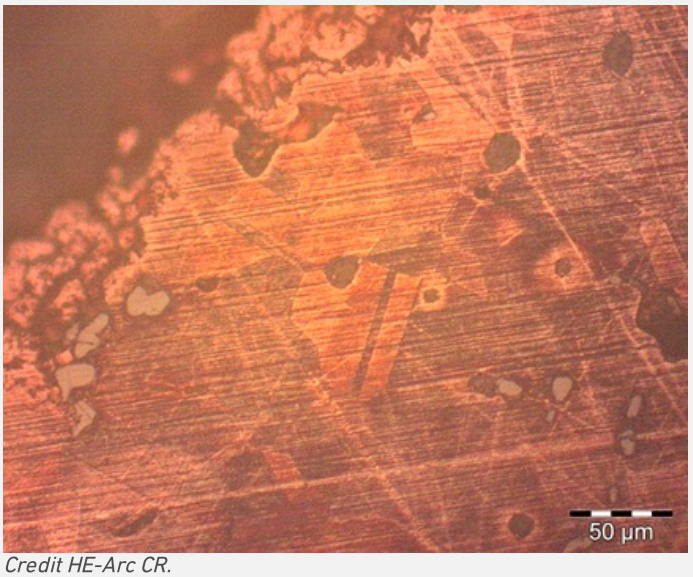
structure could be the result of cold work and annealing after casting, possibly through the application of an artificial patina under heat.

Fig. 9: Micrograph of a selected area showing grains and twin lines,

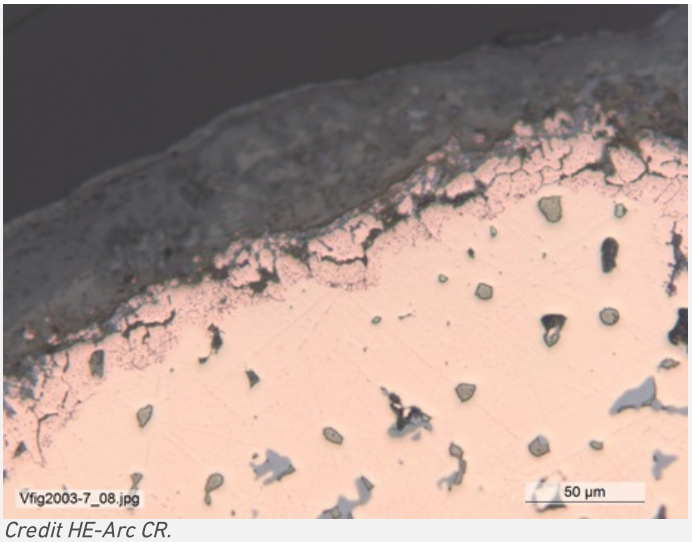
The remaining metal seems to have developed intergranular corrosion at the interface metal / corrosion layer (Fig. 10) slightly enriched in Sn (Fig. 12). The outer green corrosion product (CP2) is matte, powdery and mixed with sediments. It looks regular on Figs. 10 and 11 (around 50µm). This corrosion layer is mainly composed of lead (and/or sulphur), oxygen, silicon, chlorine and is depleted in Cu (Fig. 12 and table 2) except in its top part (CP1) where it is Cl, Cu and O-rich (Fig. 12 and table 2). FTIR seems to indicate that it is constituted of atacamite ($Cu_2Cl(OH)_3$, Fig. 13). This is confirmed on the EDS spectra of figure 14 where Pb is clearly detected. The inner black corrosion product (CP3) is a dark brown, matte layer (Figs. 2 and 11). It covers all the surface of the object, and forms a very thin layer. It is sulphur and oxygen-rich (Fig. 15). FTIR analysis could not reveal the presence of a specific corrosion product.

Fig. 10: Micrograph of the metal sample from Fig. 6, unetched, bright field,

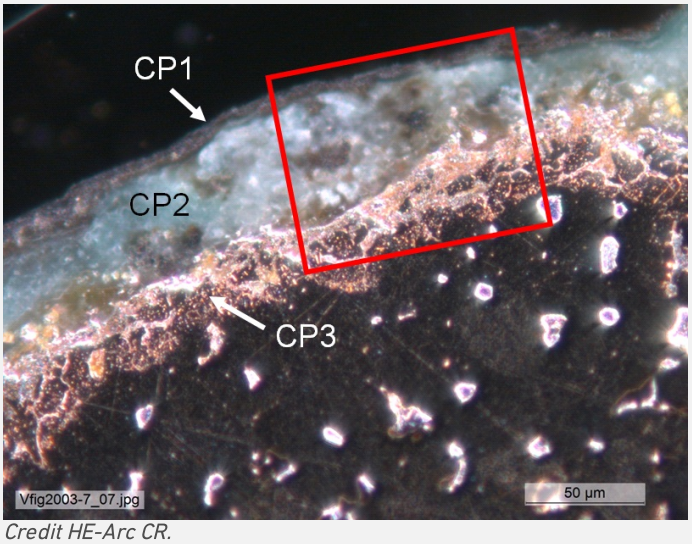
Fig. 11: Micrograph similar to Fig. 10 and corresponding to the stratigraphy of Fig. 5, polarised light. The mapped area (Fig. 12, SEM) is marked by a rectangle,

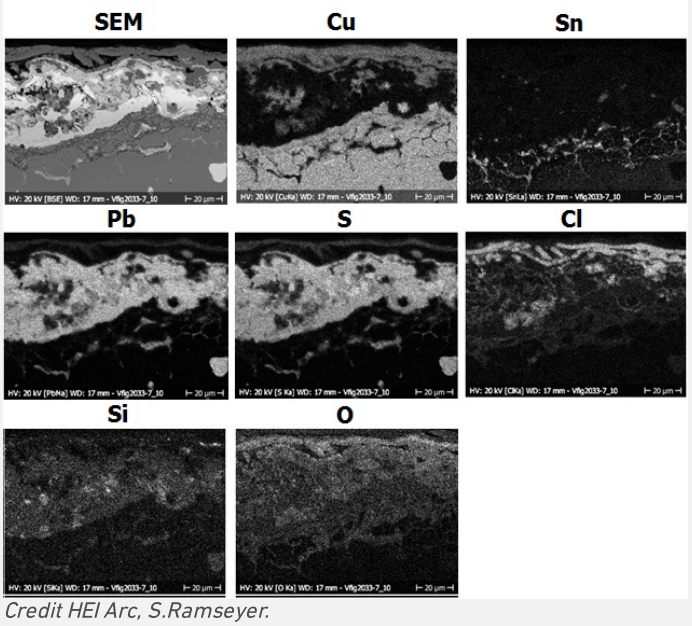
Fig. 12: SEM image, SE-mode, and elemental chemical distribution of the selected area of Fig. 11. Method of examination: SEM-EDS, Lab of Electronic Microscopy and Microanalysis, IMA (Néode), HEI Arc,

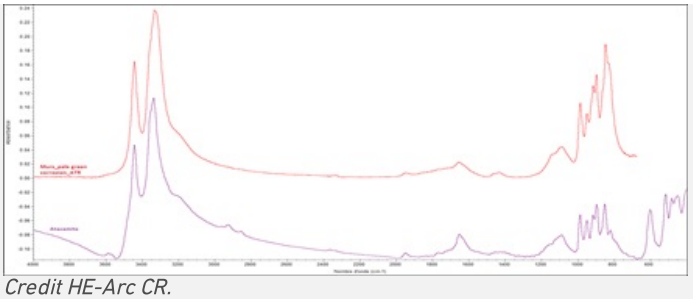
Fig. 13: FTIR spectrum (ATR mode) of the green corrosion powder and comparison to atacamite (purple) spectrum. Method of analysis: FTIR spectroscopy, HE- Arc CR,

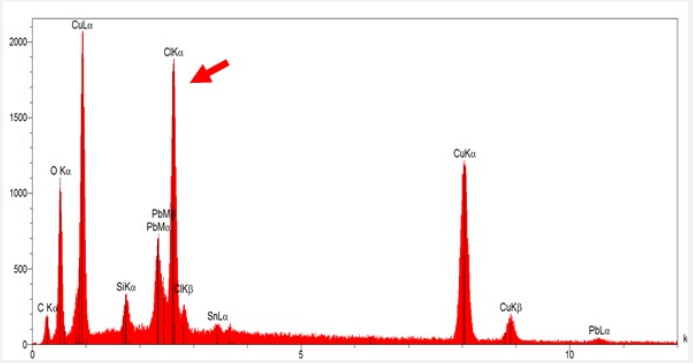
Fig. 14: EDS analysis of the green corrosion powder (Fig. 2). Method of analysis: SEM-EDS, Lab of Electronic Microscopy and Microanalysis, IMA (Néode), HEI Arc,

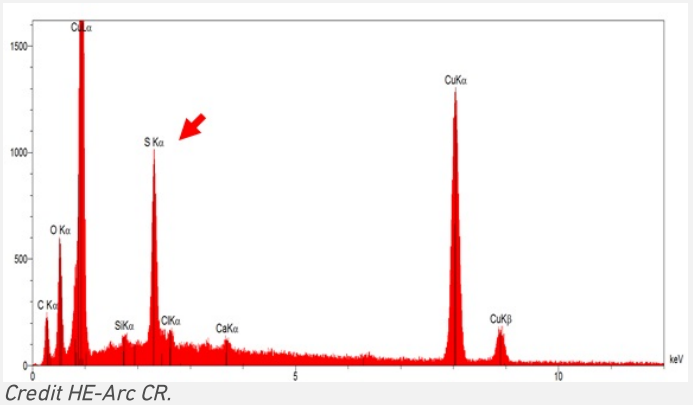
Fig. 15: EDS analysis of the black corrosion powder (Fig. 2). Method of analysis: SEM-EDS, Lab of Electronic Microscopy and Microanalysis, IMA (Néode), HEI Arc,

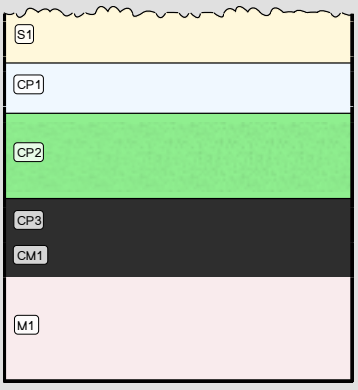
Fig. 5: Stratigraphic representation of the object in cross-section using the MiCorr application. This representation can be compared to Fig 11, Credit HE-Arc CR.

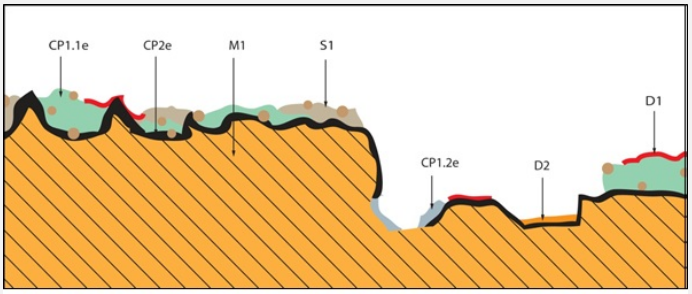
Based on the analyses carried out, the schematic representation of the stratigraphy of corrosion layers has been corrected: a thin, black sulphur-rich layer covers the metal surface. A thick green layer has developed on top and seems to be constituted mainly of atacamite enriched in lead with sediments on top.

Strata	Composition
Sediments (S1)	Si, O
Deposits (D1 & D2)	?
Outer green corrosion product (CP1e)	Atacamite
Inner black corrosion product (CP2i)	S, Cu, O
Remnant metal phase (M1)	Bronze (90%Cu, 10% Sn)

Fig. 16: Improved stratigraphic representation of the artefact from visual observations and analyses (additional mention e or i within the coding correspond to strata in contact with the environment (e) and internal strata (i),
