VOTIVE FIGURE OF A BAT IVB4168 – GILDED BRASS

Artefact name	Votive figure of a bat IVb4168
Authors	Christian. Degrigny (HE-Arc CR, Neuchâtel, Neuchâtel, Switzerland) & Naima. Gutknecht (HE-Arc CR, Neuchâtel, Neuchâtel, Switzerland) & Valentin. Boissonnas (HE-Arc CR, Neuchâtel, Neuchâtel, Switzerland)
Url	/artefacts/401/

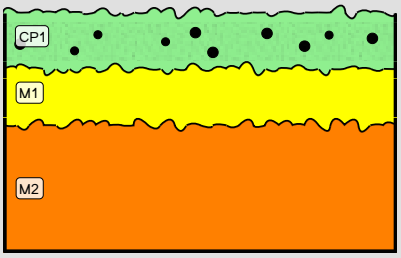
Fig 5: MiCorr stratigraphy 1 from Fig. 4, Credit HE-Arc CR, N.Gutknecht.

The metal seems to have been heavily attacked (acid dissolution). There are several perforations on the lower part of the object, and where the gold layer is absent the surface is unevenly pitted by corrosion (Figs. 1, 2 and 7). The submetallic core is not visible from the surface.

There are two corrosion products (Figs. 7, 8 and 9). The red one (CP2) has a submetallic brightness and is opaque, non-magnetic, compact, hard and adherent. It is very thin (less than a few microns thick) and only appears where the

The light green to white corrosion product (CP1) has a waxy consistency and is thin, translucent, non-magnetic, powdery and very soft. It is very loosely bound. It is distributed on the whole object (front and back) as disparate clumps. It is mainly located on the cavities and irregularities of the surface. Its FTIR analysis (ATR mode) (Fig. 11) was performed on green and white areas of CP1. The two compounds have similar spectra and were identified as copper nitrate (Fig. 11b).

FTIR analysis of the green/white corrosion product suggests that it is a copper nitrate, a highly water soluble corrosion product that cannot be found in an archaeological context. However, it has been recorded on artificially patinated copper alloys (Scott, D. (2000) p. 250-251 ; Craddock, P. (2009) p. 365).

The dissolution of the metal and the subsequent formation of the patina is most likely the result of a forced attack with concentrated nitric acid. The holes and pits in the metal are unnatural for a natural corrosion process which would produce a stratified, adherent and thick corrosion crust (Craddock, P. (2009) p. 349-351). The copper nitrates could have formed over time from residual acidic solution that was left on the surface.

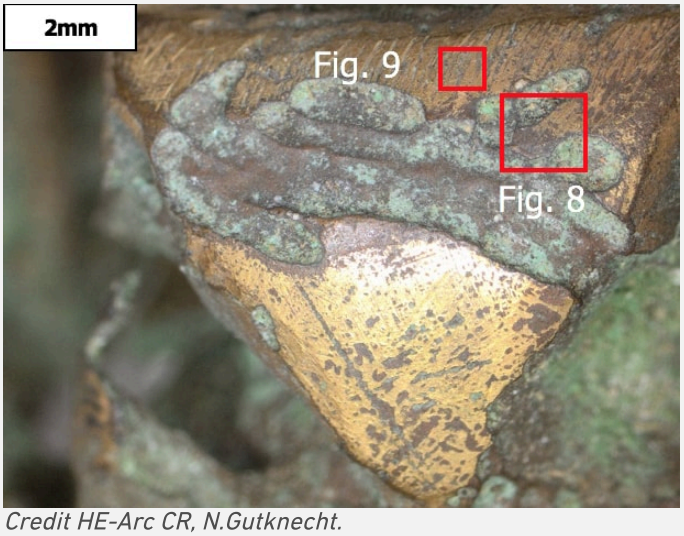
Fig. 4: Location of the areas used to build the MiCorr stratigraphies of figures 5 and 6,
