DOMED CAP NUT - ZN AL SN CU ALLOY - MODERN TIMES - FRANCE

Artefact name	Domed cap nut
Authors	Christian. Degrigny (HE-Arc CR, Neuchâtel, Neuchâtel, Switzerland) & Mathea. Hovind (University of Oslo, Department of archaeology, conservation and history (IAKH-UiO), Oslo, Oslo, Norway)
Url	/artefacts/402/

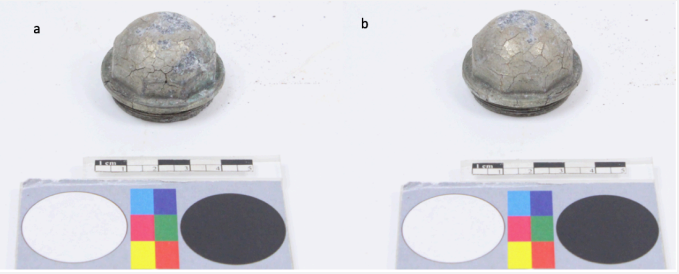
Fig. 1: Domed, threaded fitting, consisting of a Zn/Al/Pb/Cu/Sn alloy. Profile «a» and «b», to the left and right, respectively,

Description of the artefact	A domed, threaded fitting, consisting of a cast alloy with a metallic plating (Fig. 1). Its shape is octagonal and the inside is hollow. The plating is heavily cracked, leading to surface flaking. The metal appears to be consumed by some kind of internal corrosion. Dimensions: L (ø) = 40mm; H = 28mm; T = 5mm; WT = 49g.
Type of artefact	Cap
Origin	Château de Germolles, Mellecey, Bourgogne, France
Recovering date	Date unknown
Chronology category	Modern Times
chronology tpq	1801 A.D.
chronology taq	2000 A.D.
Chronology comment	19th - 20th century
Burial conditions / environment	Outdoor atmosphere

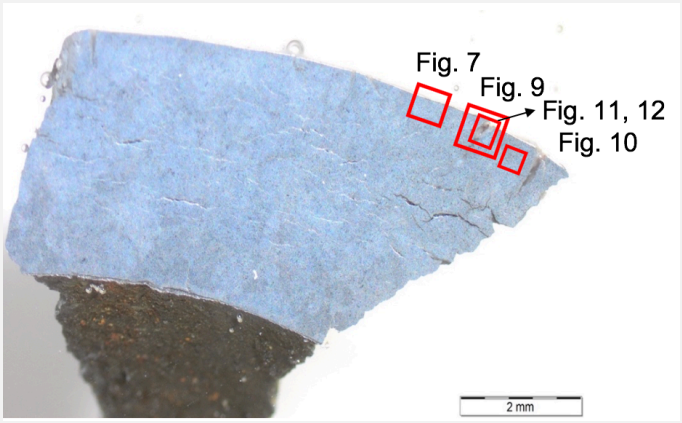
Fig. 4: Micrograph of the cross-section showing the locations of Figs. 7 and 9-12,

Description of sample	The sample is a cross section of the metal, representative of the head of the fitting. It shows external cracks extending from the metal surface and into its structure in addition to internal cracks, visible as thin lines along its longitudinal axis (Fig. 4).
Alloy	Zn Al Sn Cu Alloy
Technology	None
Lab number of sample	NZC2018 (Ni/Zn Cap, sampled in 2018)
Sample location	HE-Arc CR, Neuchâtel, Neuchâtel
Responsible institution	Haute Ecole Arc Conservation-Restauration
Date and aim of sampling	March 2018, study of corrosion stratigraphy and chemical analyses

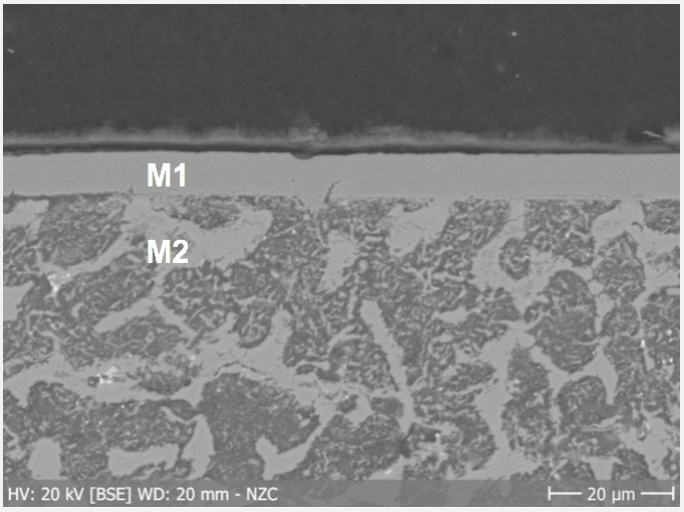
The metal of the domed fitting (M2) consists of a Zn/Al/Pb/Cu/Sn alloy (Table 1) externally covered by a nickel-based plating (M1) (Figs. 7 and 8). The bulk metal (M2) has a dendritic microstructure appearing light grey in bright field, while the interdendritic phase appears white (Fig. 9). The latter is Zn-rich, while the dendritic phase consists of approximately equal amounts of Zn and Al (Table 2, Fig. 11). Observation in SEM (BSE-mode) reveals the presence of Pb-nodules, visible as white irregular spots with a scattered distribution, in addition to opaque grey patches which are rich in Al and Fe (Fig. 10).

Fig. 7: SEM-image (BSE-mode) of a selected area from Fig. 4 (detail), showing the metal plating (M1) and the bulk metal (M2),

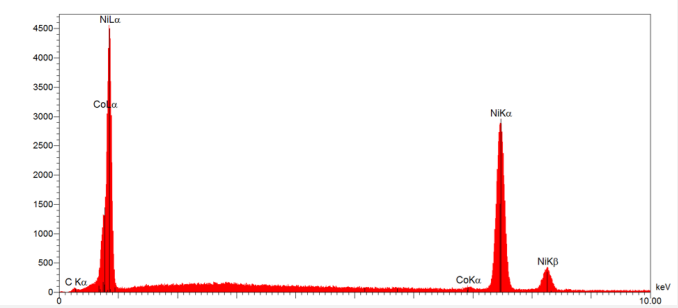
The dendritic phase is heavily oxidized compared to the interdendritic phase (Table 2 and Fig. 12). The corrosion has developed throughout the entire metal body, generating cracks (Fig. 9). The cracks are Zn and O-rich (Fig. 12) and could be composed of zinc carbonate. It could be a case of zinc pest, an intergranular corrosion phenomenon known to cause disintegration in poor quality alloys (Selwyn 2004:155-156, Zhang 2011:890).

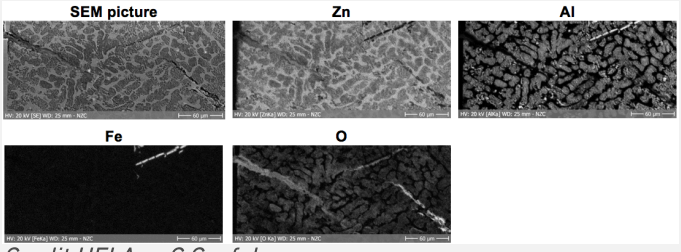
Fig. 12: SEM image and elemental chemical distribution of the selected area from Fig. 9 (rotated 270° and inversed). Method of analysis: SEM-EDS. Lab. of Electronic Microscopy and Microanalysis, Néode, HEI Arc,

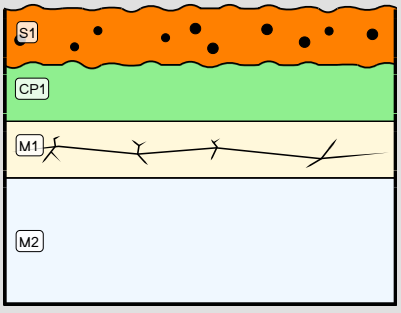
Fig. 5: A MiCorr stratigraphy representative of an area with intact metal plating (M1). S1 represents Fe-polluted soil while CP1 is a green translucent corrosion product, Credit UiO-IAKH, M.Hovind.

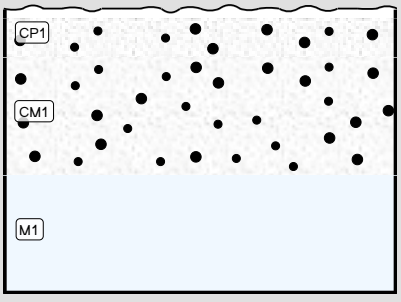
Fig. 6: A MiCorr stratigraphy representative of an area where the metal plating is missing. CP1 corresponds to CP2 in Fig. 3, CM1 represents the corroded metal phase, while M1 corresponds to the bulk metal (M2 in Fig. 3), Credit UiO-IAKH, M.Hovind.
