ROOF GUTTER ELEMENT – ZN ALLOY – MODERN TIMES – FRANCE

Artefact name	Roof gutter element
Authors	Christian. Degrigny (HE-Arc CR, Neuchâtel, Neuchâtel, Switzerland) & Mathea. Hovind (University of Oslo, Department of archaeology, conservation and history (IAKH-UiO), Oslo, Oslo, Norway)
Url	/artefacts/403/

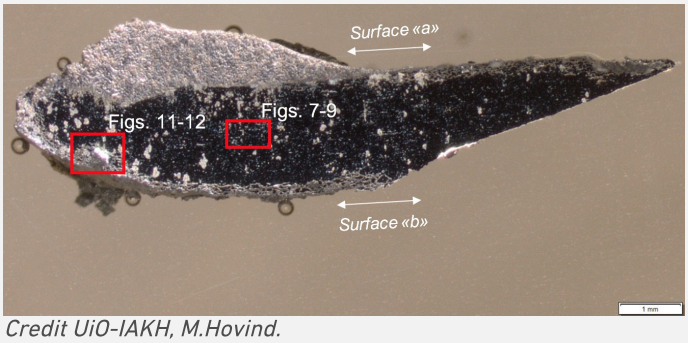
MiCorr stratigraphy(ies) – Bi

The schematic representation below (Fig. 3) gives an overview of the corrosion layers encountered on the object from a first visual macroscopic observation.

Captions	Description
D1	Remains of lead solder.
S1	Light brown and porous soil. Located only on surface "b".
CP1	Light grey to white, thin and adherent layer. Located on both surfaces.
M1	Intact metal. Submetallic and light grey in colour.

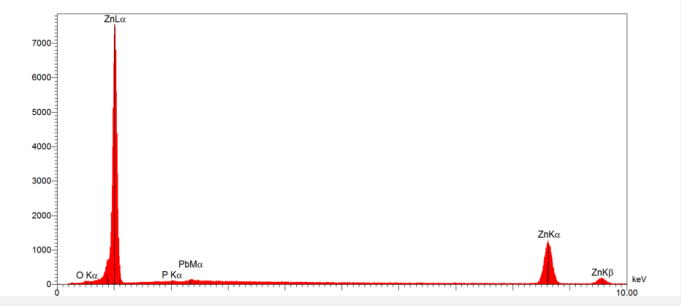
Fig. 6: Chemical composition of the metal. Method of analysis: SEM-EDS. Lab. of Electronic Microscopy and Microanalysis, Néode, HEI Arc,

The flashing is composed of Zn with P and Pb (Fig. 6). The latter is probably originating from the solder that was applied to adjoin several metal sheets for the flashings.

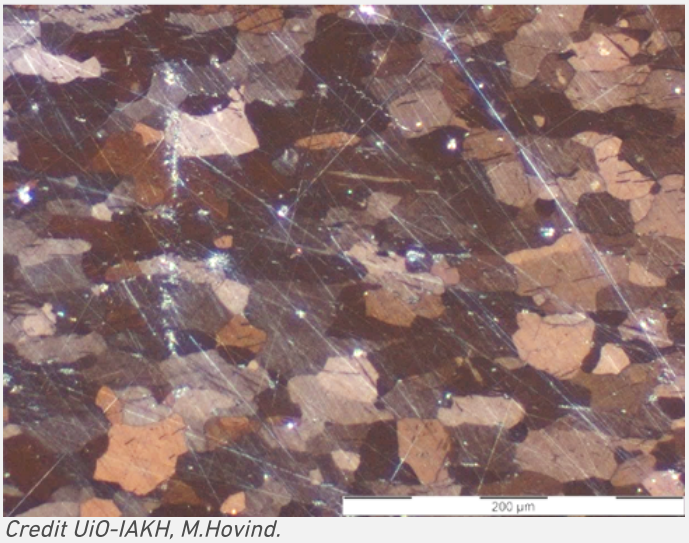
The metal appears white to light grey under bright field (Fig. 7). Under polarized light however (Fig. 8), the microstructure of the metal is visible as small polygonal grains appearing in various shades of brown, a coloured effect due to the anisotropic properties of the metal (Scott 1991: 49). In the SEM-image, white elongated inclusions are visible (Fig. 9) consisting mainly of Zn and Pb with some O (Fig. 10).

Fig. 7: Micrograph of the metal sample from Fig. 4 (detail). Unetched, bright field,

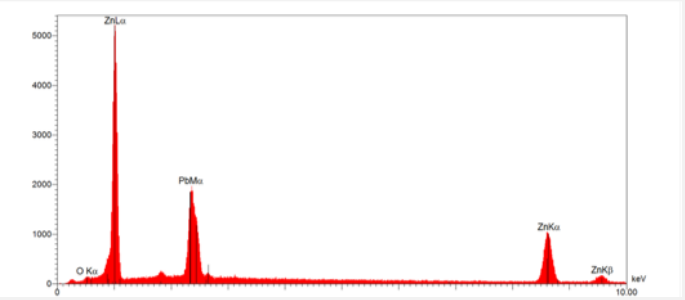
Fig. 10: SEM-EDS spectrum showing the composition of the elongated inclusions from Fig. 9. Method of analysis: SEM-EDS. Lab. of Electronic Microscopy and Microanalysis, Néode, HEI Arc,

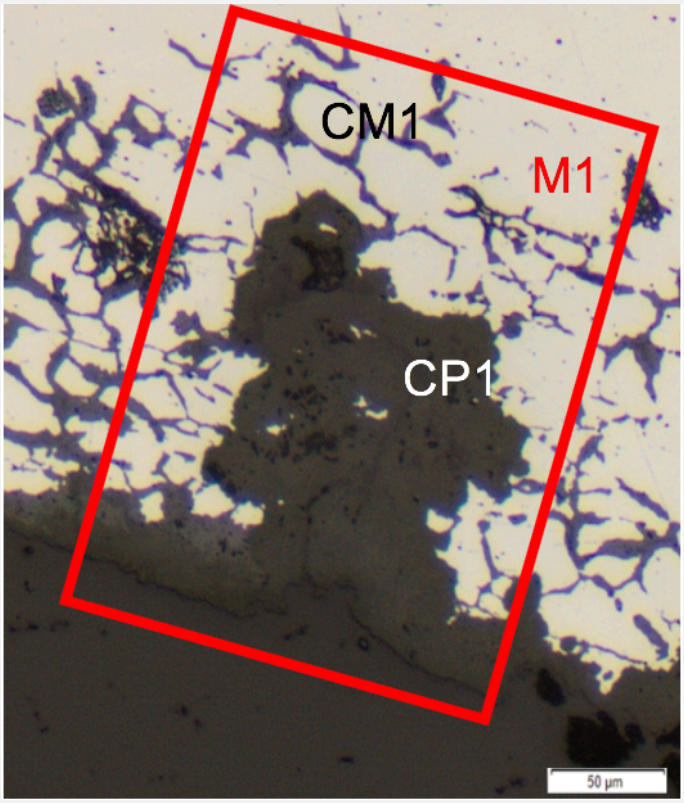
The metal is suffering from intergranular corrosion visible as a white corrosion product (CP1) located within crevices and along the grain boundaries (Figs. 11 and 12). Both the corrosion product (CP1) and the corroded metal (CM1) appear dark grey in bright field (Fig. 11) and white under polarized light (Fig. 12). They both consist of Zn and O (Table 1). The external corrosion product (CP1) contains some S (and not Pb as suggested by Table 1 and Fig. 14) which is probably due to atmospheric pollution. The structural composition of the corrosion product was determined by crystallographic analysis (XRD) to consist of a mixture of zincite (ZnO) and pure zinc (Zn) (Table 2, Fig 13). Mapping of the corroded area by SEM-EDS displays a similar composition but shows additionally the presence of Cl in some of the cracks (Fig. 14).

Elements mass%*	C	O	Zn	Pb	S	Al	Si	Fe	Cu	Sn
CP1, white corrosion product	7	33	51	3	5	-	0.3	0.1	0.1	0.4
CM1, intergranular corrosion	6	22	68	3	0.1	0.1	0.1	0.1	0.1	0.5

Fig. 11: Micrograph of the metal sample from Fig. 4 (detail). Unetched, bright field. The corrosion product (CP1) is located at the surface of the metal and in its crevices. Intergranular corrosion (CM1) is visible as thin grey lines in between the metal grains (M1). The area selected for elementary mapping (Fig. 14) is marked by a red square

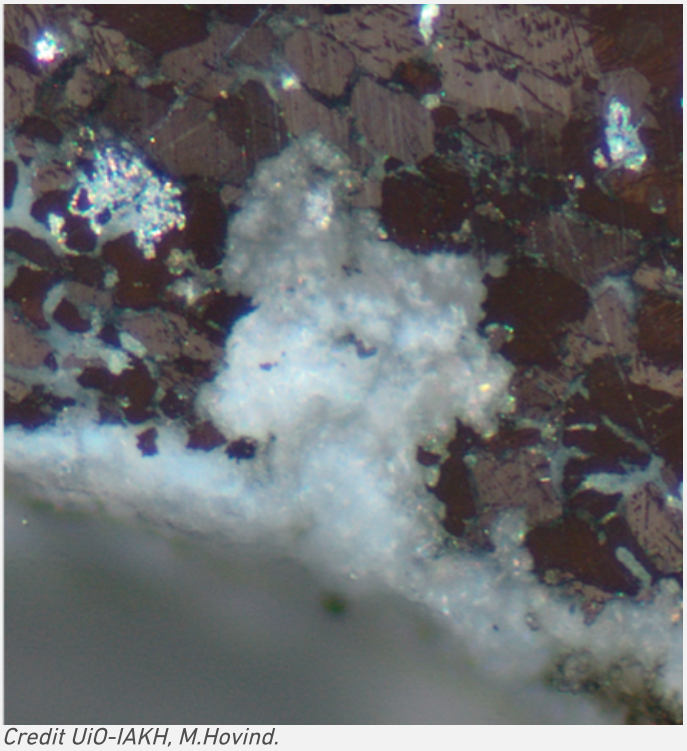
Fig. 12: Micrograph similar to Fig. 11 but under polarized light, the corrosion product (CP1) and the corroded metal (CM1) appear white,

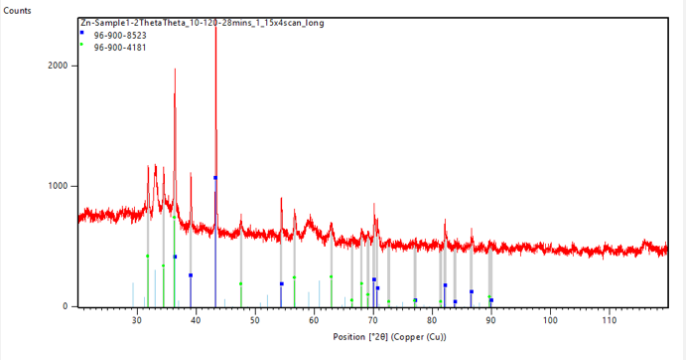
Table 2: Summary of the results from the crystallographic analysis of the white corrosion product (CP1). A representative spectrum is given in Fig. 13. Method of analysis: XRD. Center of X-ray Analytics, Empa-Swiss Federal Laboratories for

Fig. 13: XRD-spectrum for the analysis of powder sample 1. Ref. 96-900-8523 (in blue) corresponds to pure zinc and 96-900-4181 (in green) to zincite (ZnO),

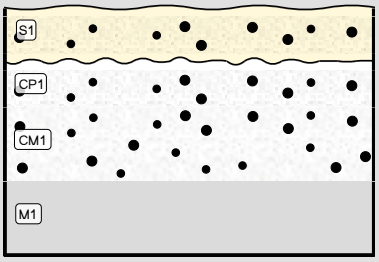
Fig. 5: MiCorr stratigraphy corresponding to the corrosion layers on surface “b” (Figs. 2 and 3). To be compared with Figs. 11 and 12, Credit UiO-IAKH, M.Hovind.
