AXE HEAD N11 – TIN BRONZE – MIDDLE BRONZE AGE

Artefact name Axe head N11

Authors Christian. Degrigny (HE-Arc CR, Neuchâtel, Neuchâtel, Switzerland) & Valentin. Boissonnas (HE-Arc CR, Neuchâtel, Neuchâtel, Switzerland)

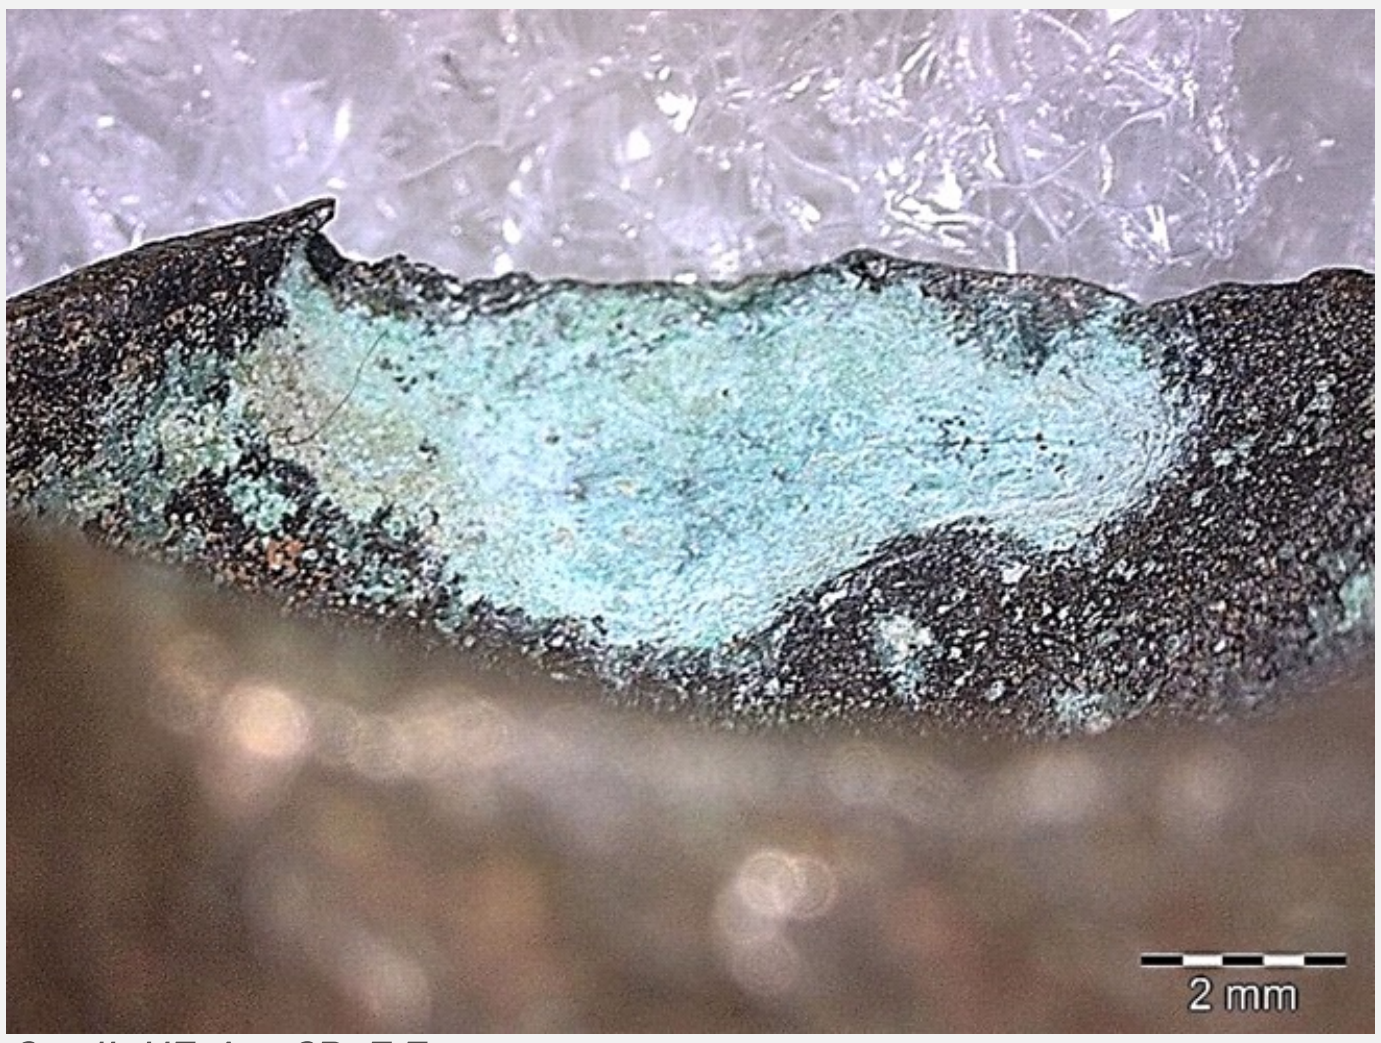
Fig. 5: Local corrosion (length max: 30 mm) where sample 2 has been taken,

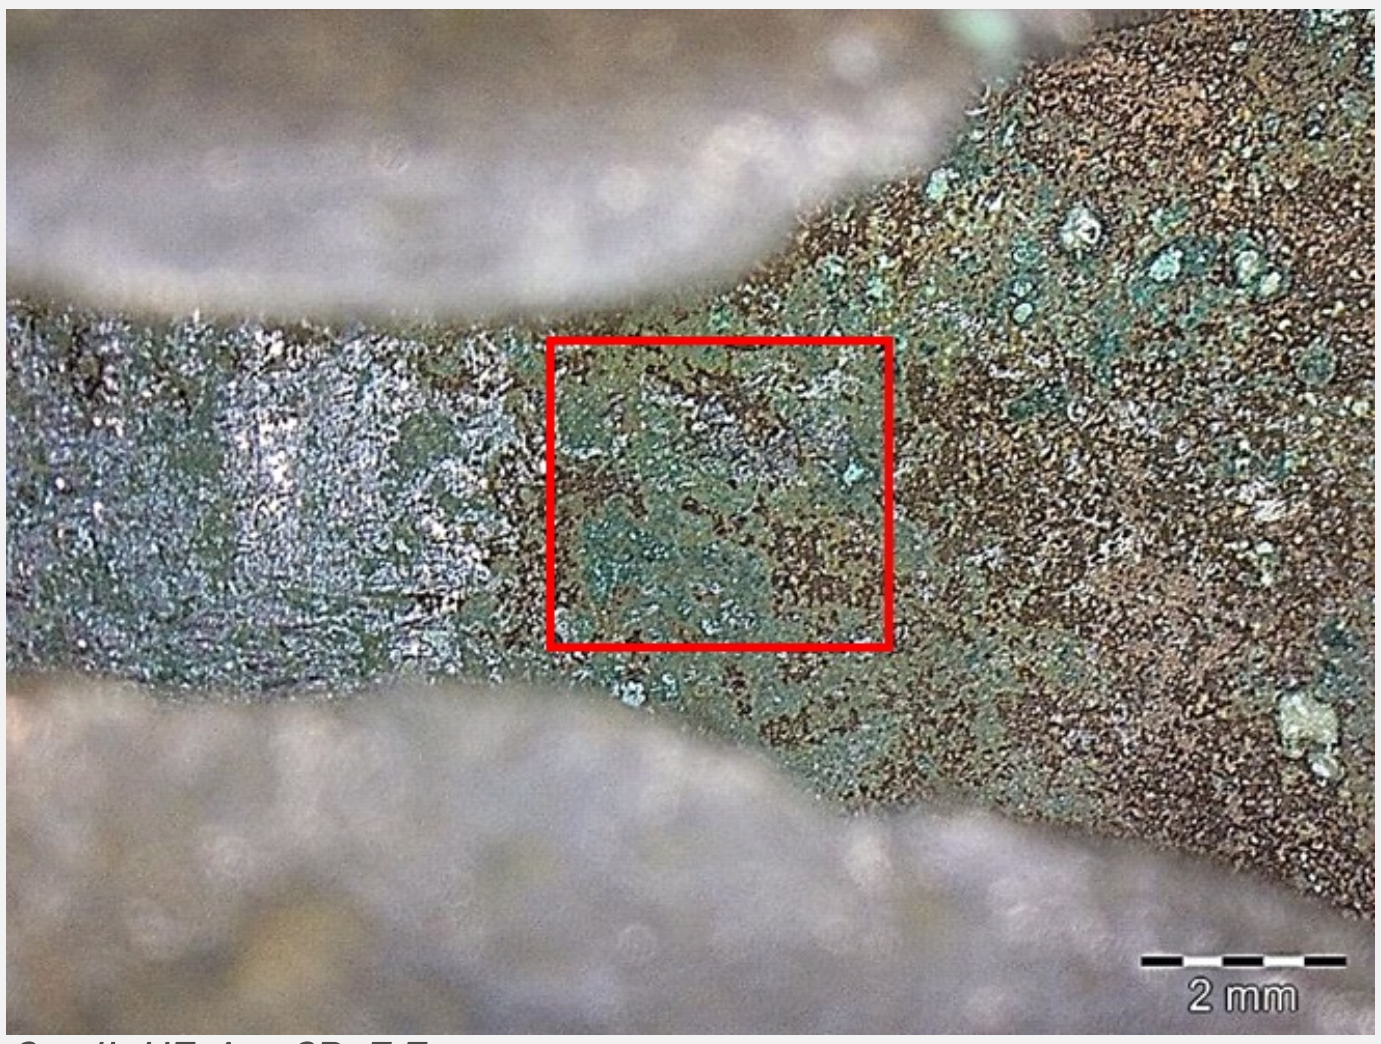
Fig. 6: Local corrosion (length max: 10 mm) where sample 3 has been taken,

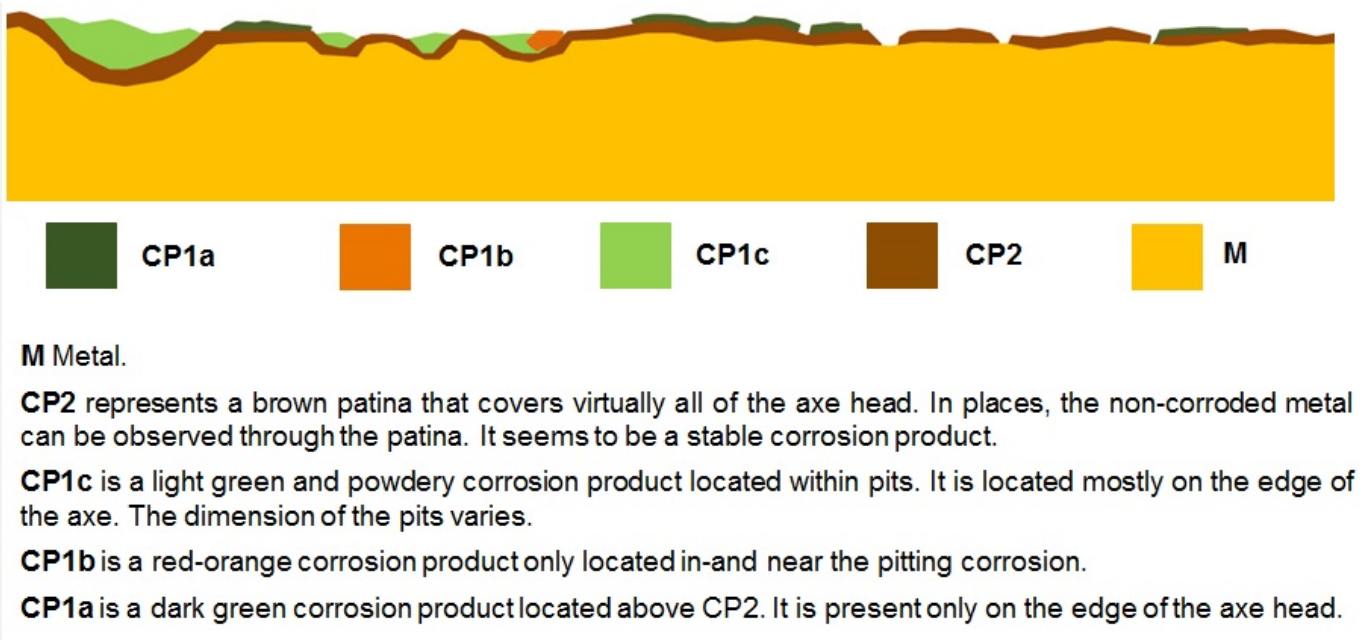
The schematic representation below gives an overview of the corrosion layers encountered on the head axe from a first visual macroscopic observation.

Fig. 8: Stratigraphic representation of corrosion products of the axe head (based on visual observations),

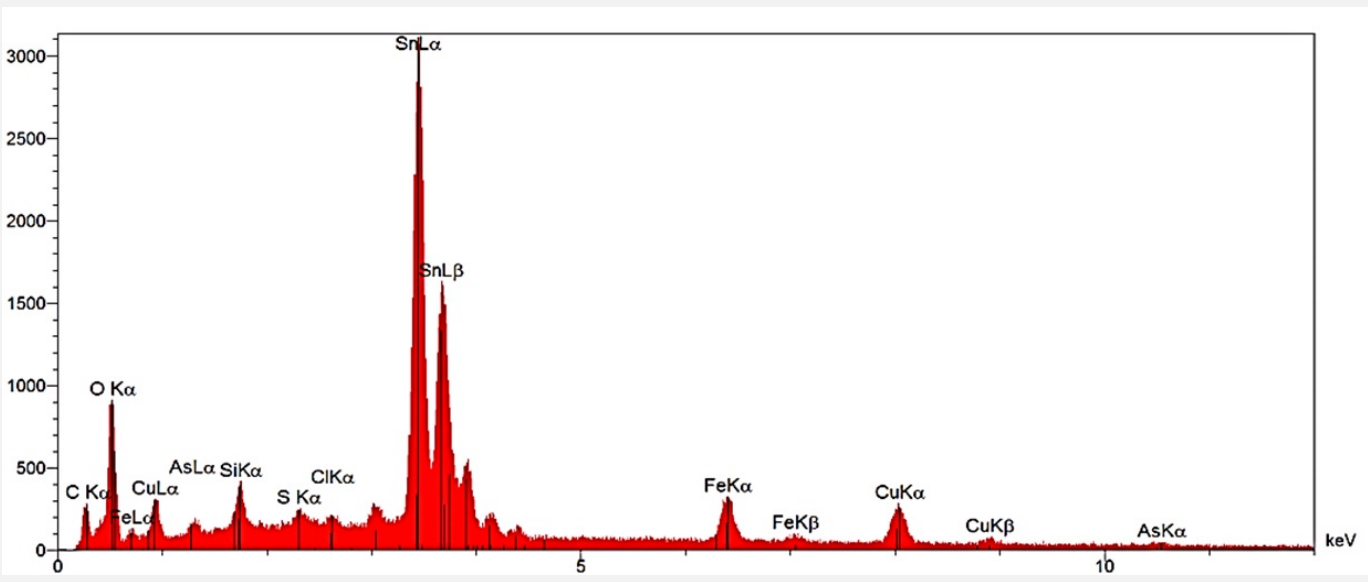
Analyses by SEM/EDS indicate that the light yellow particles of sample 1 are predominantly composed of Sn and O with minor presence of C, Cu, Fe, S, Cl and As (Fig. 12), while the green and red particles of sample 2 are respectively composed of O, Cu, Cl, and Sn, with a minor presence of Fe and S (Fig. 13) and Cu, O (Fig. 14, possibly cuprite). Sample 3 consists of green particles composed mostly of Sn, Cl, Cu and O with S, Al and Fe as minor elements (Fig. 15). Sample 4 is constituted of green and white particles. The former have the same composition as the particles of sample 3 while the white particles are significantly different in composition: containing a large amount of C with a small amount of O, Cl, S, K and Cu (Fig. 16). The FTIR spectrum of the white particles (Fig. 17) shows several characteristic peaks of an organic compound: 2919 cm-1 and 2850 cm-1 (C-H- bond), 3445 cm-1 and 3323 cm-1 (O-H- bond) or 1030cm-1, 1006cm-1 and 951cm-1 (C-O-C- bond).

Fig, 12: EDS spectrum of sample 1 (yellow powder), *Credit HEI Arc, S.Ramseyer.*

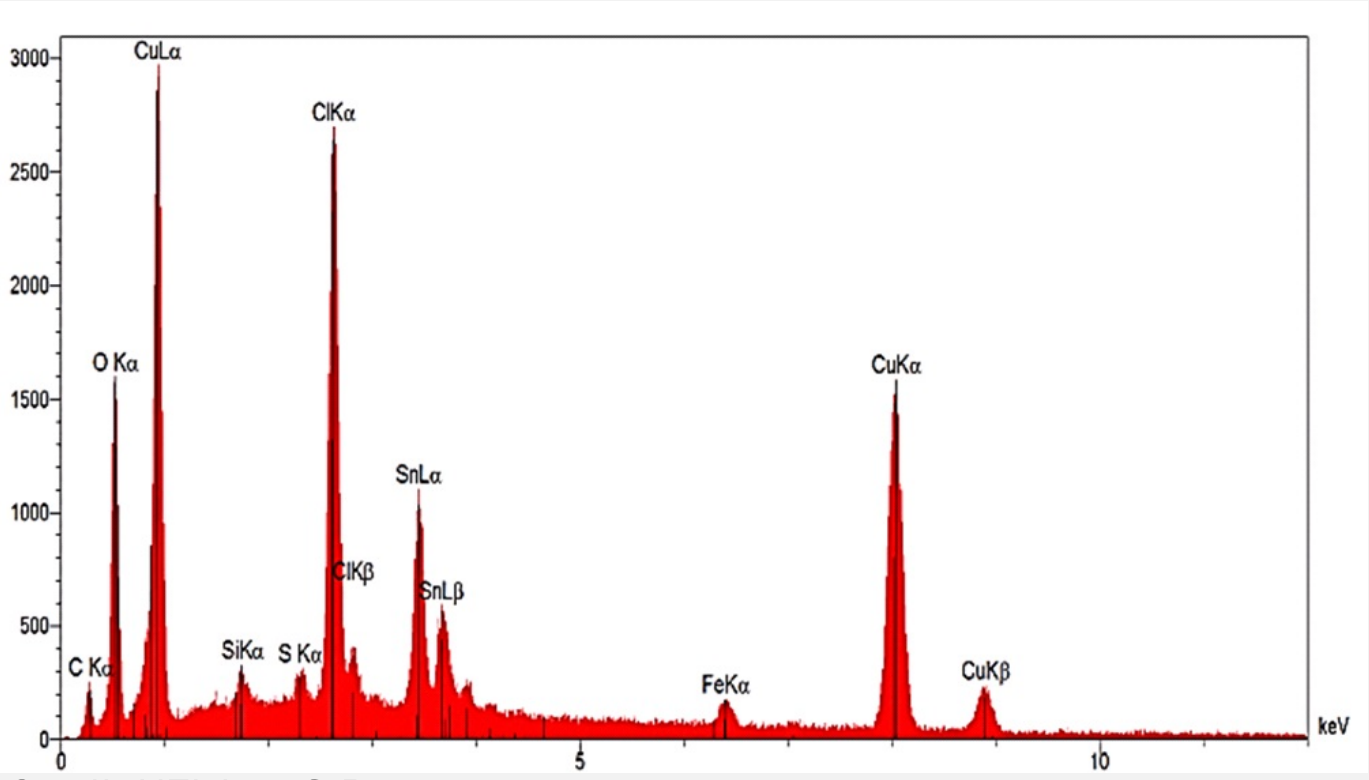
Fig. 13: EDS spectrum of sample 2 (green particle),

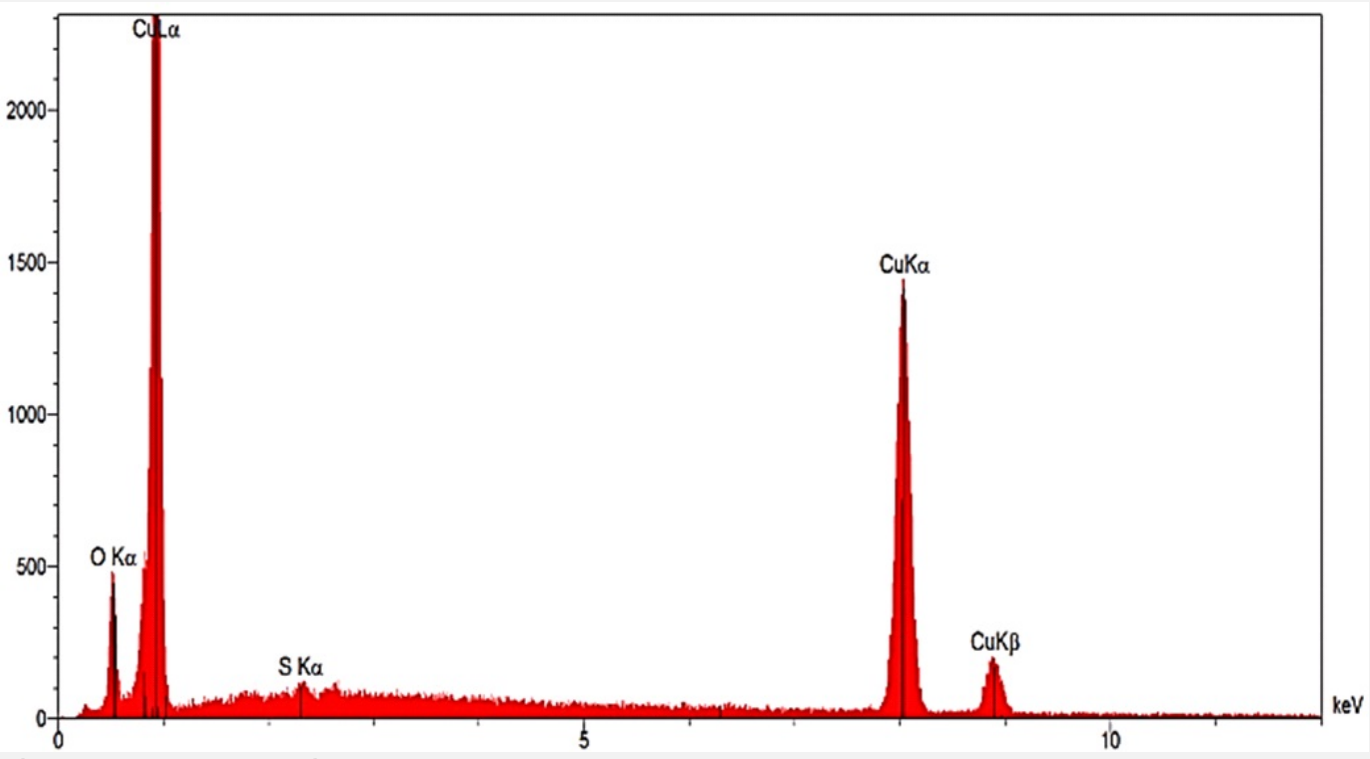
Fig. 14: EDS spectrum of sample 2 (red particle),

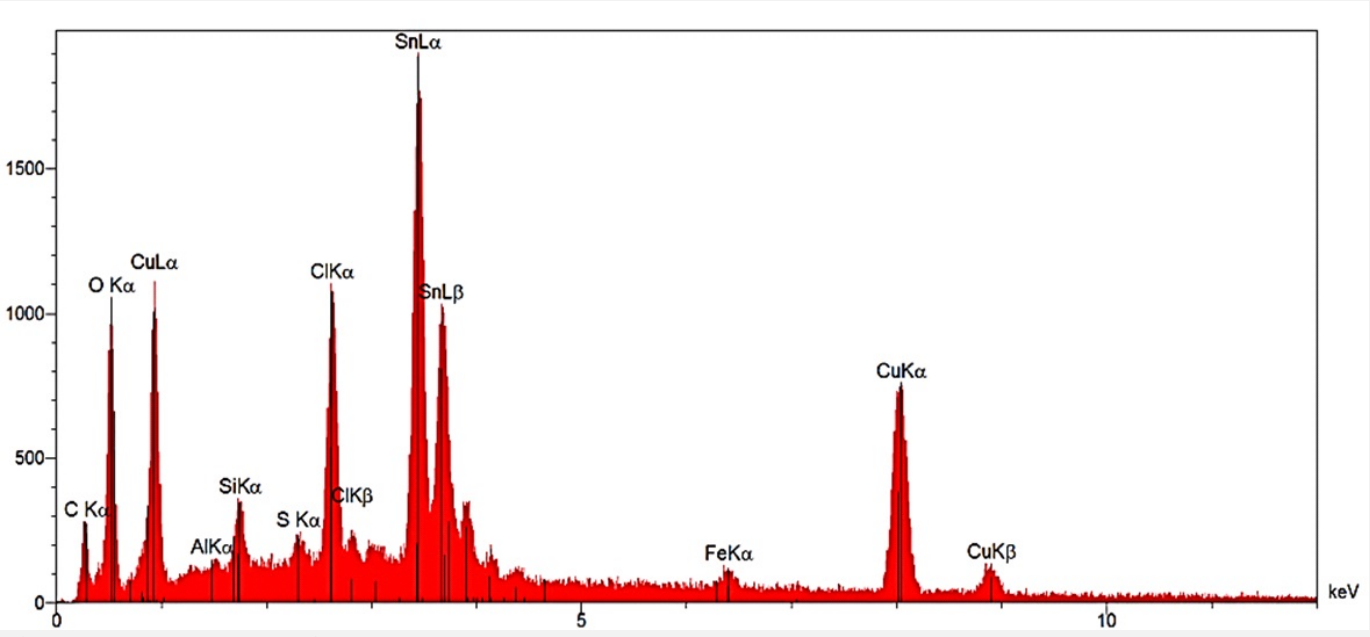
Fig. 15: EDS spectrum of sample 3 (green corrosion product),

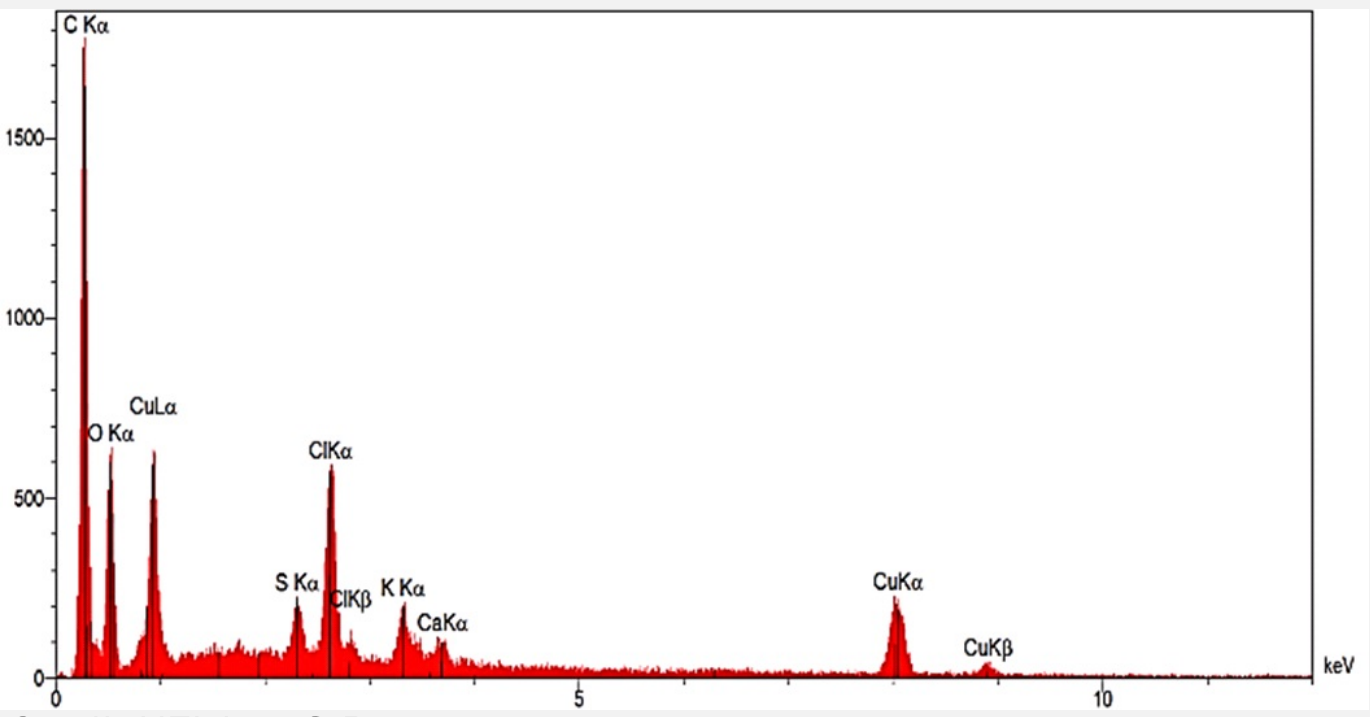
Fig. 16: EDS spectrum of sample 4 (white particle),

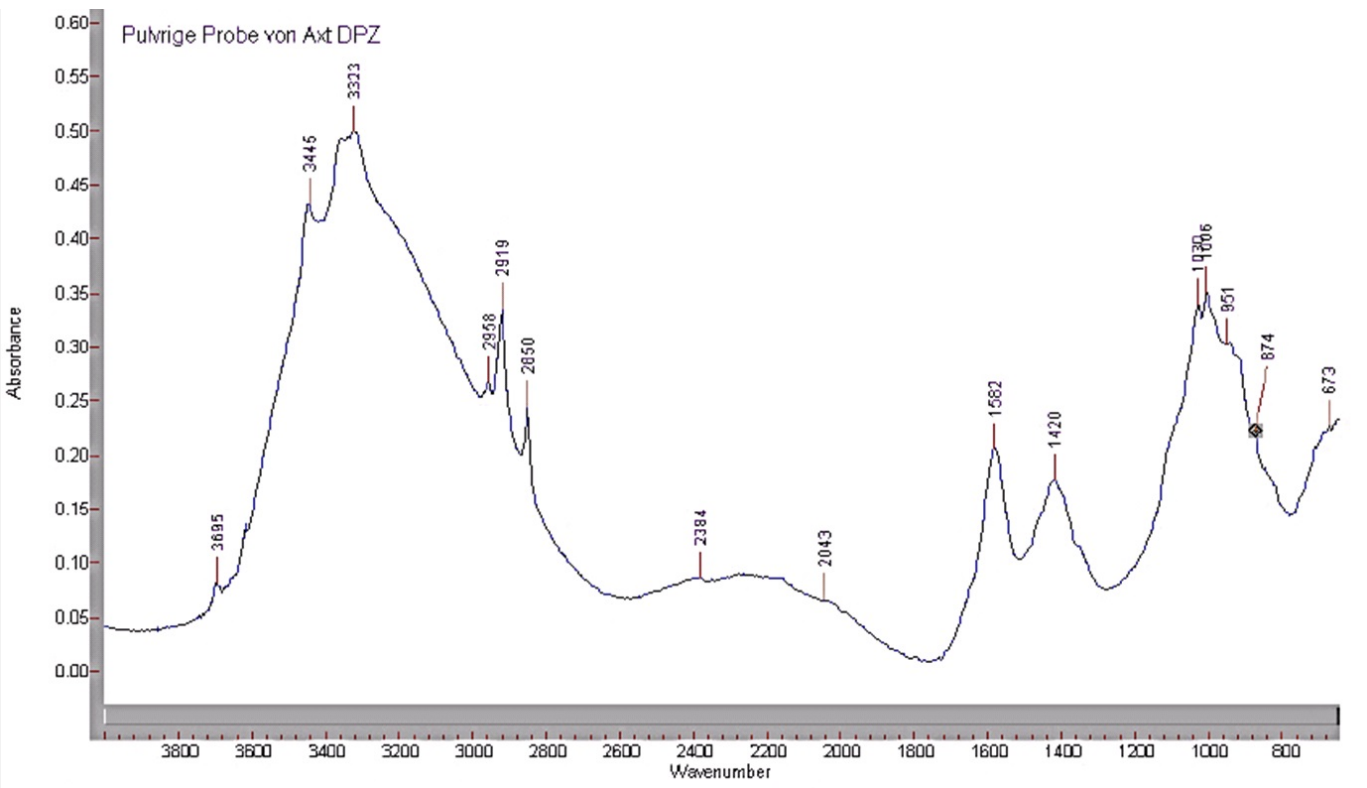
Fig. 17: FTIR spectrum of sample 4 (white particle),

The axe head is probably a tin bronze containing a small amount of As. It is difficult to interpret the corrosion layer only by macroscopic observation. The analyses show that all green corrosion products contain chlorides that might originate from strip-cleaning by hydrochloric acid (although not documented). Active corrosion is not proved but we suspect the presence of atacamite, paratacamite or clinoatacamite (Cu2Cl(OH)3). FTIR revealed the presence of an organic compound on the metal surface (possibly a protective coating).

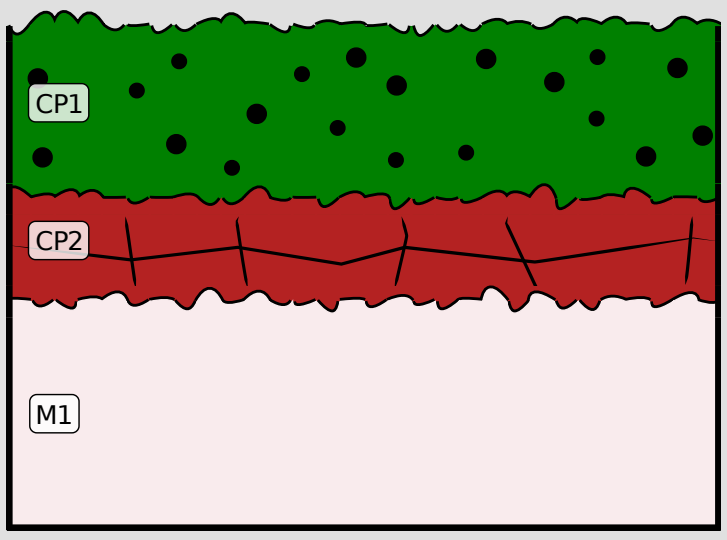
Fig. 11: Stratigraphic representation. of the object in cross-section using the MiCorr application. This presentation can be compared to Fig. 18. CP1 corresponds to CP1a, Credit HE-Arc CR, C.Degrigny.

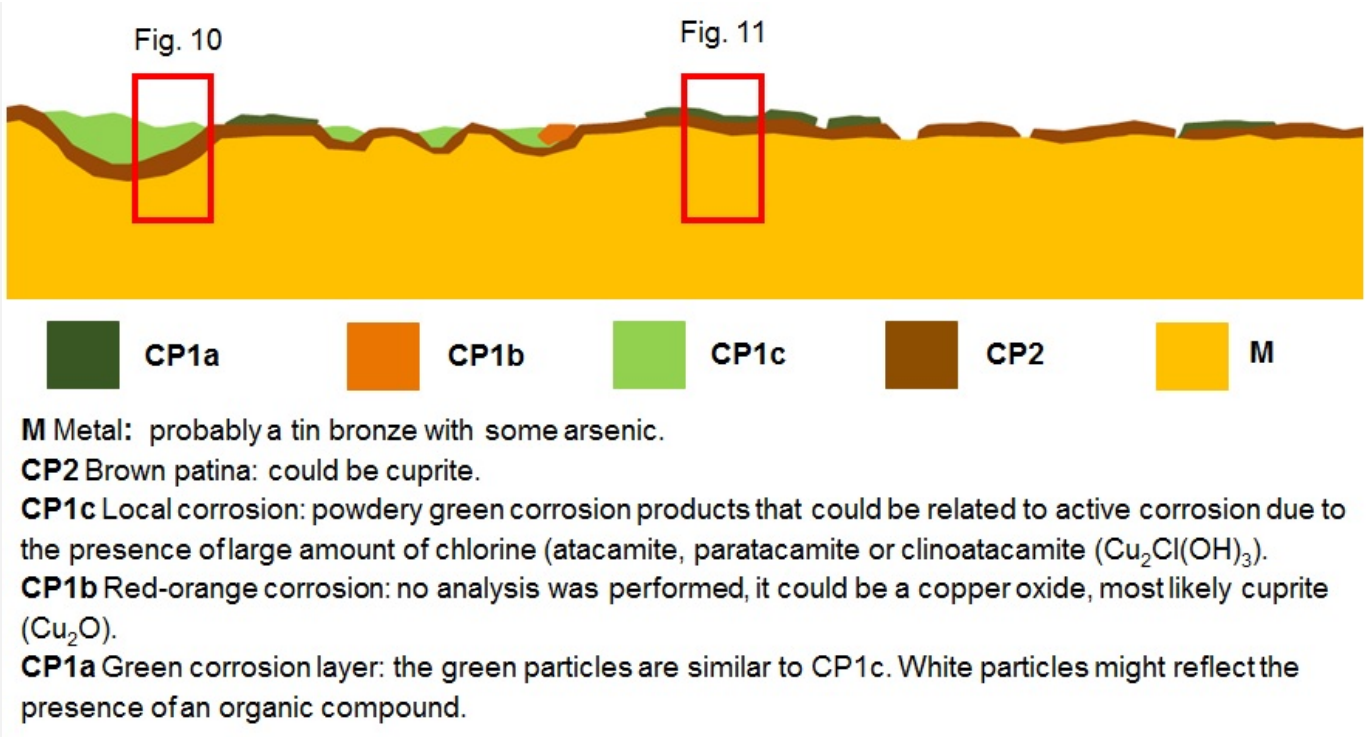
Fig. 18: Complementary stratigraphic representation of a virtual cross-section through the axe head based on visual observations and additional analyses with indication of stratigraphies of Figs. 10 and 11.
