KNIFE WITH A GROOVE ON BOTH SIDES DEV 995 814 PR – FE ALLOY – EARLY MEDIEVAL TIMES – SWITZERLAND

Artefact name	Knife with a groove on both sides DEV 995 814 PR
Authors	Marianne. Senn (EMPA, Dübendorf, Zurich, Switzerland) & Christian. Degrigny (HE-Arc CR, Neuchâtel, Neuchâtel, Switzerland)
Url	/artefacts/435/

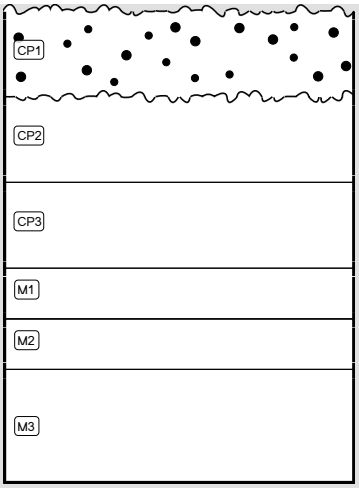
Fig. 4: Stratigraphic representation of the object in cross-section using the MiCorr application. The characteristics of the strata are only accessible by clicking on the drawing that redirects you to the search tool by stratigraphy representation. This representation can be compared to Fig. 13, Credit HE-Arc CR.
