HEADREST OR HORSE BIT VFIG 2003.7 - LEADED BRONZE - MODERN TIMES

Artefact name	Headrest or horse bit VFig 2003.7
Authors	Christian. Degrigny (HE-Arc CR, Neuchâtel, Neuchâtel, Switzerland) & Valentin. Boissonnas (HE-Arc CR, Neuchâtel, Neuchâtel, Switzerland)
Url	/artefacts/436/

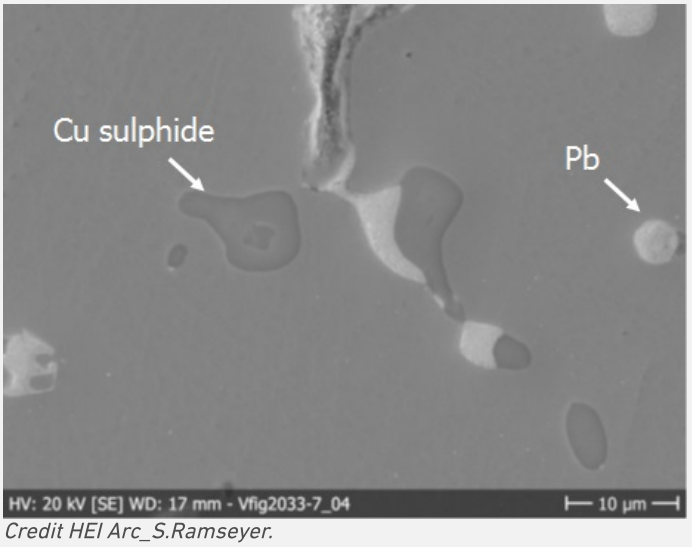
The remaining metal is a leaded bronze (Table 1) containing numerous copper sulphide and lead (Pb) inclusions (Figs. 6 and 7). The porosity is difficult to distinguish since the pores seem to have similar dimensions as the inclusions that could have been removed during the polishing of the sample (Fig. 6). After etching, the structure of the metal appears to be made up mostly of dendrites, but a grain structure seems to have developed on the right side of the sample, with occasional twin lines (Figs. 8 and 9). The twinned grain

Fig. 6: Micrograph of the cross-section of Fig. 4 (detail), unetched, bright field. Light grey copper sulphide and tiny round Pb inclusions as well as "porosities" can be observed. Area of Fig. 10 is marked by a rectangle,

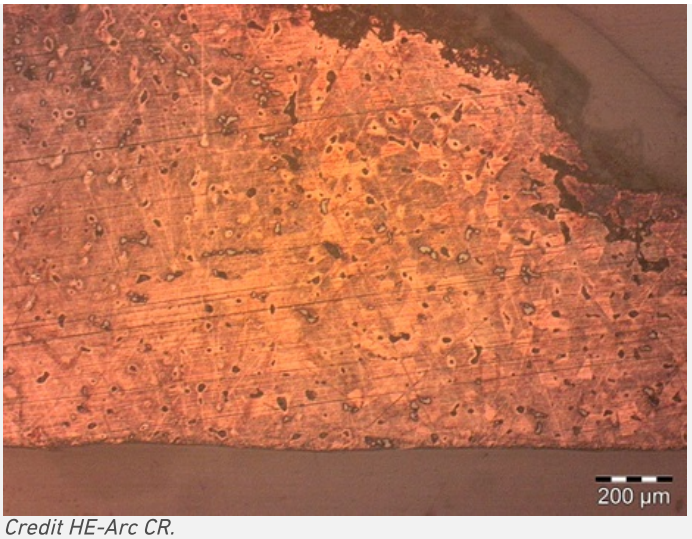
Fig. 8: Micrograph of the metal sample from Fig. 4 showing a dendritic structure and grains,

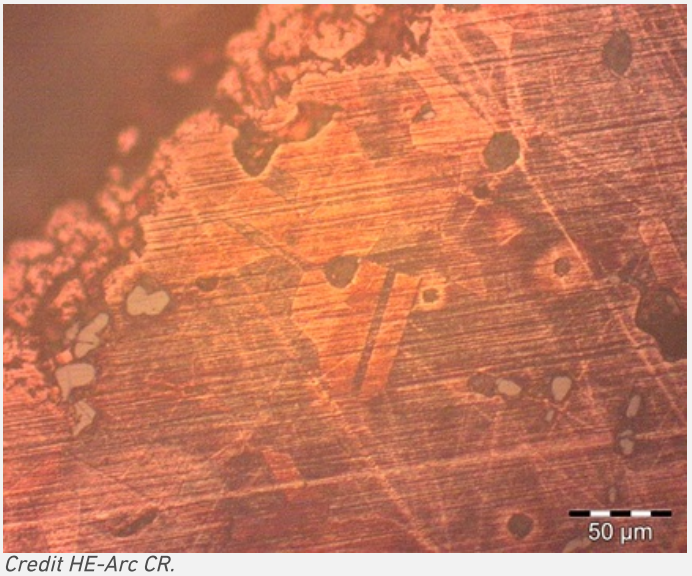
structure could be the result of cold work and annealing after casting, possibly through the application of an artificial patina under heat.

Fig. 9: Micrograph of a selected area showing grains and twin lines,

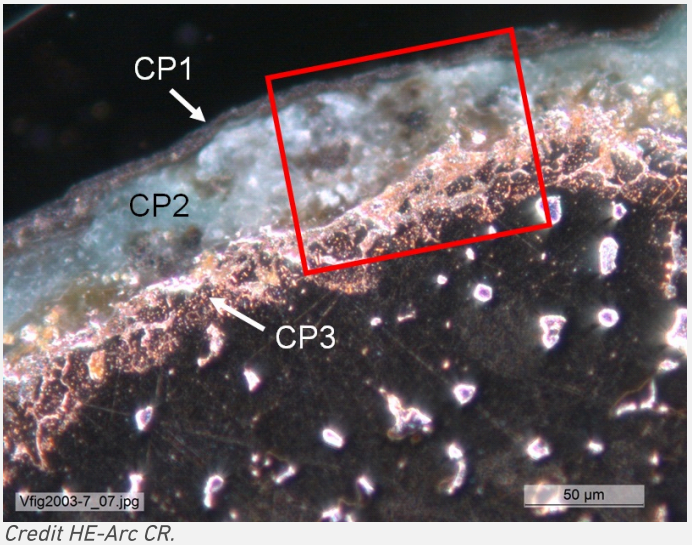
The remaining metal seems to have developed intergranular corrosion at the interface metal / corrosion layer (Fig. 10) slightly enriched in Sn (Fig. 12). The outer green corrosion product (CP2) is matte, powdery and mixed with sediments. It looks regular on Figs. 10 and 11 (around 50µm). This corrosion layer is mainly composed of lead (and/or sulphur), oxygen, silicon, chlorine and is depleted in Cu (Fig. 12 and table 2) except in its top part (CP1) where it is Cl, Cu and O-rich (Fig. 12 and table 2). FTIR seems to indicate that it is constituted of atacamite ($Cu_2Cl(OH)_3$, Fig. 13). This is confirmed on the EDS spectra of figure 14 where Pb is clearly detected. The inner black corrosion product (CP3) is a dark brown, matte layer (Figs. 2 and 11). It covers all the surface of the object, and forms a very thin layer. It is sulphur and oxygen-rich (Fig. 15). FTIR analysis could not reveal the presence of a specific corrosion product.

Fig. 10: Micrograph of the metal sample from Fig. 6, unetched, bright field,

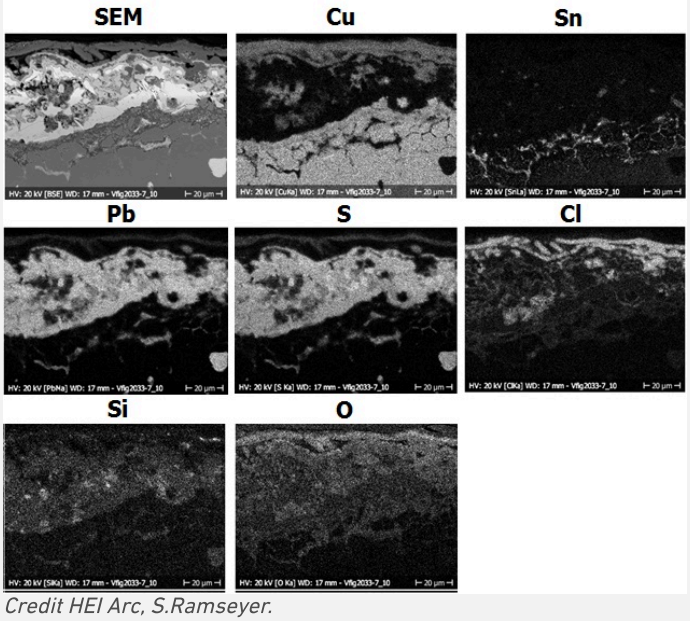
Fig. 12: SEM image, SE-mode, and elemental chemical distribution of the selected area of Fig. 11. Method of examination: SEM-EDS, Lab of Electronic Microscopy and Microanalysis, IMA (Néode), HEI Arc,

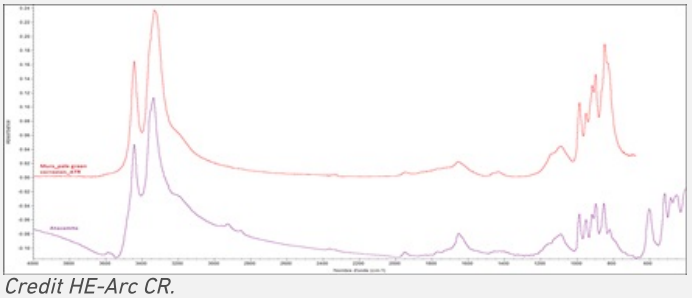
Fig. 13: FTIR spectrum (ATR mode) of the green corrosion powder and comparison to atacamite (purple) spectrum. Method of analysis: FTIR spectroscopy, HE- Arc CR,

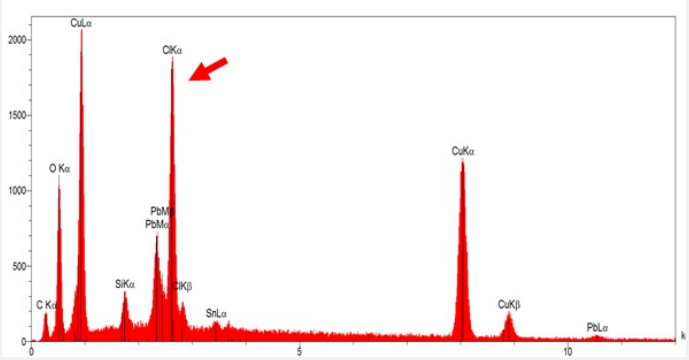
Fig. 14: EDS analysis of the green corrosion powder (Fig. 2). Method of analysis: SEM-EDS, Lab of Electronic Microscopy and Microanalysis, IMA (Néode), HEI Arc,

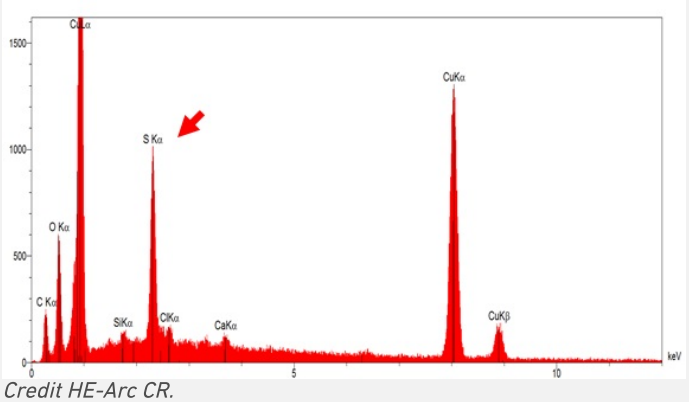
Fig. 15: EDS analysis of the black corrosion powder (Fig. 2). Method of analysis: SEM-EDS, Lab of Electronic Microscopy and Microanalysis, IMA (Néode), HEI Arc,

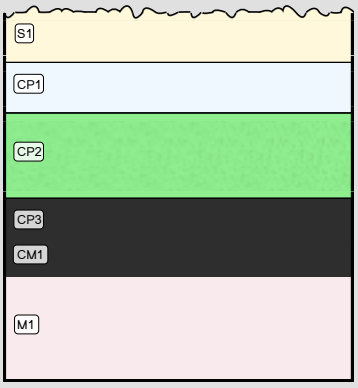
Fig. 5: Stratigraphic representation of the object in cross-section using the MiCorr application. The characteristics of the strata are only accessible by clicking on the drawing that redirects you to the search tool by stratigraphy representation. This representation can be compared to Fig 11, Credit HE-Arc CR.

Based on the analyses carried out, the schematic representation of the stratigraphy of corrosion layers has been corrected: a thin, black sulphur-rich layer covers the metal surface. A thick green layer has developed on top and seems to be constituted mainly of atacamite enriched in lead with sediments on top.
