TANG FRAGMENT OF A KNIFE HR-6246 - TIN BRONZE - LATE BRONZE AGE - SWITZERLAND

Artefact name Tang fragment of a knife HR-6246

Authors Marianne. Senn (EMPA, Dübendorf, Zurich, Switzerland) & Christian. Degrigny (HE-Arc CR, Neuchâtel, Neuchâtel, Switzerland)

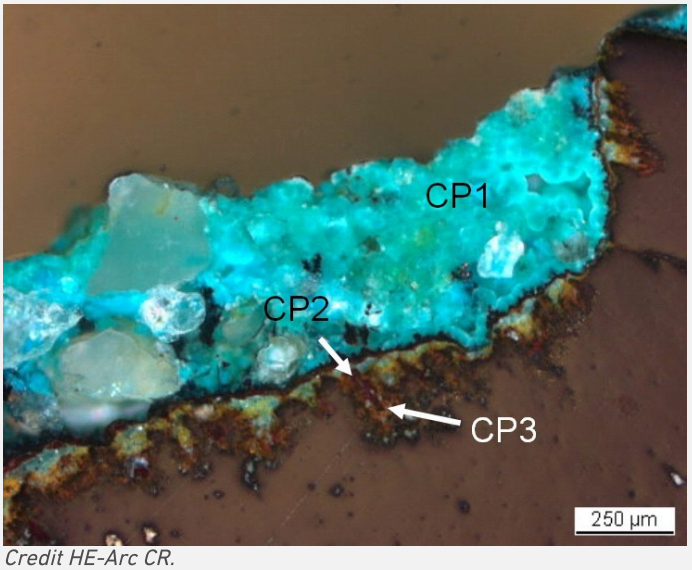
The corrosion crust has a thickness between 0.1mm and 0.7mm (Fig. 3). In bright field (Fig. 7), one can observe that the metal has been replaced by light-grey corrosion products. Adjacent to the metal is a thick, heterogeneous, dark-grey layer with a band of light-grey corrosion products. In polarised light (Fig. 8), all corrosion products which were previously light-grey appear brown-orange, the dark-grey layer turquoise. The elemental chemical distribution of the SEM images (Figs. 9 and 10) reveals that the inner corrosion products are Sn-rich whereas the adjacent band is Cu and S-rich (Fig. 11). The outer layer contains large inclusions (quartz and others, Si, Al and Na, see Figs. 10-11) and is most probably composed of malachite/Cu2(CO3)(OH)2 (only Cu and O are detected – Fig. 11). S is distributed throughout this layer. XRD analyses indicated the presence of posnjakite/Cu4SO4(OH)6H2O, chalcocite/CuS and djurleïte/Cu1.93S (Schweizer 1994).

Fig. 7: Micrograph of the metal sample from Fig. 3 (detail), unetched, bright field. The inner light-grey corrosion products extend into the metal surface (in pink) and appear as a line within the dark-grey corrosion layer,

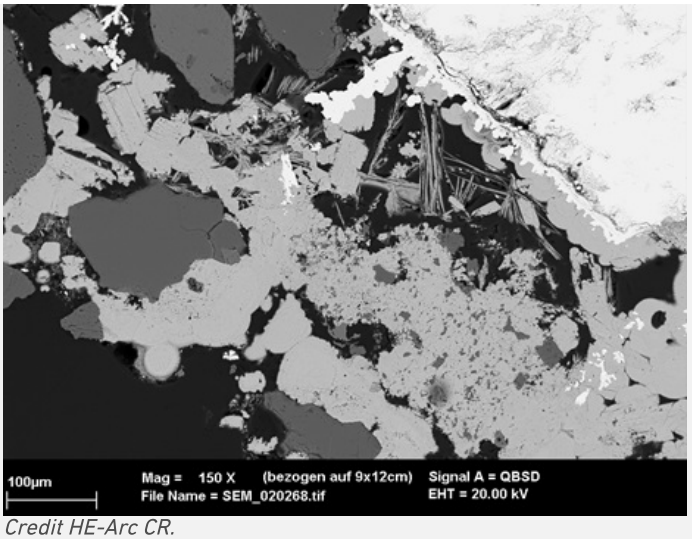
Fig. 9: SEM image (detail of Fig. 7), SE-mode. From bottom to top right: the thick, porous outer corrosion layer, the light-grey band and the remaining metal,

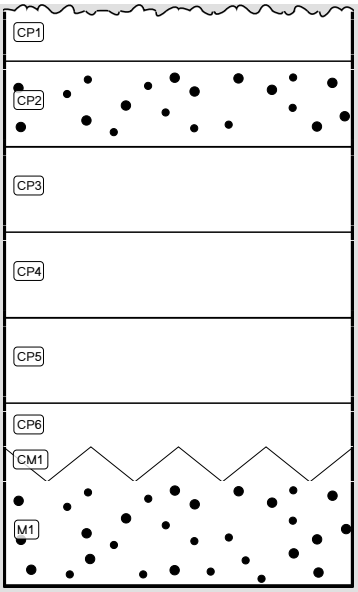
Fig. 4: Stratigraphic representation of the object in cross-section using the MiCorr application. The characteristics of the strata are only accessible by clicking on the drawing that redirects you to the search tool by stratigraphy representation. This representation can be compared to Fig. 8, Credit HE-Arc CR.
