CURVED PIN OR TANG FK 2670.20 – TIN BRONZE – LATE BRONZE AGE – SWITZERLAND

Artefact name Curved pin or tang FK 2670.20

Authors Marianne. Senn (EMPA, Dübendorf, Zurich, Switzerland) & Christian. Degrigny (HE-Arc CR, Neuchâtel, Neuchâtel, Switzerland)

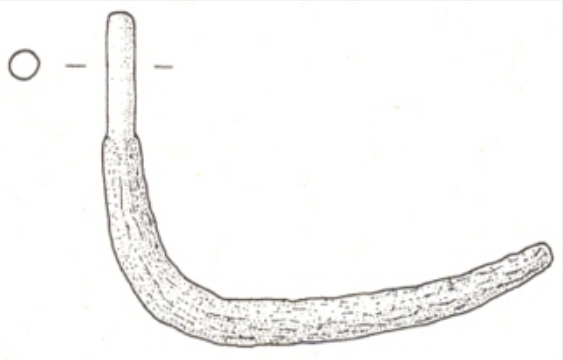
Fig. 1: Tin bronze curved pin or tang (after Fischer 1997, plate 43),

Description of the artefact Curved pin or tang (Fig. 1). Several samples were taken. Only one is presented here (Fig. 2). The metal is covered with black corrosion products attributed to a burning process mixed with green corrosion products. Dimensions: L = 114mm; Ø = 4.6mm; WT = 16.7g.

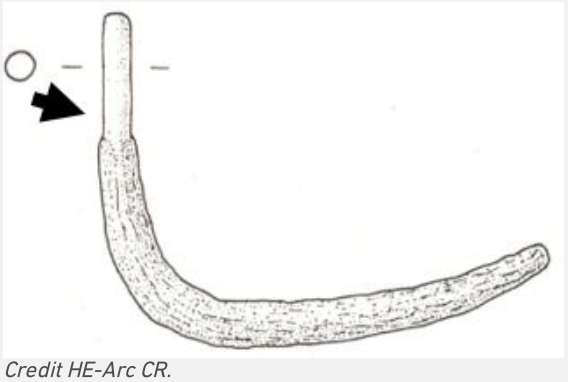
Fig. 2: Location of sampling area,

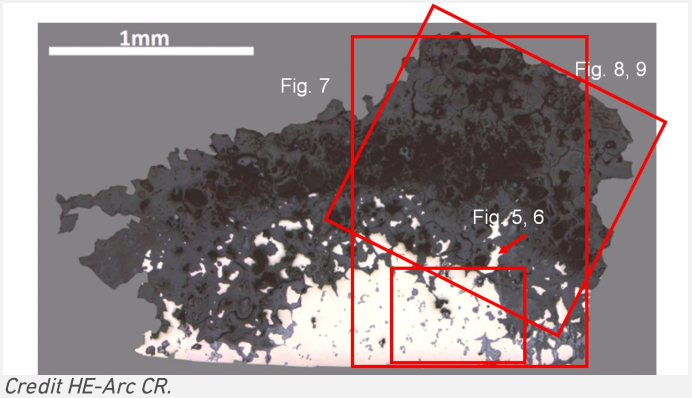
Fig. 3: Micrograph of the cross-section showing the location of Figs. 5 to 9,

The sample (Fig. 3) is a section from the pin (or tang). The metal is covered by a thick corrosion crust (blue layer adhering to the metal, topped by a green layer mixed with black corrosion products - Museum report (1992)). Dimensions: L = 1.8mm; W = 1.2mm.

The corrosion crust has an average thickness of 500µm but can in areas be much thicker (Fig. 3). It is divided in two layers. The inner layer is itself divided in two sub-layers: a thin light-grey sub-layer at the interface with the remaining metal surface (CP4, in bright field) which appears red-orange in polarised light (Fig. 7) topped by a medium-grey sub-layer (in bright field) that contains remnant metal (CP3). It turns dark-blue in polarised light (Fig. 7). The outer corrosion layer can also be divided into two sub-layers: a porous sub-layer (CP2) followed by a dark-grey sub-layer in which crystals are outlined by cracks (CP1, in bright field). Under polarized light, the latter turns blue-green while on top it appears olive and brown (Fig. 7). Chemically the corrosion crust is Sn enriched and Cu-depleted (Table 3, Figs. 8 and 9). The maximum of the Sn enrichment occurs on the outer olive and brown sub-layer (CP2). The corrosion layer also contains P, Si, C and O. Inclusions containing Fe or Ag can be found in the corrosion crust (Figs. 8 and 9).

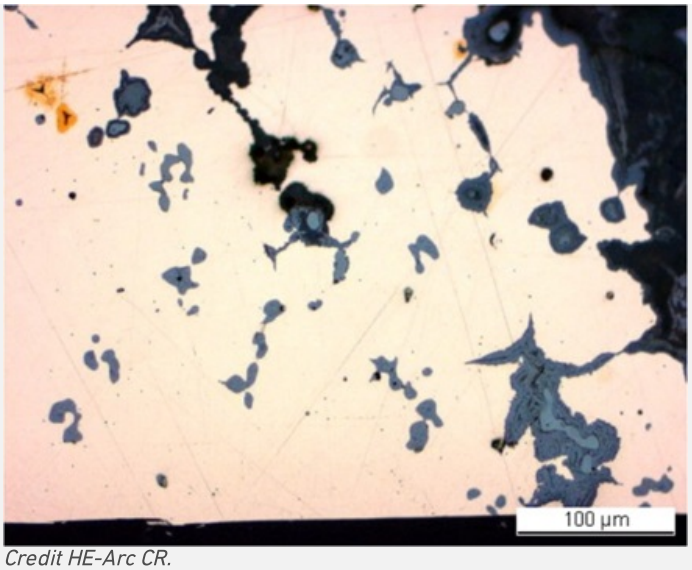
The remaining metal is a tin bronze (Table 1) with copper sulphide inclusions that contain some Fe (Figs. 5 and 6, Table 2). After etching, the tin bronze shows polygonal grains with few twins (Fig. 6). The grain size varies between 70 and 180µm indicating grain growth due to an extended or excessively hot annealing process. The copper sulphide inclusions appear in blue. The average hardness of the metal is HV1 70.

Fig. 5: Micrograph of the metal sample from Fig. 3 (detail), unetched, bright field. In pink the metal, in light-blue the copper sulphide inclusions and in dark- blue corrosion products,

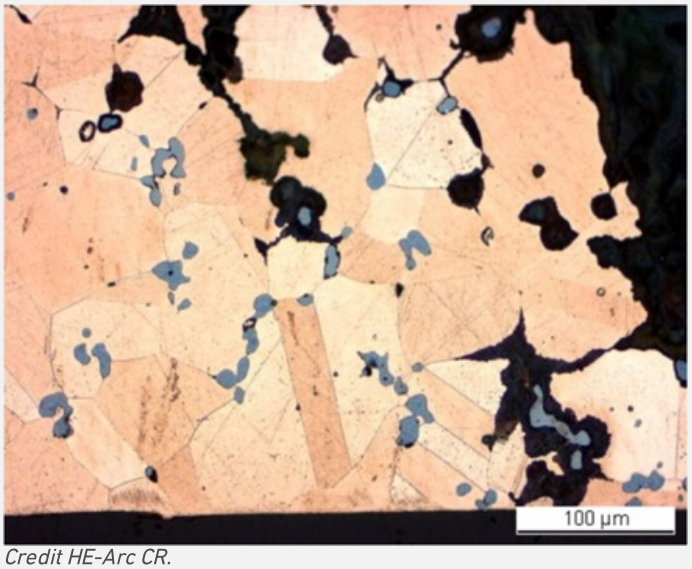
Fig. 6: Micrograph of the metal sample from Fig. 3 (same as Fig. 5), etched, bright field. In pink the metal with few twins, in black the resin and the corrosion products, in light-blue the copper sulphide inclusions,

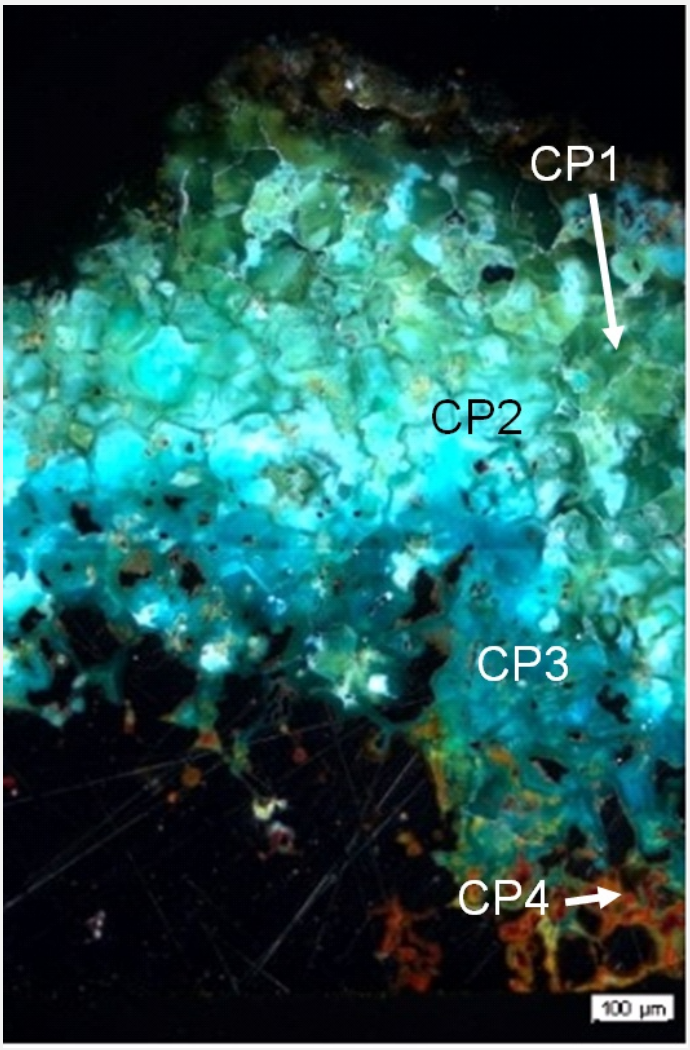
Table 3: Chemical composition (mass %) of the corrosion crust from Fig. 7. Method of analysis: SEM/EDS, Laboratory of Analytical Chemistry, Empa.

Fig. 7: Micrograph of the metal sample from Fig. 3 (detail) and corresponding to the stratigraphy of Fig. 4, unetched, polarised light. At the metal - corrosion products interface the colour of the corrosion layer is dark-blue, changing to green-blue in the outer part. The top surface of the corrosion crust is olive to brown,

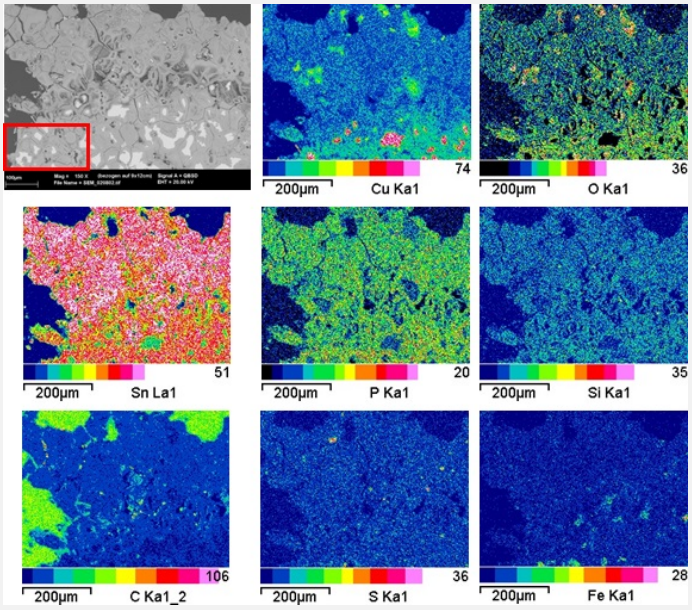
Fig. 8: SEM image, BSE-mode, and elemental chemical distribution of the selected area from Fig. 3 (due to repolishing before SEM/EDX investigation, the SEM image is slightly different from the area indicated in Fig. 3). The rectangle in the SEM image marks the detail mapping of Fig 9. Method of examination: SEM/EDS, Laboratory of Analytical Chemistry, Empa,

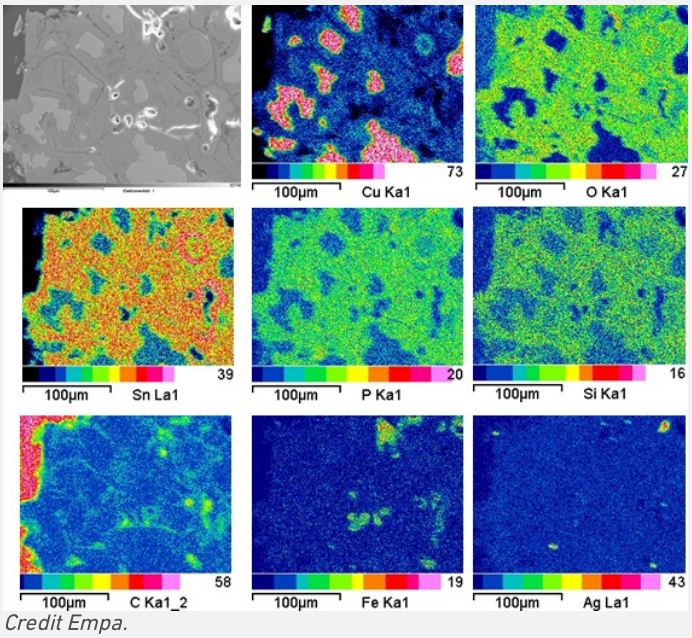
Fig. 9: SEM image, SE-mode, and elemental chemical distribution of the selected area from Fig. 8. Method of examination: SEM/EDS, Laboratory of Analytical Chemistry, Empa,
