CURVED PIN OR TANG FK 2670.20 – TIN BRONZE – LATE BRONZE AGE – SWITZERLAND

Artefact name Curved pin or tang FK 2670.20

Authors Marianne. Senn (EMPA, Dübendorf, Zurich, Switzerland) & Christian. Degrigny (HE-Arc CR, Neuchâtel, Neuchâtel, Switzerland)

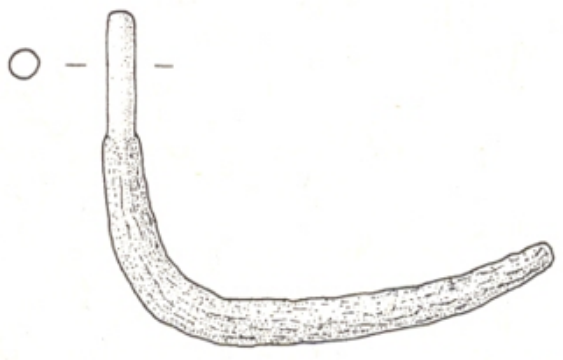
Fig. 1: Tin bronze curved pin or tang (after Fischer 1997, plate 43),

Description of the artefact	Curved pin or tang (Fig. 1). Several samples were taken. Only one is presented here (Fig. 2). The metal is covered with black corrosion products attributed to a burning process mixed with green corrosion products. Dimensions: L = 114mm; Ø = 4.6mm; WT = 16.7g.
Type of artefact	Not defined
Origin	Steinmöri, Neftenbach / Dorf Neftenbach, Zurich, Switzerland
Recovering date	Excavation in 1991?, grave 18
Chronology category	Late Bronze Age
chronology tpq	1400 B.C.
chronology taq	1300 B.C.
Chronology comment	14th Century BC, Bronze Age D
Burial conditions / environment	Soil
Artefact location	Kantonsarchäologie, Dübendorf, Zurich
Owner	Kantonsarchäologie, Dübendorf, Zurich

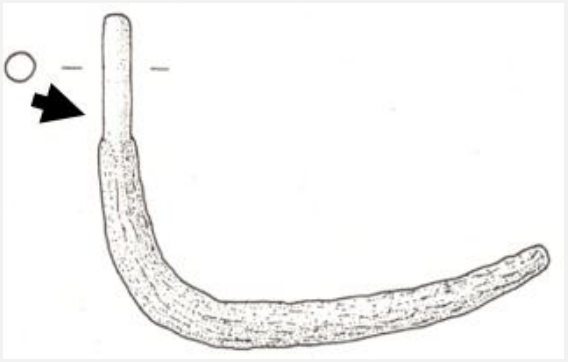
Fig. 2: Location of sampling area,

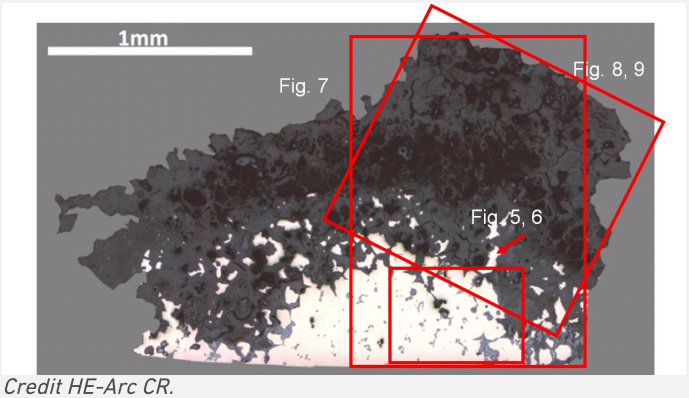
Fig. 3: Micrograph of the cross-section showing the location of Figs. 5 to 9,

The sample (Fig. 3) is a section from the pin (or tang). The metal is covered by a thick corrosion crust (blue layer adhering to the metal, topped by a green layer mixed with black corrosion products - Museum report (1992)). Dimensions: L = 1.8mm; W = 1.2mm.

The corrosion crust has an average thickness of 500µm but can in areas be much thicker (Fig. 3). It is divided in two layers. The inner layer is itself divided in two sub-layers: a thin light-grey sub-layer at the interface with the remaining metal surface (CP4, in bright field) which appears red-orange in polarised light (Fig. 7) topped by a medium-grey sub-layer (in bright field) that contains remnant metal (CP3). It turns dark-blue in polarised light (Fig. 7). The outer corrosion layer can also be divided into two sub-layers: a porous sub-layer (CP2) followed by a dark-grey sub-layer in which crystals are outlined by cracks (CP1, in bright field). Under polarized light, the latter turns blue-green while on top it appears olive and brown (Fig. 7). Chemically the corrosion crust is Sn enriched and Cu-depleted (Table 3, Figs. 8 and 9). The maximum of the Sn enrichment occurs on the outer olive and brown sub-layer (CP2). The corrosion layer also contains P, Si, C and O. Inclusions containing Fe or Ag can be found in the corrosion crust (Figs. 8 and 9).

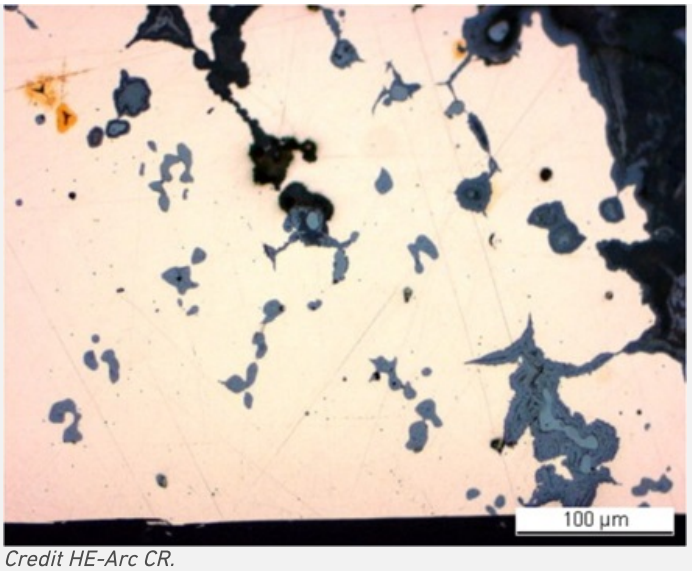
The remaining metal is a tin bronze (Table 1) with copper sulphide inclusions that contain some Fe (Figs. 5 and 6, Table 2). After etching, the tin bronze shows polygonal grains with few twins (Fig. 6). The grain size varies between 70 and 180µm indicating grain growth due to an extended or excessively hot annealing process. The copper sulphide inclusions appear in blue. The average hardness of the metal is HV1 70.

Fig. 5: Micrograph of the metal sample from Fig. 3 (detail), unetched, bright field. In pink the metal, in light-blue the copper sulphide inclusions and in dark- blue corrosion products,

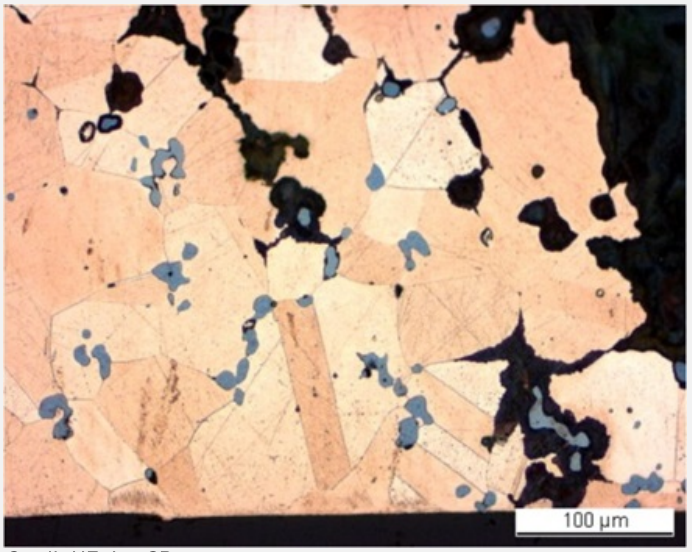
Fig. 6: Micrograph of the metal sample from Fig. 3 (same as Fig. 5), etched, bright field. In pink the metal with few twins, in black the resin and the corrosion products, in light-blue the copper sulphide inclusions,

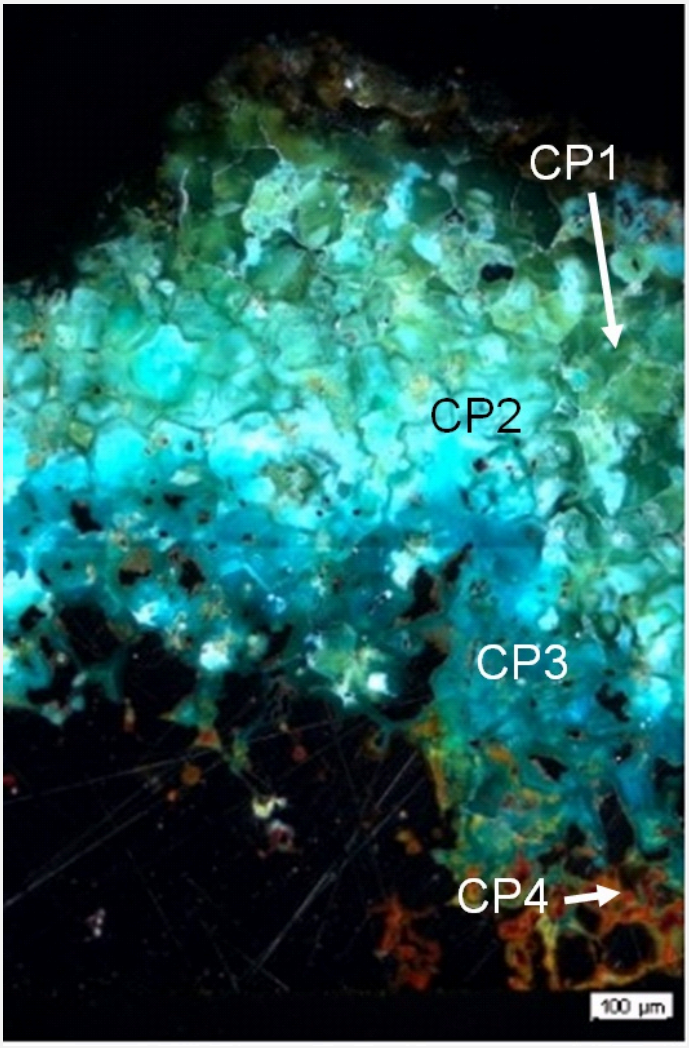
Table 3: Chemical composition (mass %) of the corrosion crust from Fig. 7. Method of analysis: SEM/EDS, Laboratory of Analytical Chemistry, Empa.

Fig. 7: Micrograph of the metal sample from Fig. 3 (detail) and corresponding to the stratigraphy of Fig. 4, unetched, polarised light. At the metal - corrosion products interface the colour of the corrosion layer is dark-blue, changing to green-blue in the outer part. The top surface of the corrosion crust is olive to brown,

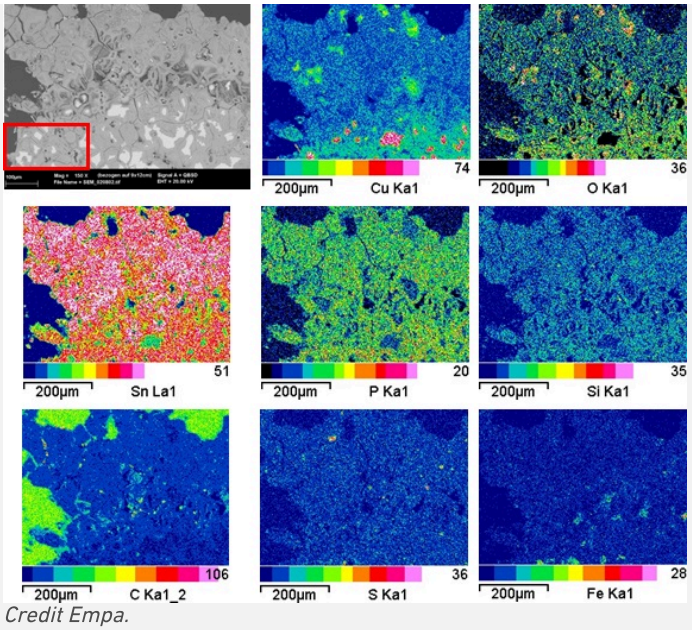
Fig. 8: SEM image, BSE-mode, and elemental chemical distribution of the selected area from Fig. 3 (due to repolishing before SEM/EDX investigation, the SEM image is slightly different from the area indicated in Fig. 3). The rectangle in the SEM image marks the detail mapping of Fig 9. Method of examination: SEM/EDS, Laboratory of Analytical Chemistry, Empa,

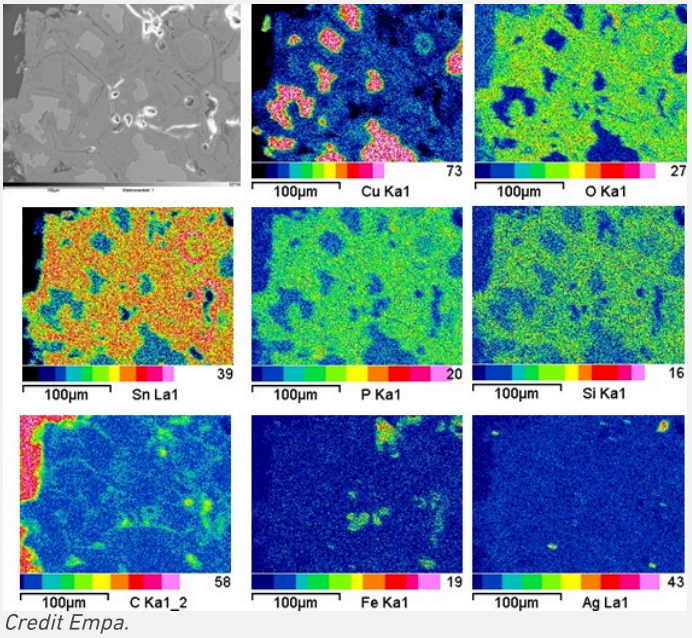
Fig. 9: SEM image, SE-mode, and elemental chemical distribution of the selected area from Fig. 8. Method of examination: SEM/EDS, Laboratory of Analytical Chemistry, Empa,

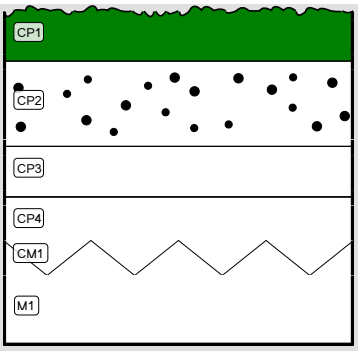
Fig. 4: Stratigraphic representation of the object in cross-section using the MiCorr application. The characteristics of the strata are only accessible by clicking on the drawing that redirects you to the search tool by stratigraphy representation. This representation can be compared to Fig. 7, Credit HE-Arc CR.
