DEFORMED FRAGMENT OF METAL SHEET WT10-M305 – TIN BRONZE – IRON AGE – SWITZERLAND

Artefact name	Deformed fragment of metal sheet WT10-M305
Authors	Marianne. Senn (EMPA, Dübendorf, Zurich, Switzerland) & Christian. Degrigny (HE-Arc CR, Neuchâtel, Neuchâtel, Switzerland)
Url	/artefacts/444/

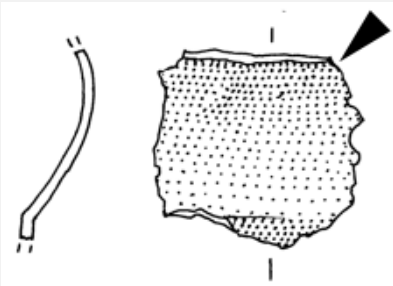
Fig. 1: Tin bronze sheet fragment (section and front side) (after Department of Prehistory, University of Zurich),

|	
Description of the artefact	Sheet fragment with a dark green and grey powdery surface (patina) that might have been caused by exposure to high temperatures (Fig. 1). A green layer appears below the dark surface. Dimensions: L = 2.4cm; W = 2.3cm; WT = 4.8g.
Type of artefact	Metal sheet
Origin	Ritual place Wartau Ochsenberg, Sankt Gallen, Saint Gallen, Switzerland
Recovering date	Excavation in 1991
Chronology category	Iron Age
chronology tpq	500 B.C. ⌄
chronology taq	401 B.C. ⌄
Chronology comment	5th Century BC
Burial conditions / environment	Soil
Artefact location	Kantonsarchäologie, Sankt Gallen, Saint Gallen
Owner	Kantonsarchäologie, Sankt Gallen, Saint Gallen
Inv. number	WT10-M305
Recorded conservation data	Not conserved

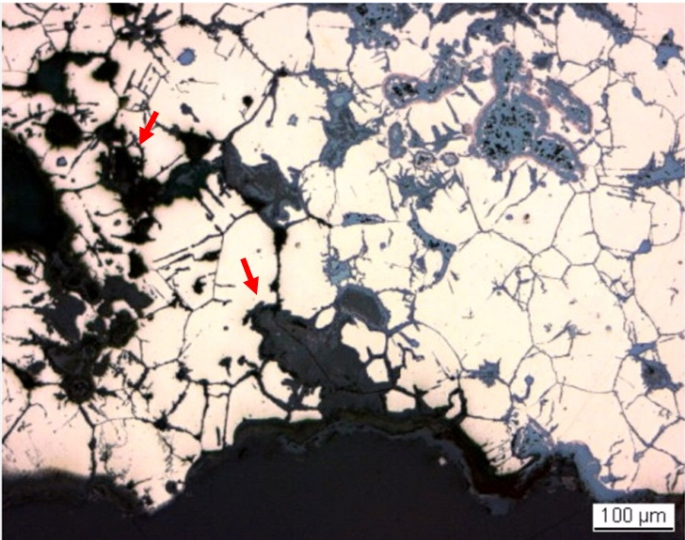
Fig. 3: Micrograph of the cross-section showing the location of Figs. 5, 6, 8 and 9,

Description of sample	The sample is a section from the top right corner of the sheet (Fig. 2). Its dimensions are: L = 2.5mm and W = 2.3mm. The metal is surrounded on three sides by corrosion products. Intergranular corrosion has developed throughout the metal section (Fig. 3).
Alloy	Tin Bronze
Technology	Secondary recrystallization (produced by burning) after cold working
Lab number of sample	MAH 92-5-2-003
Sample location	Musées d'art et d'histoire, Genève, Geneva

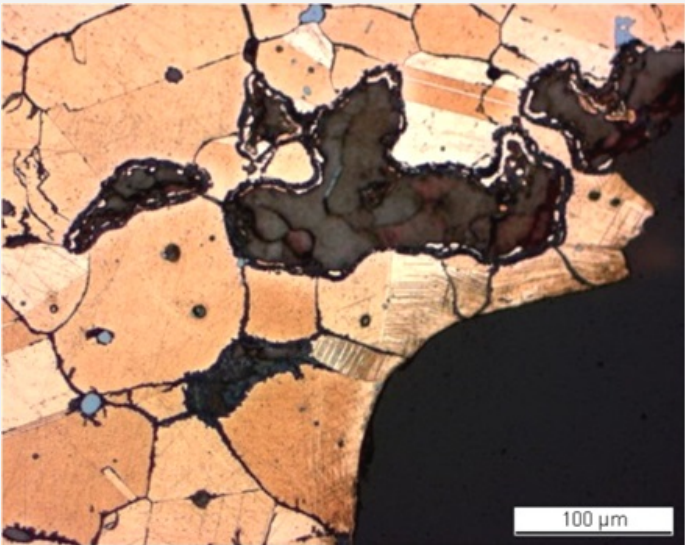
The remaining metal is a porous (red arrows on Fig. 5) tin bronze (Table 1). Five analyses were carried out. S was detected in the non-corroded part of the metal (2 measurements) while P was present only in the corroded metal (3 measurements). As no major difference in the composition was observed (comparison of relative standard deviation, RSD) all analyses were used to calculate the median value. Inter- and transgranular corrosion has developed so extensively that all grain boundaries and twin lines are outlined (Fig. 5). After etching, the metal shows annealed polygonal grains with a few twins and slip lines below the surface (Fig. 6). The slip lines are restricted to the right side of the sample where the metal is best preserved (Fig. 6). The grain size varies between 50 and 170μm, due to an excessively long or hot annealing procedure leading to a grain coarsening. Small copper sulphide inclusions appear in blue (Fig. 6). The average hardness of the metal is HV1 90.

Fig. 5: Micrograph of the metal sample from Fig. 3 (detail), unetched, bright field. Extensive inter- and transgranular corrosion has developed within the metal. Possible large pores are visible (arrows) inside the remaining metal,

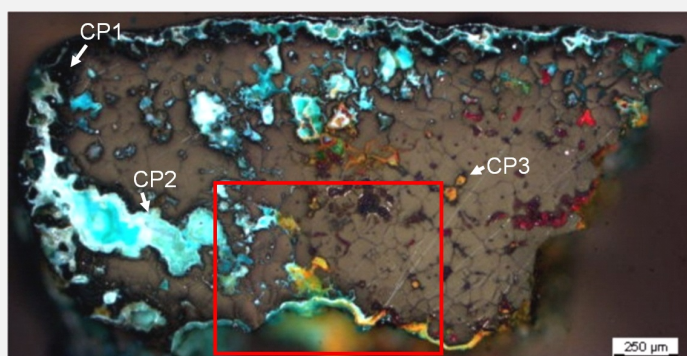
Fig. 6: Micrograph of the metal sample from Fig. 3 (detail), etched, bright field. We observe pink-orange polygonal grains with twins and slip lines as well as copper sulphide inclusions (in blue),

|	
Microstructure	Large polygonal grains with few twins + strain lines
First metal element	Cu
Other metal elements	As, Sn

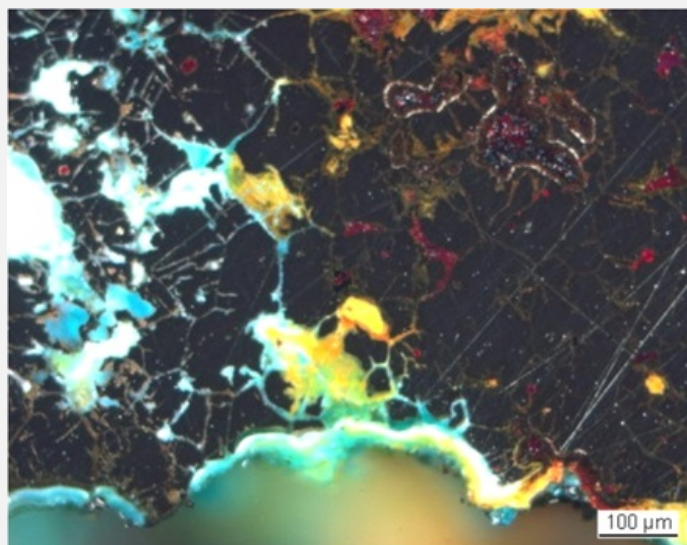
The corrosion crust varies in thickness between 60 and 150µm (Fig. 3). In bright field, it appears dark-grey (Fig. 5) and consists of two layers (CP1 and CP2). The inner layer is dark-grey and dense while the thin outer layer is slightly lighter coloured. Within the metal, the corrosion products are light-grey (CP3, Fig. 5). Under polarized light, the corrosion layer turns blue-green with dark-blue areas (Figs. 7 and 8) whereas corrosion products inside the metal are either light-blue or red-orange (Figs. 7 and 8). The red corrosion products (CP3) have the composition of cuprite/Cu_2O while the orange compounds (also CP3) are enriched in Sn (Table 2). The blue-green corrosion products (CP2) both within the remaining metal and on the surface are even richer in Sn and O, and contain some P (Table 2 and Fig. 9). The thin, irregular dark-grey surface layer (CP1) is enriched in P, Fe, Si and Al (Table 2 and Fig. 9). XRD analyses of powdery particles sampled from the thin, dark surface corrosion layer (CP1) indicate the presence of tenorite/CuO and cassiterite/SnO_2 (Museum report 1992). The Raman spectra of this layer (Fig. 10) confirmed the presence of tenorite.

Elements	O	Cu	Sn	Si	Fe	P	As	Total
CP1, outer dark-grey corrosion layer. Fig 7	34	16	49	<	3.4	3.0	0.86	108
CP2, blue-green middle corrosion layer. Fig. 7	40	21	41	1.4	<	1.7	0.58	106
CP3, Red corrosion product (average of 2 similar analyses). Fig. 7	11	95	<	<	<	<	<	106
CP3, Orange corrosion product (average of 2 similar analyses). Fig. 7	24	54	30	0.6	<	<	0.59	109
Blue-green corrosion product. Fig. 8	32	21	51	1.1	<	<	1.0	106
Blue-green inner corrosion layer. Fig. 8	34	22	39	0.8	<	1.4	<	98

Table 2: Chemical composition (mass %) of the different corrosion products and layers from Figs. 7 and 8. Method of analysis: SEM/EDS, Laboratory of Analytical Chemistry, Empa.
