SHINGLE OF A ROOF – CU ALLOY – MODERN TIMES – SWITZERLAND

Artefact name	Shingle of a roof
Authors	Marianne. Senn (EMPA, Dübendorf, Zurich, Switzerland) & Christian. Degrigny (HE-Arc CR, Neuchâtel, Neuchâtel, Switzerland)
Url	/artefacts/446/

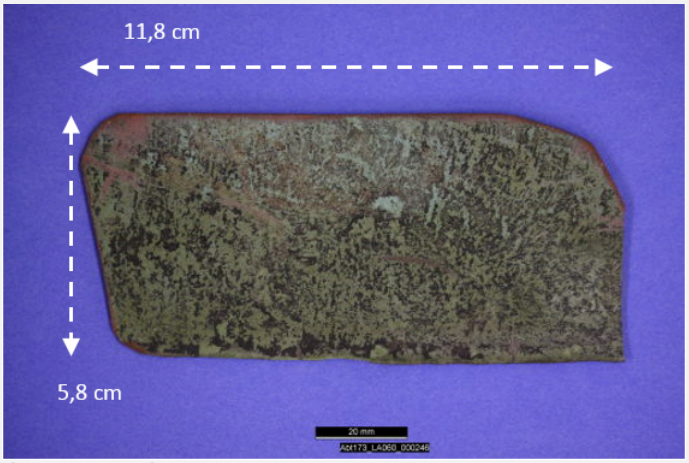
Fig. 1: Copper alloy shingle, internal side,

Description of the artefact	Shingle, slightly curved, the internal side is covered with heterogeneously distributed green and black corrosion products (Fig. 1). The external side shows a regular dark green corrosion crust. Dimensions: L = 11.8cm; W = 5.8cm.
Type of artefact	Architectural element
Origin	Roof of the Abbey of St Gallen, Sankt Gallen, Saint Gallen, Switzerland
Recovering date	None
Chronology category	Modern Times
chronology tpq	1780 A.D.
chronology taq	----
Chronology comment	1780
Burial conditions / environment	Outdoor atmosphere
Artefact location	Conservation Department of the Musées d'art et d'histoire, Genève, Geneva

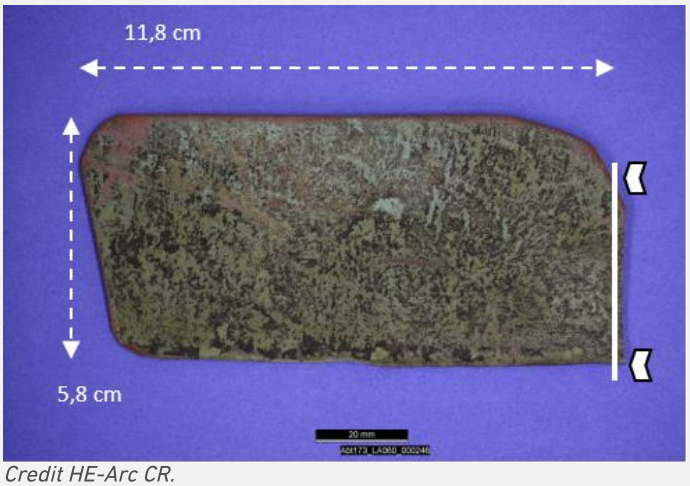
Fig. 2: showing the location of sampling area,

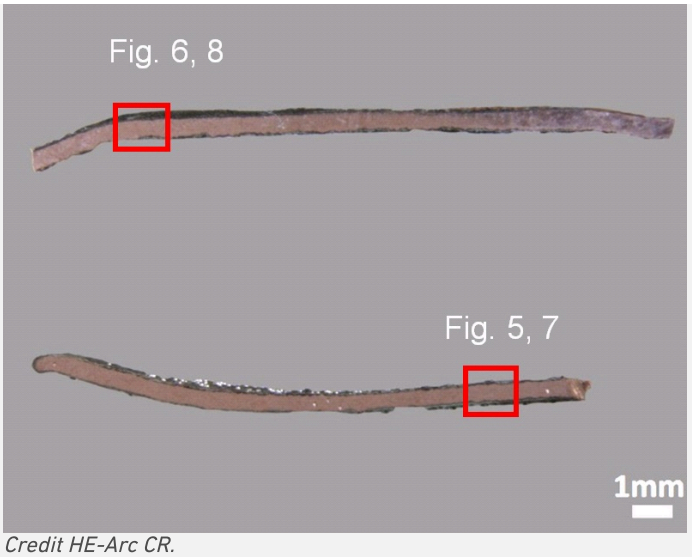
Fig. 3: Micrograph of the cross-sections showing the location of Figs. 5 to 8,

Description of sample	Two samples were taken (Fig. 2). The polished samples show a well-preserved metal surface with a thin corrosion crust (Fig. 3). T = 0.5mm.
Alloy	Cu Alloy
Technology	Rolled (probably hot rolling) and annealed
Lab number of sample	MAH-98-257
Sample location	Empa (Marianne Senn)
Responsible institution	Conservation Department of the Musées d'art et d'histoire, Genève, Geneva
Date and aim of sampling	2009, integration of sample to the MIFAC-Métal project

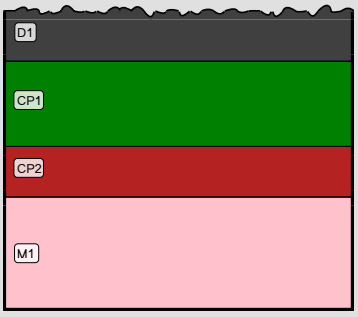
Fig. 4: Stratigraphic representation of the object in cross-section using the MiCorr application. The characteristics of the strata are only accessible by clicking on the drawing that redirects you to the search tool by stratigraphy representation. This representation can be compared to Fig. 7, Credit HE-Arc CR.
