CORRODED METAL SHEET FN 655.13.01 – FE ALLOY – MODERN TIMES – SWITZERLAND

Authors Marianne. Senn (EMPA, Dübendorf, Zurich, Switzerland) & Christian. Degrigny (HE-Arc CR, Neuchâtel, Neuchâtel, Switzerland)

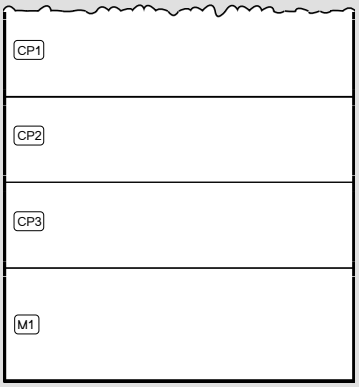
Fig. 4: Stratigraphic representation of the object in cross-section using the MiCorr application. The characteristics of the strata are only accessible by clicking on the drawing that redirects you to the search tool by stratigraphy representation. This representation can be compared to Figs. 7 and 8, Credit HE-Arc CR.
