SWORD M-SCH-B2735 - P-RICH IRON - IRON AGE - SWITZERLAND

Artefact name	Sword M-Sch-B2735
Authors	Marianne. Senn (EMPA, Dübendorf, Zurich, Switzerland) & Christian. Degrigny (HE-Arc CR, Neuchâtel, Neuchâtel, Switzerland)
Url	/artefacts/449/

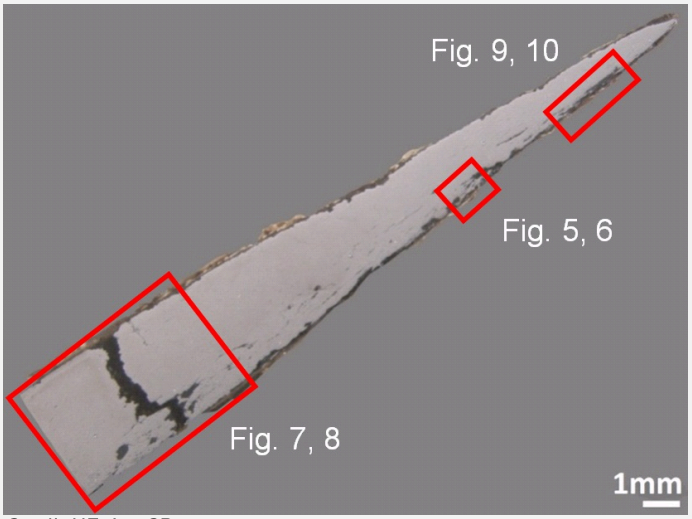
Fig. 3: Micrograph of the cross-section showing the location of Figs. 5 to 10,

Description of sample	The sample includes half of the sword blade (Figs. 2 and 3). The corrosion layer is thin (Fig. 3).
Alloy	P-rich iron
Technology	Forged, annealed and cold worked
Lab number of sample	M-SCH-B2735
Sample location	Empa (Marianne Senn)
Responsible institution	Schweizerisches Landesmuseum, Zürich, Zurich
Date and aim of sampling	1969, metallography

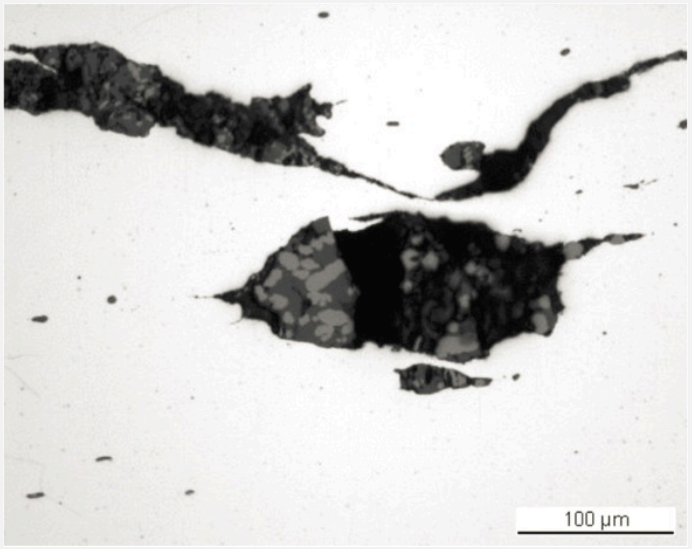
The remaining metal is a P-rich (0.2 mass%) iron (Table 1) with long parallel slag inclusions (Fig. 5) concentrated on one side of the blade. The slag inclusions are composed of wüstite/FeO dendrites and fayalite/Fe_2SiO_4 in a glassy matrix (Fig. 6 and Table 2). Their chemical composition is typical for iron produced by the bloomery process (dominated by iron oxides and silica). It is difficult to identify the ore type from the slag composition. Interestingly in one case the slag composition is very specific (alumina and P-rich material). After etching, the metal shows a ferritic structure (Fig. 7). The grain size is variable (between ASTM grain sizes of 4 to 7) and some grains include Neumann bands (Fig. 8). A large crack has developed through the metal section (Figs. 3 and 7). The average hardness of the metal (HV1 185) is quite high for a wrought iron. The level of hardness and Neumann bands are typical for a P-rich iron. Neumann bands are said to develop by cold working and shock deformation. According to Swiss and McDonnell 2003 they form when little cold work is carried out. Distortion (grain deformation) after cold working starts to be apparent in iron after a reduction in thickness of between 30-40%. Since no grain deformation is visible, the present reduction is probably a little less than this range.

Fig. 5: Micrograph of the metal sample from Fig. 3 (detail, rotated by 225°), unetched, bright field. In white the metal containing elongated slag inclusions (in grey); in black porosity,

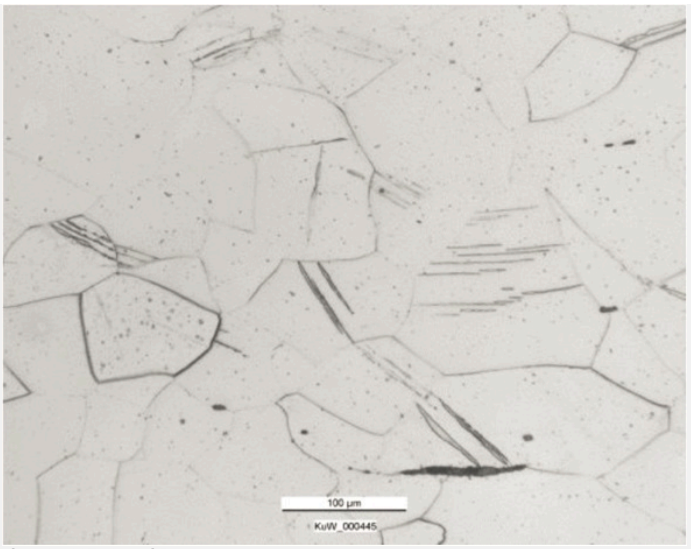
Fig. 8: Micrograph (detail of Fig. 7), etched, bright field. Ferrite grains including Neumann bands formed after cold working in a P-rich iron,

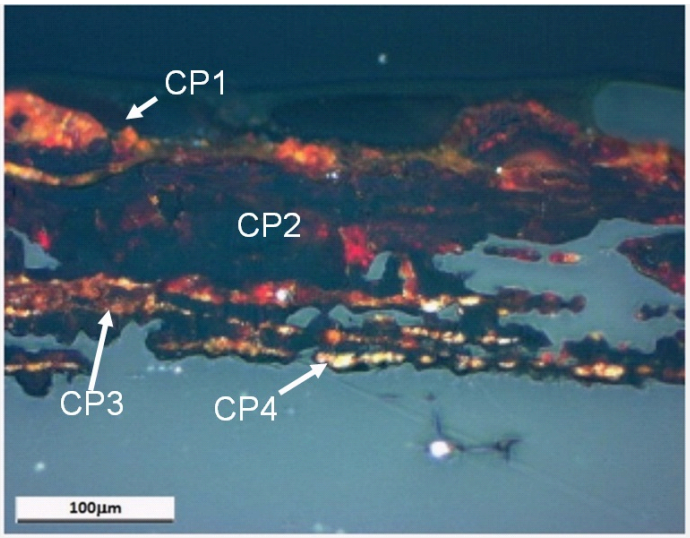
The remaining metal, including the large crack, is covered by a thin, fissured corrosion crust (Figs. 3, 5, 7 and 9). The corrosion crust is thicker on the side containing the long slag inclusions (Fig. 3). In bright field and in the BSE-mode of the SEM image only light and dark-grey areas can be distinguished (Figs. 5 and 10). Under polarised light the corrosion products appear yellow-orange near the metal surface and then become successively dark-red and black. The outer layer (CP1) is orange-yellow, as is the inner one (CP4, Fig. 9). There is a correlation between the level of grey in SEM/BSE-mode, the colours under polarised light, and the chemical composition of the corrosion layer (Table 3, Figs. 9 and 10). The lighter the grey of the SEM/BSE-mode, or the colours (light-brown and red) under polarised light, the richer the area is in Fe and the more depleted it is in O. Surprisingly the inner corrosion layers (CP3 and CP4) are contaminated with Si, Al and O.

Fig. 9: Micrograph showing the metal - corrosion crust interface from Fig. 3 (inverted picture, rotated by 135°, detail) and corresponding to the stratigraphy of Fig. 4, unetched, polarised light. The metal appears in blue and the corrosion changes from yellow-orange (CP4) to dark-red (CP3), black (CP2) and orange (CP1),

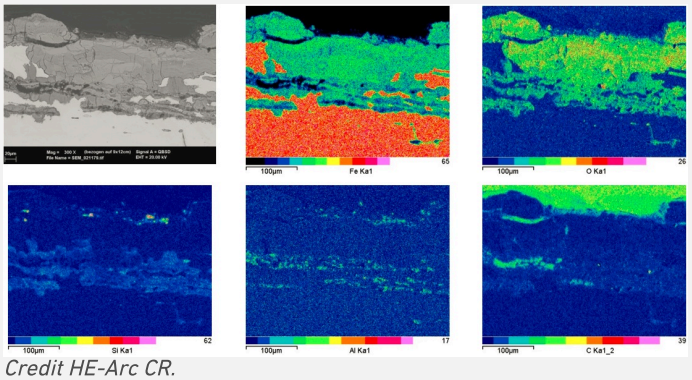
Fig. 10: SEM image, BSE-mode, and elemental chemical distribution of the selected area from Fig. 9. Method of examination: SEM/EDS, Laboratory of Analytical Chemistry, Empa.,

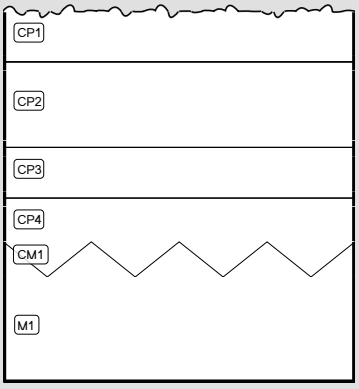
Fig. 4: Stratigraphic representation of the object in cross-section using the MiCorr application. The characteristics of the strata are only accessible by clicking on the drawing that redirects you to the search tool by stratigraphy representation. This representation can be compared to Fig. 9, Credit HE-Arc CR.
