SWORD M-SCH-B2735 - P-RICH IRON - IRON AGE - SWITZERLAND

Artefact name	Sword M-Sch-B2735
Authors	Marianne. Senn (EMPA, Dübendorf, Zurich, Switzerland) & Christian. Degrigny (HE-Arc CR, Neuchâtel, Neuchâtel, Switzerland)
Url	/artefacts/449/

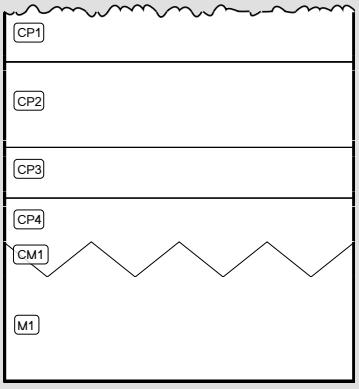
The remaining metal, including the large crack, is covered by a thin, fissured corrosion crust (Figs. 3, 5, 7 and 9). The corrosion crust is thicker on the side containing the long slag inclusions (Fig. 3). In bright field and in the BSE-mode of the SEM image only light and dark-grey areas can be distinguished (Figs. 5 and 10). Under polarised light the corrosion products appear yellow-orange near the metal surface and then become successively dark-red and black. The outer layer (CP1) is orange-yellow, as is the inner one (CP4, Fig. 9). There is a correlation between the level of grey in SEM/BSE-mode, the colours under polarised light, and the chemical composition of the corrosion layer (Table 3, Figs. 9 and 10). The lighter the grey of the SEM/BSE-mode, or the colours (light-brown and red) under polarised light, the richer the area is in Fe and the more depleted it is in O. Surprisingly the inner corrosion layers (CP3 and CP4) are contaminated with Si, Al and O.

Fig. 4: Stratigraphic representation of the object in cross-section using the MiCorr application. The characteristics of the strata are only accessible by clicking on the drawing that redirects you to the search tool by stratigraphy representation. This representation can be compared to Fig. 9, Credit HE-Arc CR.
