PIN OR NEEDLE FRAGMENT HR-3031 - TIN BRONZE - LATE BRONZE AGE - SWITZERLAND

Artefact name	Pin or needle fragment HR-3031
Authors	Marianne. Senn (EMPA, Dübendorf, Zurich, Switzerland) & Christian. Degrigny (HE-Arc CR, Neuchâtel, Neuchâtel, Switzerland)
Url	/artefacts/450/

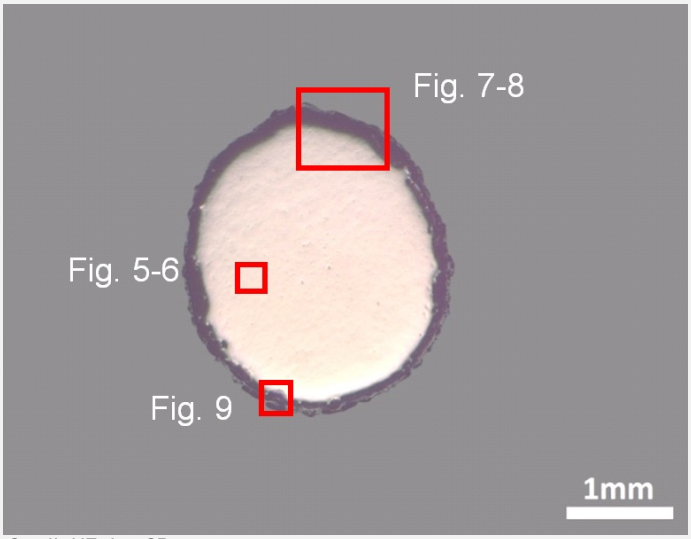
Fig. 3: Micrograph of the cross-section showing the location of Figs. 5 to 9,

Description of sample	The cross-section is circular and is a complete section through the pin (Fig. 2). The surface is completely covered with a rather thin corrosion crust of irregular thickness (Fig. 3).
Alloy	Tin Bronze
Technology	Cold worked after annealing
Lab number of sample	MAH 87-195
Sample location	Musées d'art et d'histoire, Genève, Geneva
Responsible institution	Musées d'art et d'histoire, Genève, Geneva
Date and aim of sampling	1987, metallography and corrosion characterisation

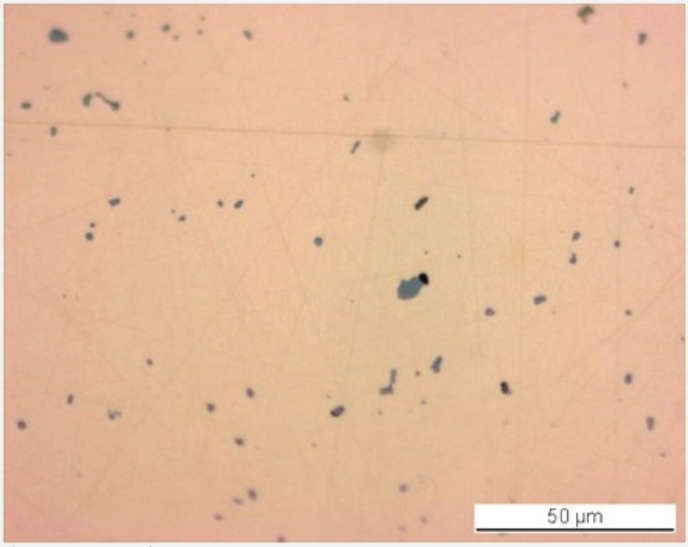
The remaining metal is a tin bronze and contains small copper sulphide and Pb-rich inclusions evenly distributed throughout the metal (Fig. 5, Tables 1 and 2). The Pb-rich inclusions are only visible with SEM appearing as white particles. The etched structure of the tin bronze shows re-crystallised and angular grains, some of them with twins (Fig. 6). Strain or slip lines are visible, especially near the metal surface. They indicate a final cold working. Copper sulphide inclusions are found both at the grain boundaries and inside the grains (Fig. 6). The average hardness of the metal is about HV1 120.

Fig. 5: Micrograph of the metal sample from Fig. 3 (detail), unetched, bright field. Grey copper sulphide inclusions are clearly visible,

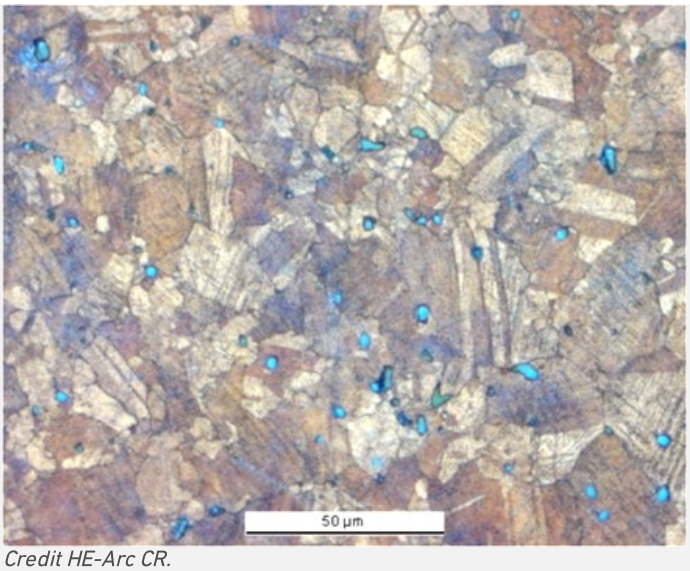
Fig. 6: Micrograph of the metal sample from Fig. 3 (detail), etched, bright field. Small angular re-crystallised grains (some with twins)

with slip lines are observed. Copper sulphide inclusions appear in blue,

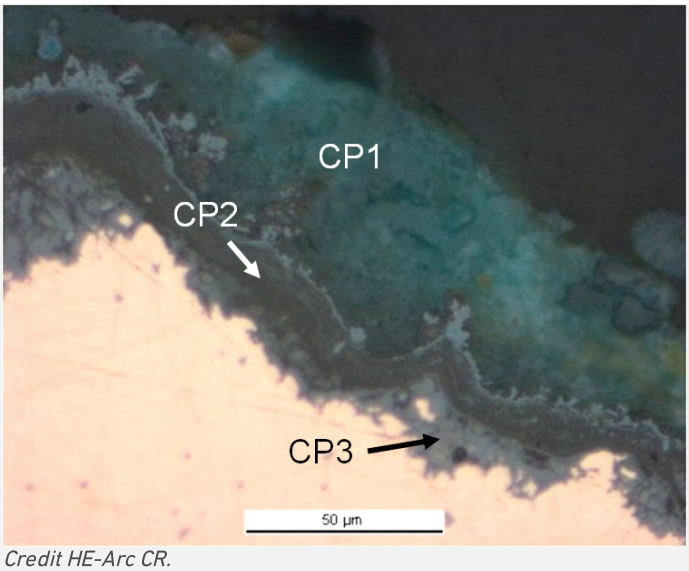
The corrosion crust has an average thickness of about 50µm (Fig. 7). In polarised light (Fig. 8), the corrosion stratigraphy is more clearly visible: it is composed of an inner orange-red corrosion layer (CP3, an agglomerate of nanoscale stannic oxides with cuprite) directly on the metal core (Table 3 and Fig. 9, already studied by Piccardo et al. 2007), an intermediate multi-layered black band (CP2) and an outer turquoise-green layer (CP1) analysed with XRD by Schweizer and identified as malachite/CuCO3Cu(OH)2 (Schweizer 1994, 150). In some areas the orange-red layers (CP3) can also be found in between the black band (CP2) and the malachite (CP1). Elemental chemical distribution of the SEM image of Fig. 9 shows that the black layers are enriched in Sn but also contain Fe (Fig. 9). Superior markers such as contextual Al and Si are present in the outer malachite layers. S is present both on the rim of the outer black layer and in the malachite (Fig. 9, Table 3).

Fig. 7: Micrograph of the metal sample from Fig. 3 (detail) and corresponding to the stratigraphy of Fig. 4, unetched, bright field. Stratigraphy of the corrosion crust: inner light grey layer (CP3), intermediate dark grey layer with a light-grey rim (CP2) and outer grey-green layer (CP1),

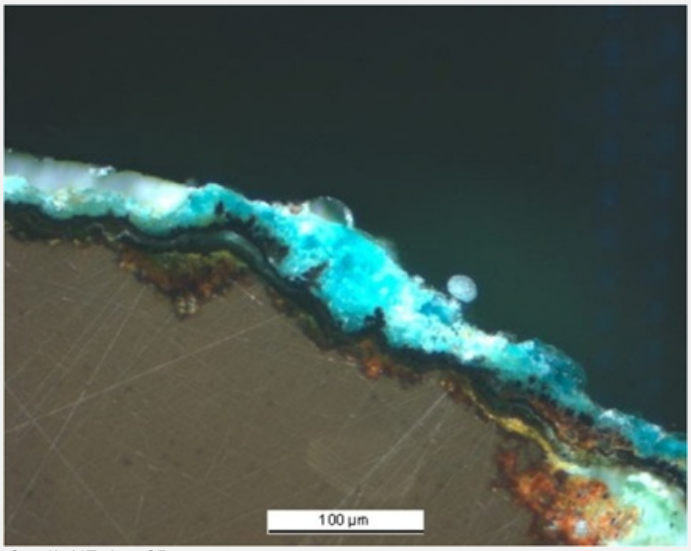
Fig. 8: Micrograph of the metal sample from Fig. 3 and corresponding to the stratigraphy of Fig. 4, polarised light. The metal appears in brown; the inner layer appears as red-orange, the intermediate layer as black and the outer layer as turquoise,

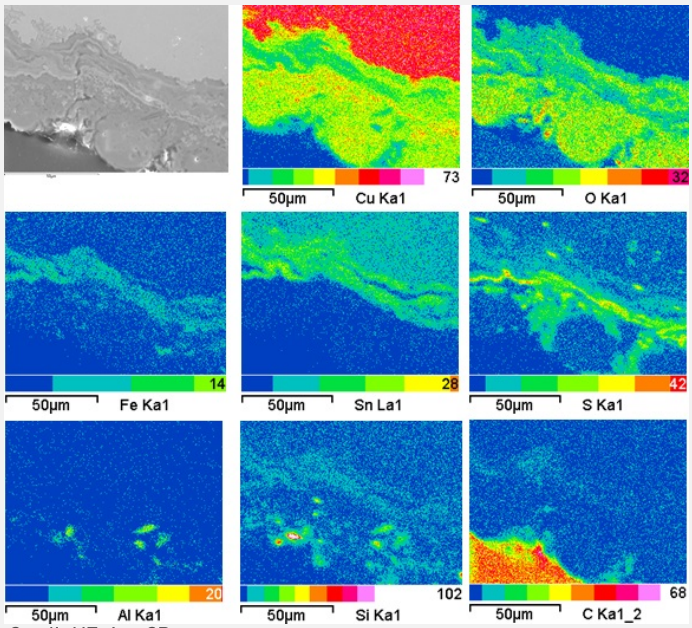
Fig. 9: SEM image, SE-mode, and elemental chemical distribution of a selected area of Fig. 3. Method of examination: SEM/EDS, Laboratory of Analytical Chemistry, Empa,

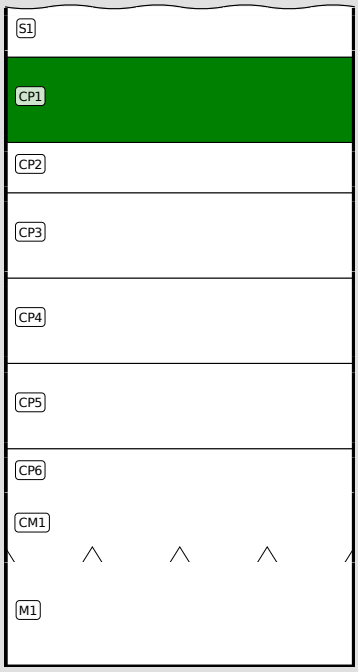
Fig. 4: Stratigraphic representation of the object in cross-section using the MiCorr application. The characteristics of the strata are only accessible by clicking on the drawing that redirects you to the search tool by stratigraphy representation. This representation can be compared to Figs. 7 and 8, Credit HE-Arc CR.
