PIN WITHOUT HEAD HR-18152 - TIN BRONZE - LATE BRONZE AGE - SWITZERLAND

Artefact name	Pin without head HR-18152
Authors	Marianne. Senn (EMPA, Dübendorf, Zurich, Switzerland) & Christian. Degrigny (HE-Arc CR, Neuchâtel, Neuchâtel, Switzerland)
Url	/artefacts/451/

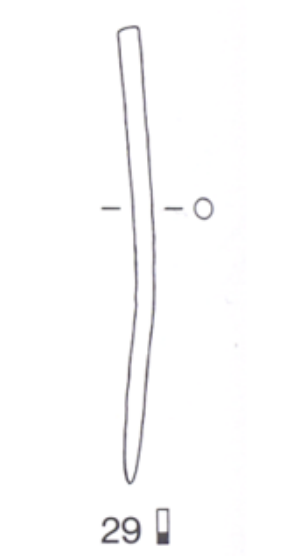
Fig. 1: Tin bronze pin without head (after Rychner-Faraggi 1993, plate 74.29),

Description of the artefact	Pin without head, light-brown patina typical of lake context (Fig. 1). Dimensions: L = 7,5cm; Ø = 3.3mm; WT = 4g.
Type of artefact	Pin
Origin	Hauterive - Champréveyres, Neuchâtel, Neuchâtel, Switzerland
Recovering date	Excavation 1983-1985, object from layer 3 to 5
Chronology category	Late Bronze Age
chronology tpq	1054 B.C.
chronology taq	1000 B.C.
Chronology comment	Hallstatt B1 (1054/1037BC _ 1000BC)

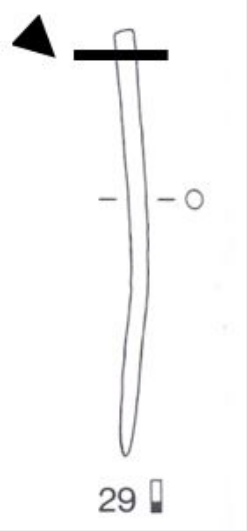
Fig. 2: Location of sampling area,

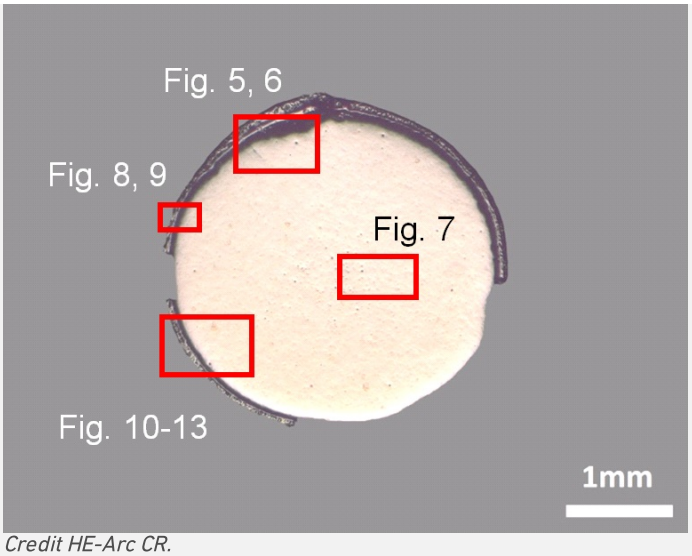
Fig. 3: Micrograph of the cross-section showing the location of Figs. 5 to 12,

Description of sample	The cross-section is circular and is a complete section through the pin (Fig. 2). It is covered with a rather thin and regular (in thickness) corrosion crust. One third of the corrosion crust is missing (Fig. 3).
Alloy	Tin Bronze
Technology	Annealed after cold working
Lab number of sample	MAH 87-194
Sample location	Musées d'art et d'histoire, Genève, Geneva
Responsible institution	Musées d'art et d'histoire, Genève, Geneva
Date and aim of sampling	1987, metallography and corrosion characterisation

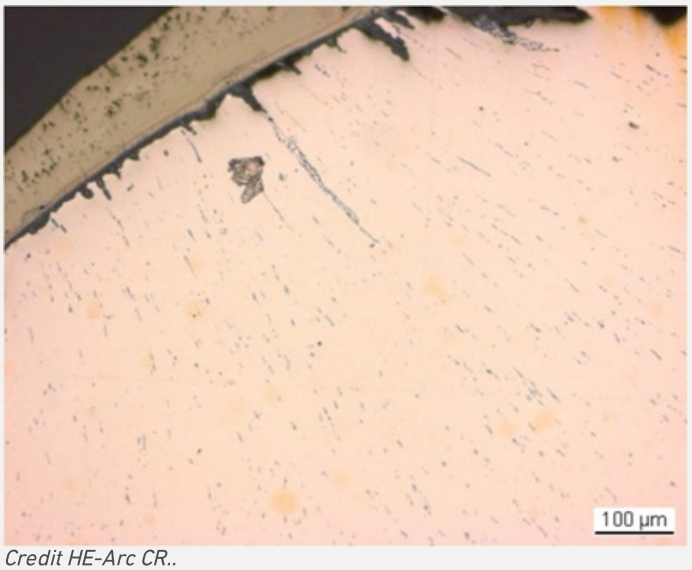
The remaining metal is a tin bronze and contains copper sulphide as well as heavy metal (Pb-rich) inclusions (Table 1, Figs. 5 and 6). Close to the surface of the remaining metal, copper sulphide inclusions are elongated and form rows (Fig. 5). The etched structure of the tin bronze shows polygonal grains; some of them are twinned (Fig. 7). In the centre of the sample and on the edges, the grains are smaller. The copper sulphide inclusions are located at the grain boundaries and in the grains. The average hardness of the metal is about HV1 110.

Fig. 5: Micrograph of the metal sample from Fig. 3 (detail), unetched, bright field. Rows of elongated copper sulphide inclusions can be observed,

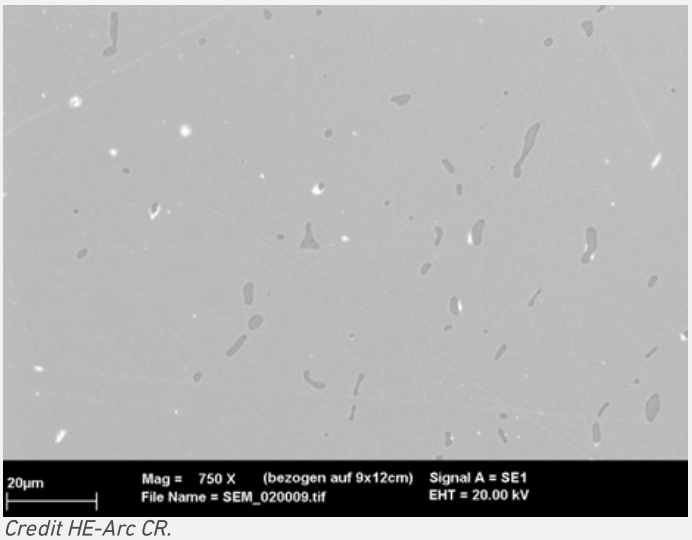
Fig. 6: SEM image of the metal sample from Fig. 3 (detail), SE-mode. Elongated copper sulphide inclusions (dark-grey) are visible as well as heavy metal (Pb-rich) inclusions (white),

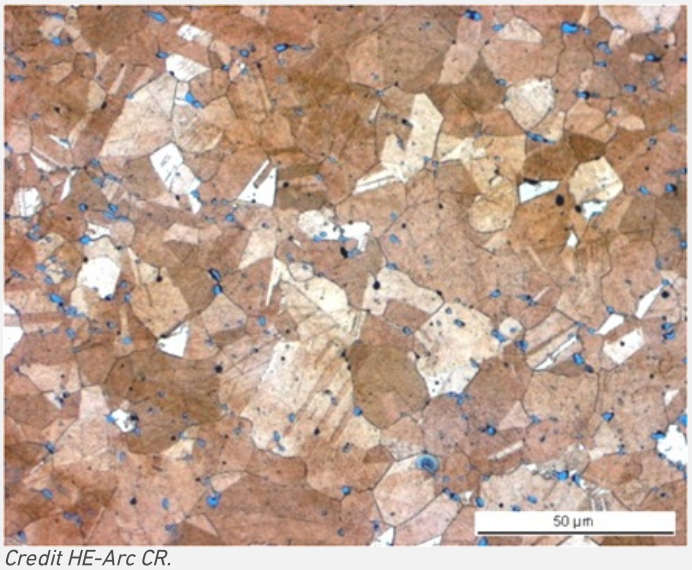
Fig. 7: Micrograph of the metal sample from Fig. 3 (detail), etched, bright field. The metal shows a structure of polygonal and twinned grains. Copper sulphide inclusions are visible as blue spots,

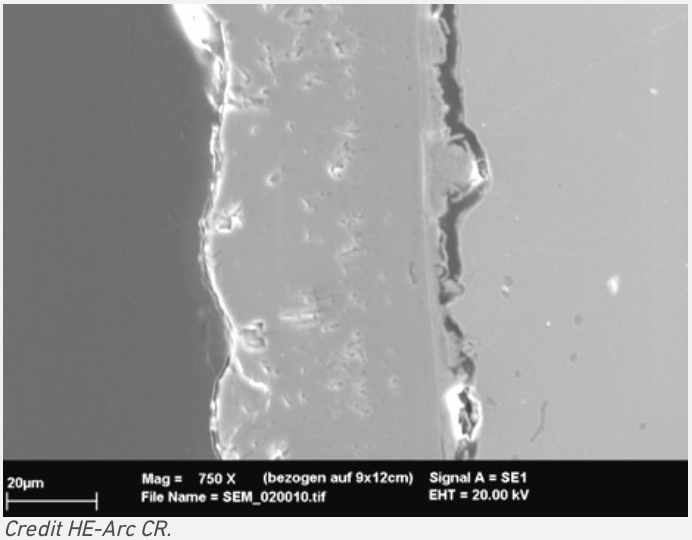
The corrosion crust is regular in thickness (100µm). One third is missing (Fig. 3). At the metal - corrosion crust interface, there is a crack showing that the latter has separated from the metal core along its whole length (Figs. 8 and 9). The corrosion crust can be divided into three distinct layers (CP1-3). Directly above the crack is a first dense but cracked and irregular inner layer (CP3, Figs. 8 and 9). In bright field it appears brown (Fig. 10), in polarised light dark brown (Fig. 11). It is separated from the adjacent layer by a clear line (Figs. 9 and 10). The second layer (CP2) is dense with little porosity (Figs. 8 and 9). In bright field it appears light brown (fig. 10), in polarised dark grey (Fig. 11). The third and outermost layer (CP1) appears light brown in bright field (Fig. 10), contains particles (Fig. 9) and is very porous (visible as golden reflections under polarized light, Fig. 11). The elemental chemical distribution of the SEM image selected reveals that the inner layer (CP3) is depleted in Cu, but rich in Sn,O and Si (Fig. 12 and Table 2) and its interface with the intermediate layer (CP2) could represent the limit of the original surface (Figs. 8 and 12). The second and third layer (CP2 and CP1) are Fe,Cu and S-rich (Fig. 12) and have a composition similar to chalcopyrite/$CuFeS_2$ (Table 2). This was confirmed by XRD. The particles (inclusions) have a composition similar to covelline or covellite/CuS (Table 2). Both chalcopyrite and covelline have been identified by Raman spectroscopy (Figs. 13 and 14).

Fig. 8: SEM image of the metal sample from Fig. 3 (detail), SE -mode. The crack between the remaining metal and the corrosion layers is clearly visible,

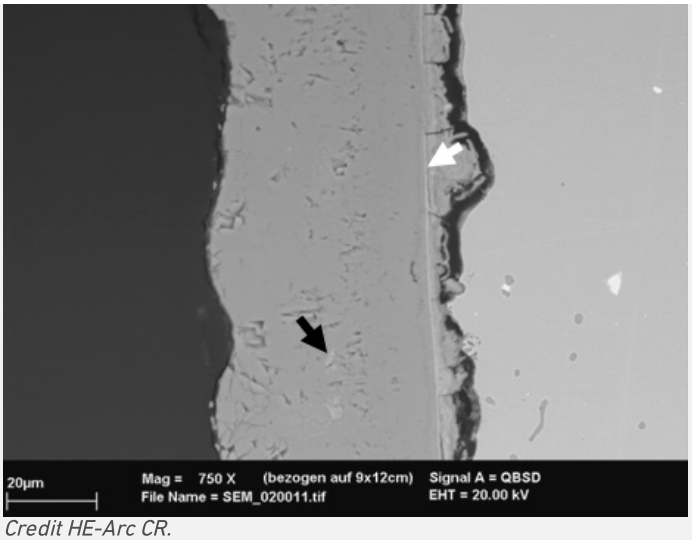
Fig. 9: SEM image similar to Fig. 8, BSE-mode. A thin line is visible (white arrow) differentiating the inner Sn-rich layer from the intermediate and outer chalcopyrite layers. The latter contains bright covelline inclusions (black arrow) and pores,

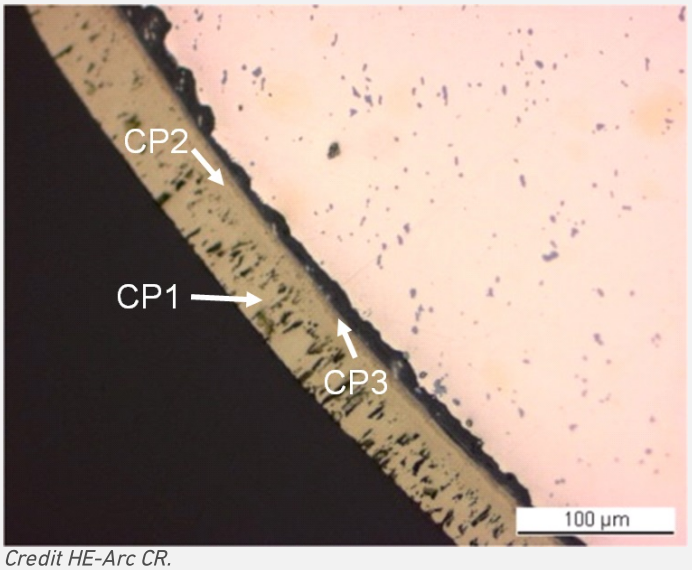
Table 2: Chemical composition (mass %) of the corrosion layer from Fig. 10. Method of analysis: SEM/EDS, Laboratory of Analytical Chemistry, Empa.

Fig. 10: Micrograph of the metal sample from Fig. 3 (detail) and corresponding to the stratigraphy of Fig. 4, unetched, bright field,

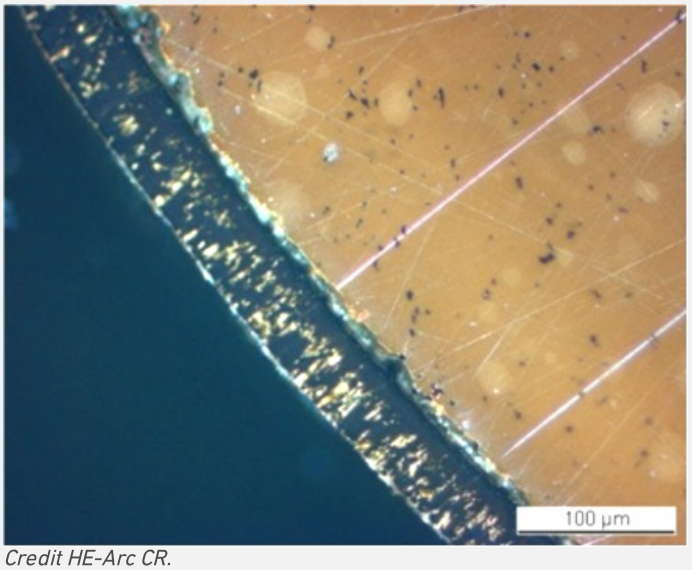
Fig. 11: Micrograph similar to Fig. 10, polarised light,

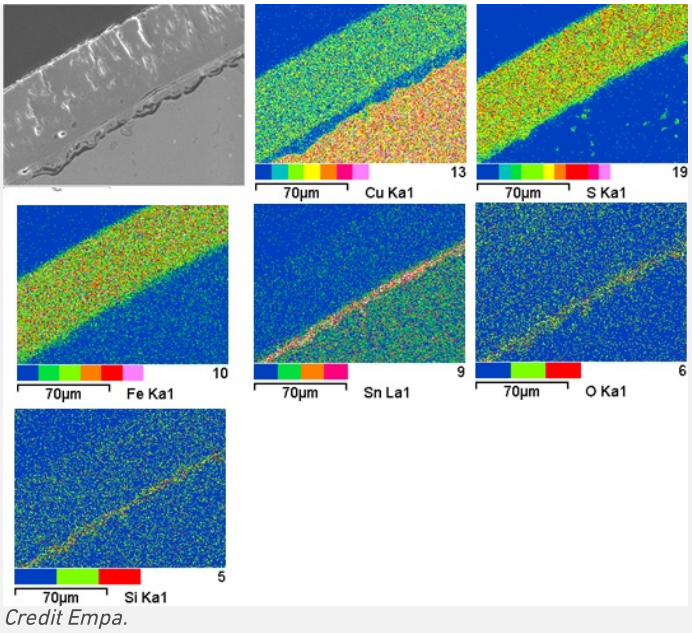
Fig. 12: SEM image and elemental chemical distribution of a selected area of Fig. 10 (rotated by 90°). Method of examination: SEM/EDS, Laboratory of Analytical Chemistry, Empa,

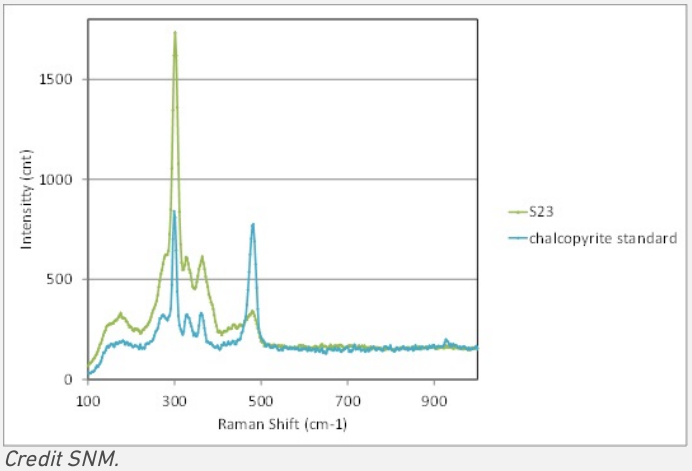
Fig. 13: Raman spectrum of the outermost layer (S23) of Fig. 9 compared to a chalcopyrite standard spectrum. Settings: laser wavelength 532nm, acquisition time 50s, 4 accumulations, filter D2 (0.75-0.8mW), hole 1000, slit 100, grating 600. Method of analysis: Raman spectroscopy, Lab of Swiss National Museum, Affoltern a. Albis ZH,

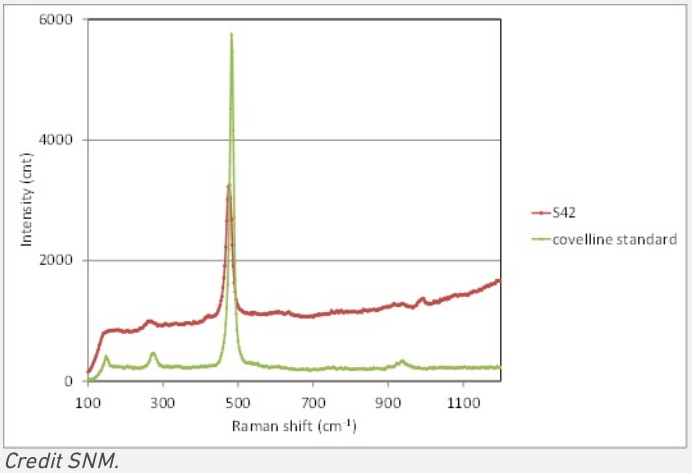
Fig. 14: Raman spectrum of the inclusions of the outermost layer (S42) of Fig. 9 compared to a covelline / covellite standard spectrum. Settings: laser wavelength 532nm, acquisition time 10s, 5 accumulations, D2 (0.75-0.8mW), hole 500, slit 80, grating 600. Method of analysis: Raman spectroscopy, Lab of Swiss National Museum, Affoltern a. Albis ZH,

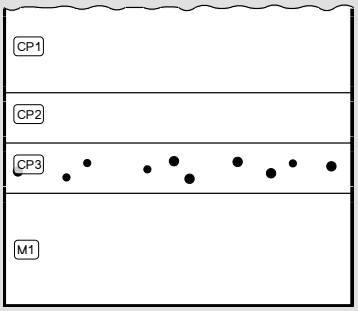
Fig. 4: Stratigraphic representation of the object in cross-section using the MiCorr application. The characteristics of the strata are only accessible by clicking on the drawing that redirects you to the search tool by stratigraphy representation. This representation can be compared to Fig. 10, Credit HE-Arc CR.
