PIN WITHOUT HEAD HR-18152 - TIN BRONZE - LATE BRONZE AGE - SWITZERLAND

Artefact name Pin without head HR-18152

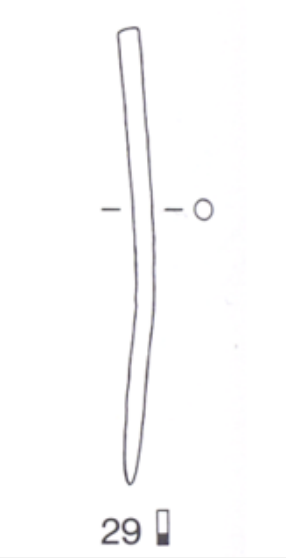
Fig. 1: Tin bronze pin without head (after Rychner-Faraggi 1993, plate 74.29),

Description of the artefact Pin without head, light-brown patina typical of lake context (Fig. 1). Dimensions: L = 7,5cm; Ø = 3.3mm; WT = 4g.

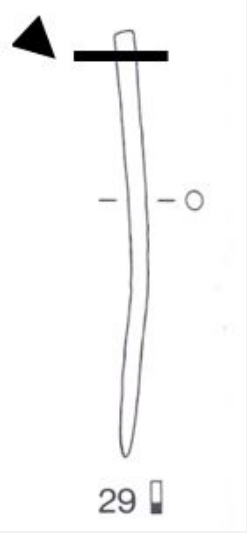
Fig. 2: Location of sampling area,

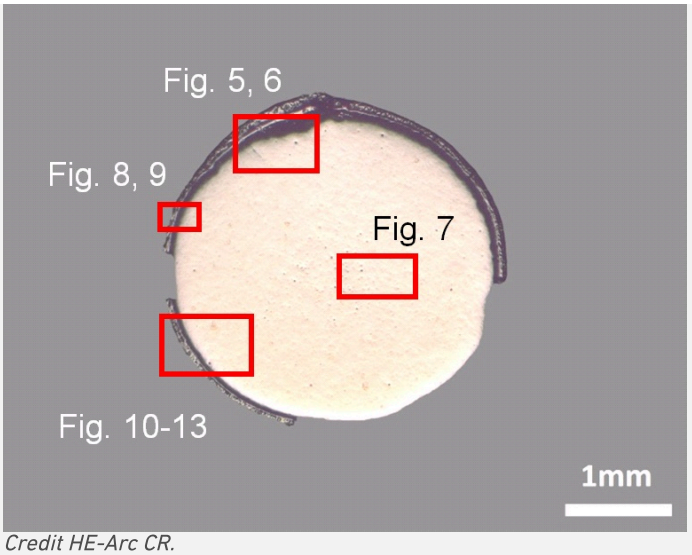
Fig. 3: Micrograph of the cross-section showing the location of Figs. 5 to 12,

Description of sample	The cross-section is circular and is a complete section through the pin (Fig. 2). It is covered with a rather thin and regular (in thickness) corrosion crust. One third of the corrosion crust is missing (Fig. 3).
Alloy	Tin Bronze
Technology	Annealed after cold working
Lab number of sample	MAH 87-194
Sample location	Musées d'art et d'histoire, Genève, Geneva
Responsible institution	Musées d'art et d'histoire, Genève, Geneva
Date and aim of sampling	1987, metallography and corrosion characterisation

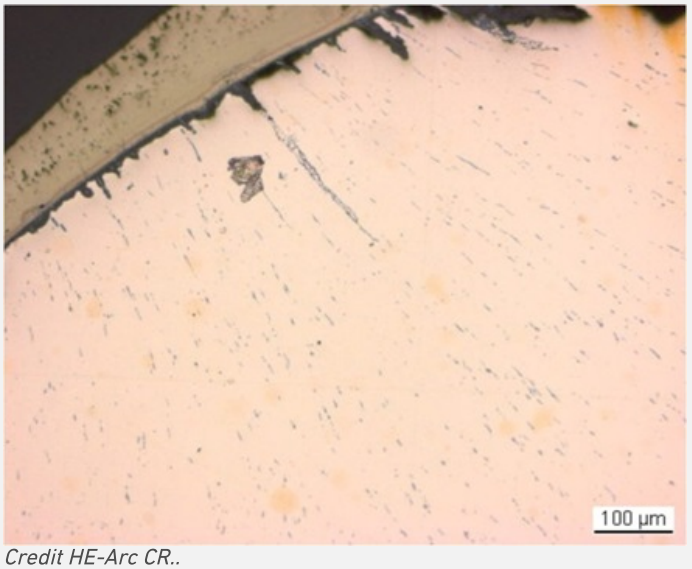
Elements	Cu	Sn	Pb	Sb	As	Ag	Fe	Ni	Co	Zn
mass%	89.22	9.57	0.34	0.26	0.19	0.15	0.09	0.05	0.06	0.05

Table 1: Chemical composition of the metal. Method of analysis: ICP-OES, Laboratory of Analytical Chemistry, Empa.

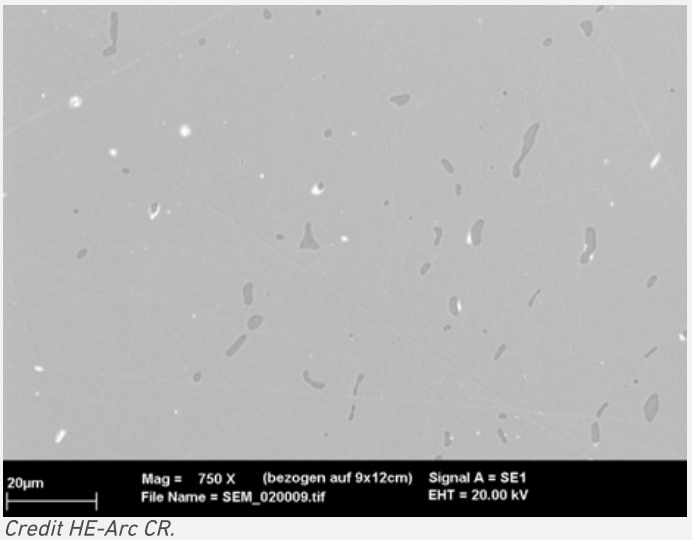
The remaining metal is a tin bronze and contains copper sulphide as well as heavy metal (Pb-rich) inclusions (Table 1, Figs. 5 and 6). Close to the surface of the remaining metal, copper sulphide inclusions are elongated and form rows (Fig. 5). The etched structure of the tin bronze shows polygonal grains; some of them are twinned (Fig. 7). In the centre of the sample and on the edges, the grains are smaller. The copper sulphide inclusions are located at the grain boundaries and in the grains. The average hardness of the metal is about HV1 110.

Fig. 5: Micrograph of the metal sample from Fig. 3 (detail), unetched, bright field. Rows of elongated copper sulphide inclusions can be observed,

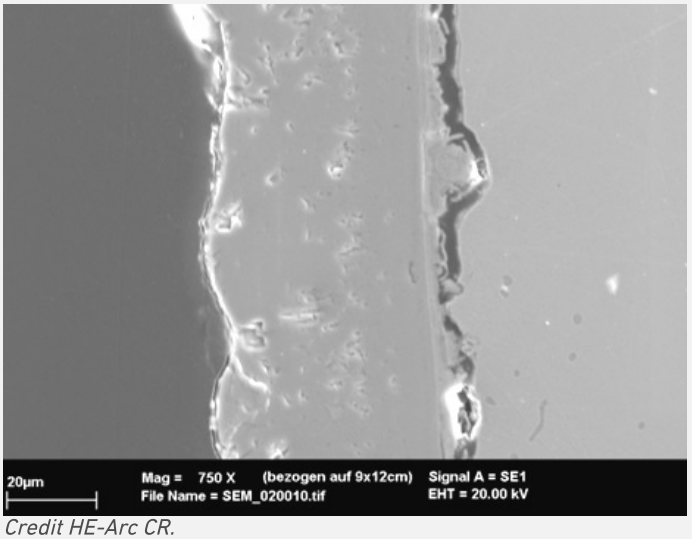
The corrosion crust is regular in thickness (100µm). One third is missing (Fig. 3). At the metal - corrosion crust interface, there is a crack showing that the latter has separated from the metal core along its whole length (Figs. 8 and 9). The corrosion crust can be divided into three distinct layers (CP1-3). Directly above the crack is a first dense but cracked and irregular inner layer (CP3, Figs. 8 and 9). In bright field it appears brown (Fig. 10), in polarised light dark brown (Fig. 11). It is separated from the adjacent layer by a clear line (Figs. 9 and 10). The second layer (CP2) is dense with little porosity (Figs. 8 and 9). In bright field it appears light brown (fig. 10), in polarised dark grey (Fig. 11). The third and outermost layer (CP1) appears light brown in bright field (Fig. 10), contains particles (Fig. 9) and is very porous (visible as golden reflections under polarized light, Fig. 11). The elemental chemical distribution of the SEM image selected reveals that the inner layer (CP3) is depleted in Cu, but rich in Sn,O and Si (Fig. 12 and Table 2) and its interface with the intermediate layer (CP2) could represent the limit of the original surface (Figs. 8 and 12). The second and third layer (CP2 and CP1) are Fe,Cu and S-rich (Fig. 12) and have a composition similar to chalcopyrite/$CuFeS_2$ (Table 2). This was confirmed by XRD. The particles (inclusions) have a composition similar to covelline or covellite/CuS (Table 2). Both chalcopyrite and covelline have been identified by Raman spectroscopy (Figs. 13 and 14).

Elements	S	Fe	Cu	O	Si	Sn	Total
CP1 and CP2	35	30	34	<	<	<	99
Particles in CP1	26	4.1	68	<	<	<	98
CP3	5.8	5.0	13	32	2	41	99

Table 2: Chemical composition (mass %) of the corrosion layer from Fig. 10. Method of analysis: SEM/EDS, Laboratory of Analytical Chemistry, Empa.

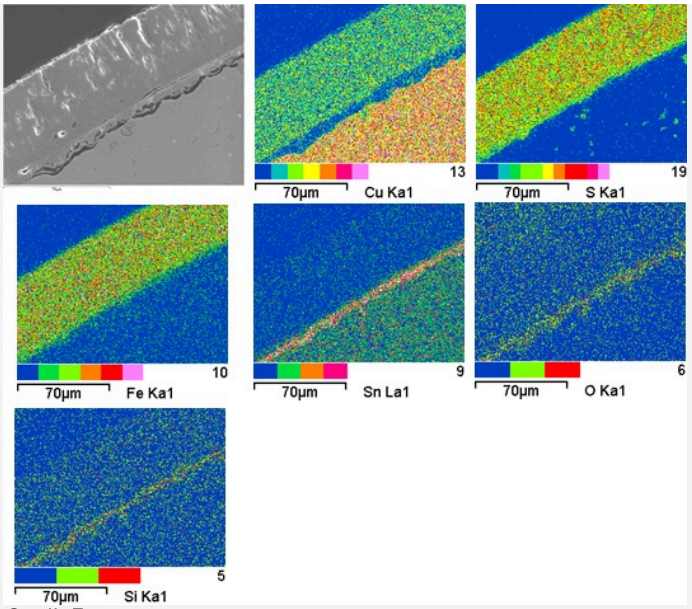
Fig. 12: SEM image and elemental chemical distribution of a selected area of Fig. 10 (rotated by 90°). Method of examination: SEM/EDS, Laboratory of Analytical Chemistry, Empa,

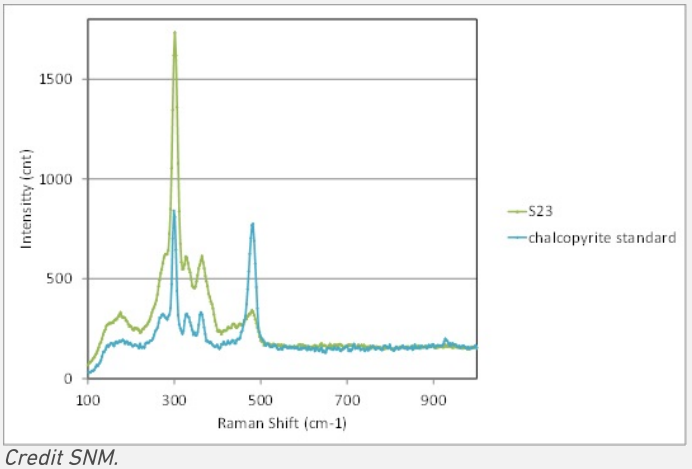
Fig. 13: Raman spectrum of the outermost layer (S23) of Fig. 9 compared to a chalcopyrite standard spectrum. Settings: laser wavelength 532nm, acquisition time 50s, 4 accumulations, filter D2 (0.75-0.8mW), hole 1000, slit 100, grating 600. Method of analysis: Raman spectroscopy, Lab of Swiss National Museum, Affoltern a. Albis ZH,

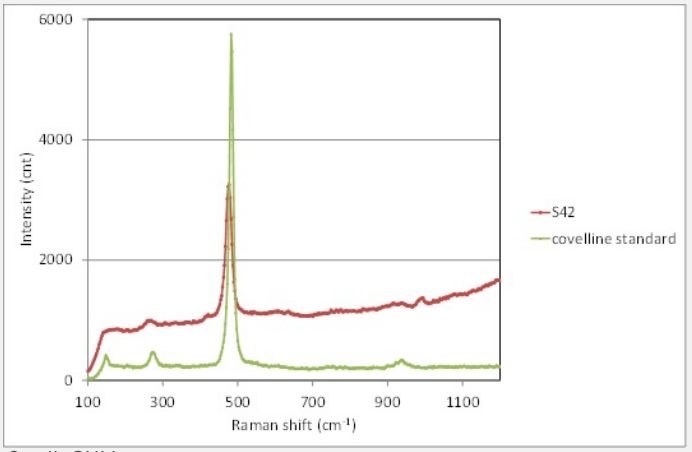
Fig. 14: Raman spectrum of the inclusions of the outermost layer (S42) of Fig. 9 compared to a covelline / covellite standard spectrum. Settings: laser wavelength 532nm, acquisition time 10s, 5 accumulations, D2 (0.75-0.8mW), hole 500, slit 80, grating 600. Method of analysis: Raman spectroscopy, Lab of Swiss National Museum, Affoltern a. Albis ZH,

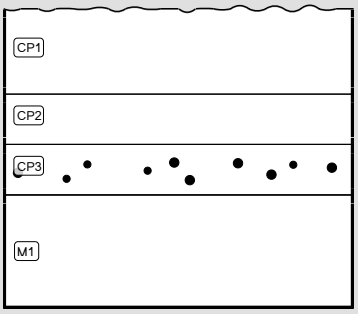
Fig. 4: Stratigraphic representation of the object in cross-section using the MiCorr application. The characteristics of the strata are only accessible by clicking on the drawing that redirects you to the search tool by stratigraphy representation. This representation can be compared to Fig. 10, Credit HE-Arc CR.
