PIN WITHOUT HEAD HR-18152 - TIN BRONZE - LATE BRONZE AGE - SWITZERLAND

Artefact name Pin without head HR-18152

Authors Marianne. Senn (EMPA, Dübendorf, Zurich, Switzerland) & Christian. Degrigny (HE-Arc CR, Neuchâtel, Neuchâtel, Switzerland)

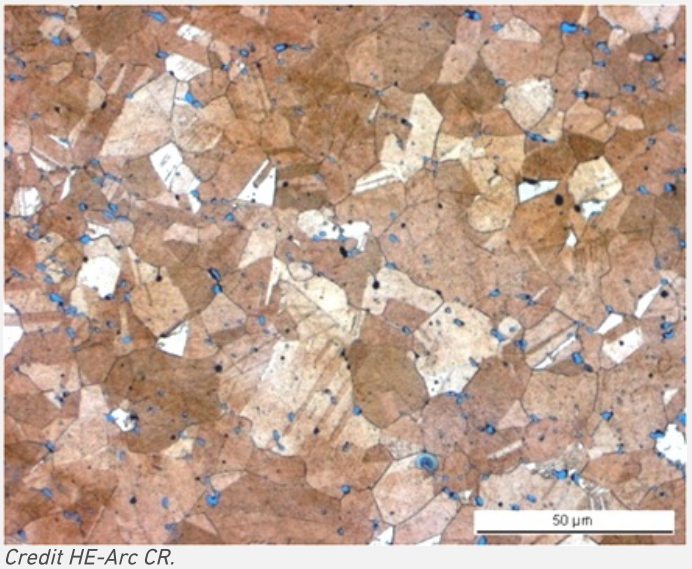
Fig. 7: Micrograph of the metal sample from Fig. 3 (detail), etched, bright field. The metal shows a structure of polygonal and twinned grains. Copper sulphide inclusions are visible as blue spots,

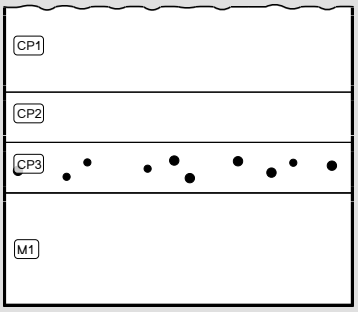
Fig. 4: Stratigraphic representation of the object in cross-section using the MiCorr application. The characteristics of the strata are only accessible by clicking on the drawing that redirects you to the search tool by stratigraphy representation. This representation can be compared to Fig. 10, Credit HE-Arc CR.
