# OVAL BRACELET WITH SURFACE DECORATIONS OF LINES AND INDENTATIONS MAH ANC. 2662 – LEADED BRONZE – LATE BRONZE AGE – SWITZERLAND

| **Authors** | Marianne. Senn (EMPA, Dübendorf, Zurich, Switzerland) & Christian. Degrigny (HE-Arc CR, Neuchâtel, Neuchâtel, Switzerland) |

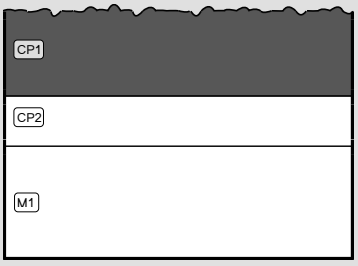
Fig. 4: Stratigraphic representation of the object in cross-section using the MiCorr application. The characteristics of the strata are only accessible by clicking on the drawing that redirects you to the search tool by stratigraphy representation. This representation can be compared to Fig. 7, Credit HE-Arc CR.

The surface of the cast leaded bronze has been replaced by a Sn-rich corrosion that retains a dendritic ghost structure. It is composed of a mixture of copper oxides (cuprite?) and a Sn-rich corrosion product (cassiterite?). The outer corrosion layer is composed of Fe-O and Sn-O-Fe areas depleted of Cu, but contaminated with Si. The enrichment in Fe seems to be the same as for the formation of patinas from lake contexts. However the outer corrosion layer was not formed in anaerobic conditions (Fig. 7). Since the original surface is absent (destroyed) we refer to type corrosion 2 after Robbiola et al. 1998.
